## Career Fire Lieutenant Killed By Roof/Ceiling Collapse During Overhaul—Georgia

### Executive Summary

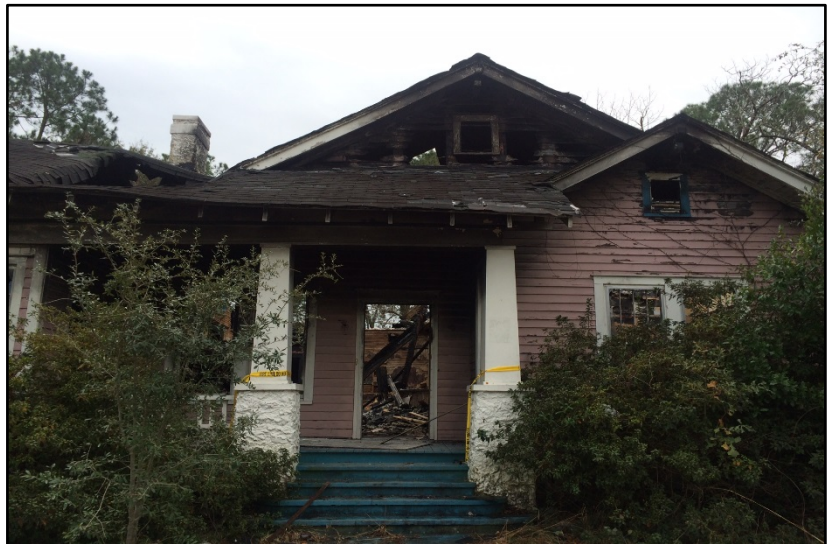
**A lieutenant was killed during overhaul after a ceiling and roof assembly collapsed in this vacant building.**  
(Photo by NIOSH.)

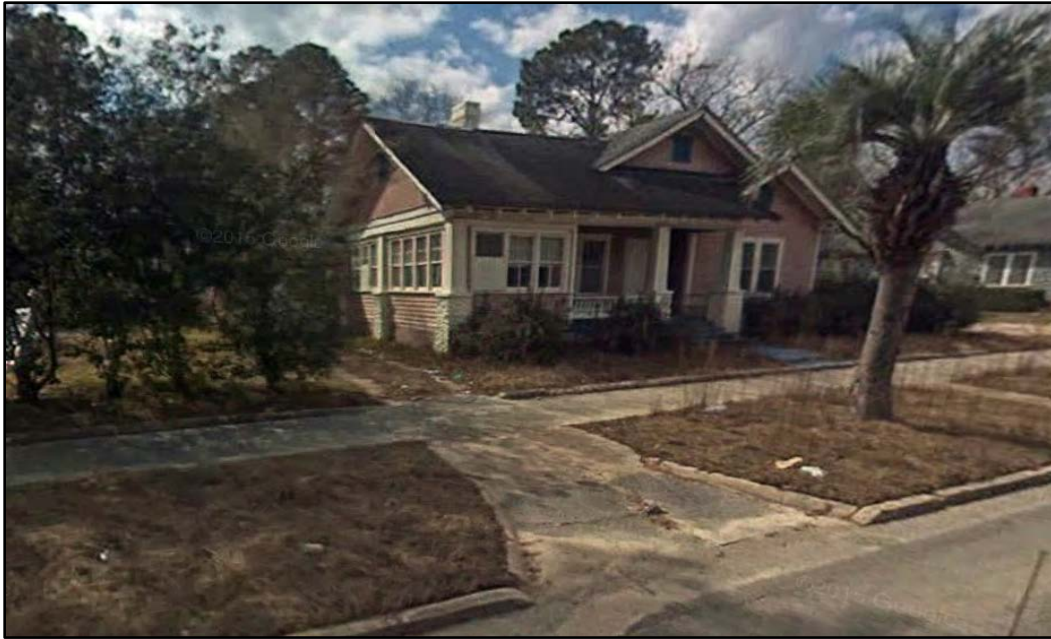
**Photo 1. Street view in 2008.**  
(Google Maps)

Built upon a raised crawl space, the structural wood framing system incorporated conventionally full dimensioned 2-inch x 4-inch construction with limited fire stopping (balloon-frame like) with a cross-gable style roof. The low pitched cross-gable roof was constructed of full dimensioned wood rafters conventionally spaced with a 1-inch x 6-inch plank roof deck covered with asphalt shingles creating multiple roof lines and slopes. The three cross-gable roofs had louvered panels located at each end gable, providing ventilation to the concealed roof underdeck attic space. Roof rafters extended beyond the roof edge, creating extended eave lines. The perimeter walls were wood clad clapboard with a large allocation of double hung windows on all building sides, characteristic of this house style. A typical entry porch and entry door were present on Side A with a glass enclosed porch addition constructed in 1958 added to Side B. A small, attached garage was present on Side B (see Photos 1, 2).

A single family residential occupancy at the time of the fire, the structure was considered an abandoned home. The property was in a state of disrepair and had a heavy overgrowth of vegetation, brush, and trees, limiting access on Side D. The structure was heavily involved in fire on arrival (see Photo 3). The local jurisdiction had issued a number of “notice of unsafe structure” notices sent to the property owners dating back to 2008 and a “certification of unsafe building” was issued by the local building official in 2011. It was also noted in the records of the Authority Having Jurisdiction (AHJ) on October 11, 2011, that the structure was to be demolished as unsafe. There were no power or utilities active at the time of the fire. The electric power was turned off in 2006 and the water turned off in 2004.

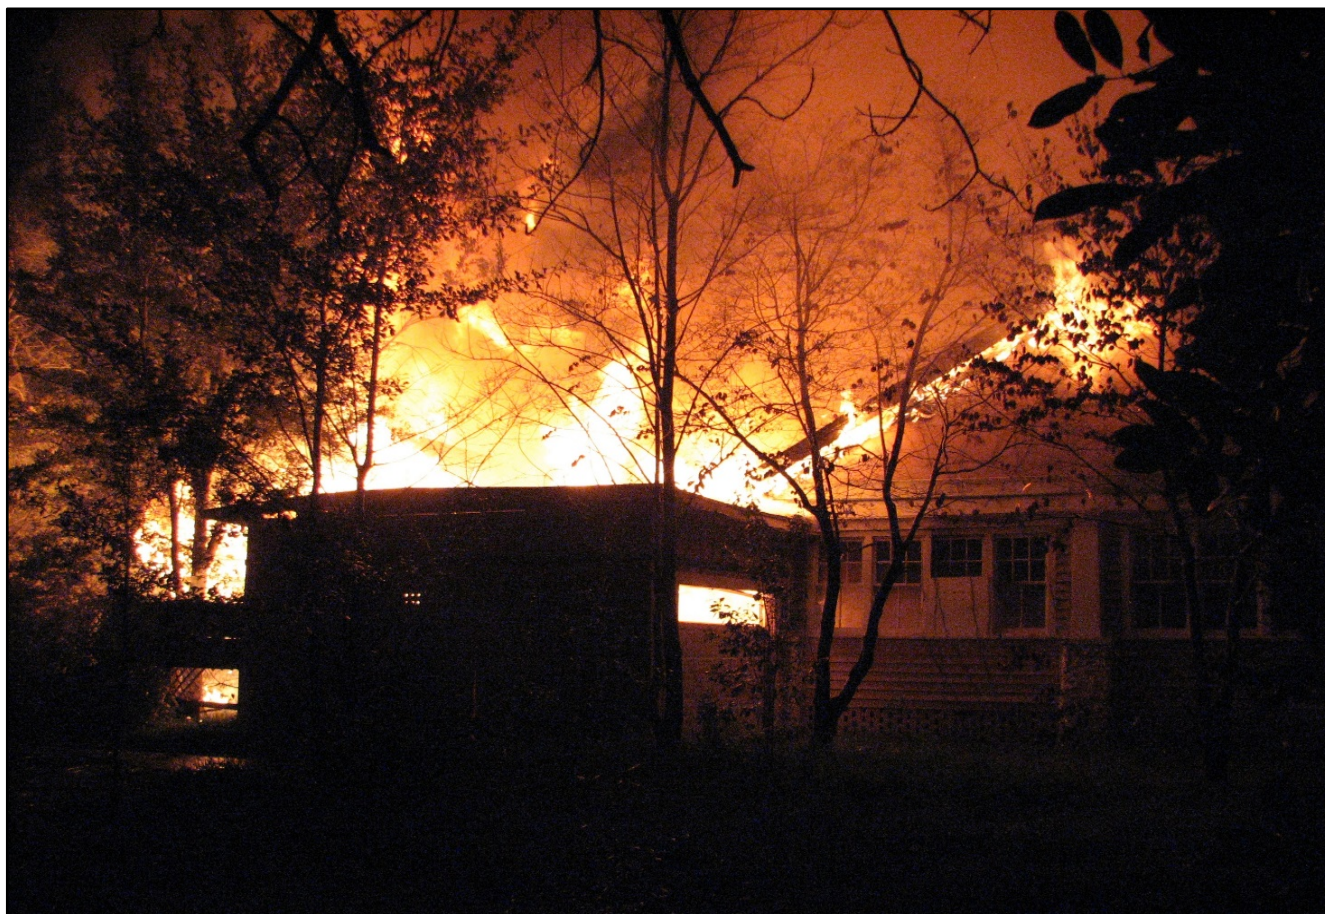
**Photo 3. Arrival photo Side B taken by chief of department.**  
*(Photo courtesy of the fire department/ fire marshal.)*

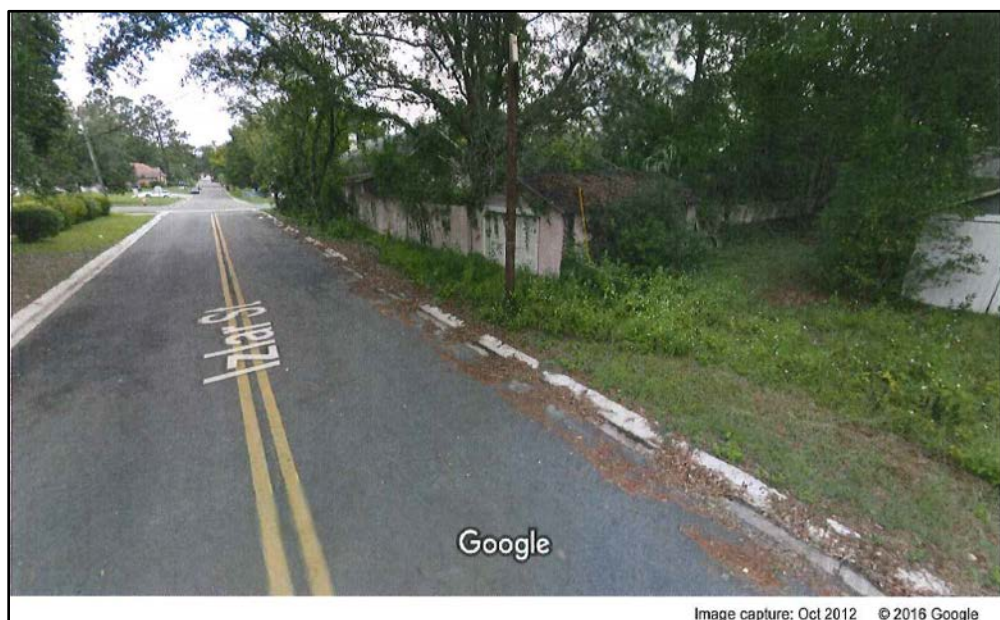
Engine 1 was a PAR 3 (PAR 3 refers to the number of fire fighters on the crew) that evening and arrived, staged on Side D (close to Side C), and stretched a 1¾-inch handline toward Side C. The crew had to break through a fence (see Photo 4) to gain access and attacked a large volume of fire from the exterior. This crew stated that walls and roof on Side C were burned away and that much of the fire was eventually knocked down. However, the fire was still burning in the attic spaces toward Side A. Ladder Truck 1 arrived (PAR 1) and staged out of the way on side-A. The driver joined the crew of Engine 1 and staffed a booster line on the exterior of Side D next to Engine 1.

**Photo 4. Pre-fire, Side D, where Engine 1 staged and had to cross fence with 1¾-inch handline to attack Side C.  
(Google Maps, streetview.)**

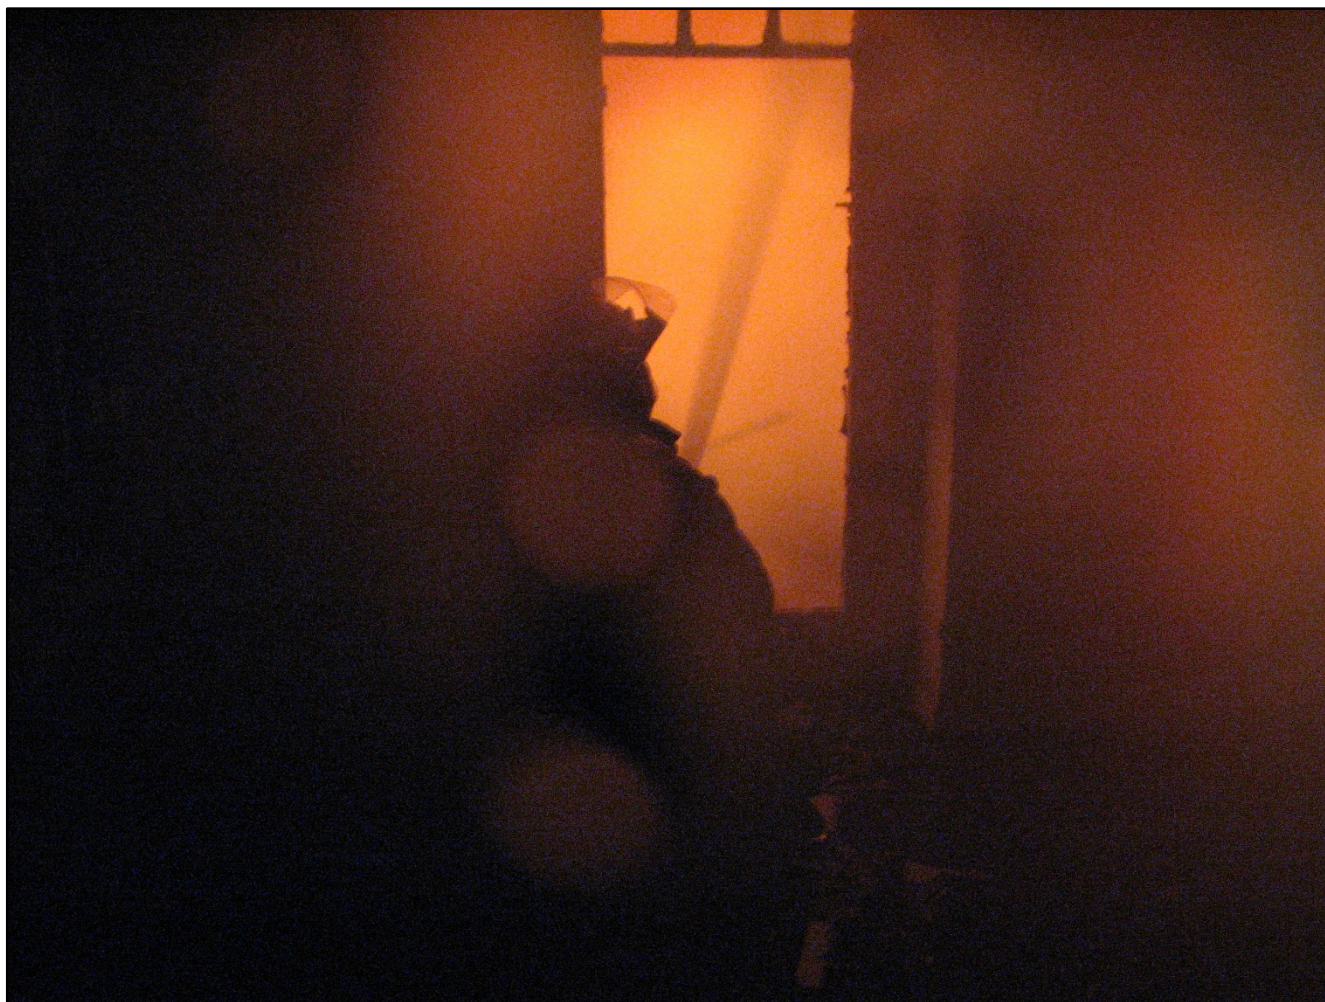
**Photo 5. Photo of lieutenant attacking fire. Photo taken by chief of department from Side B closed-in porch.**

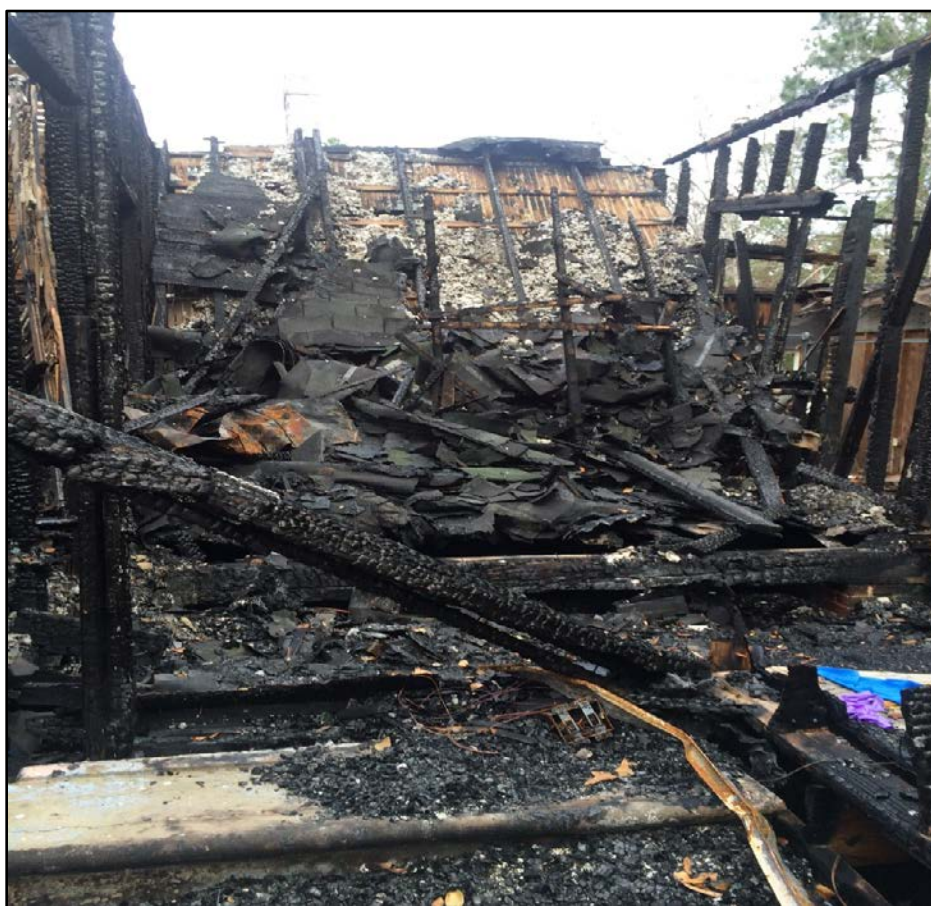
The fire was reported under control at 0142, and fire fighters were operating in a overhaul mode. Crews reported during interviews great difficulty trying to pull ceilings to access the fire in the attic space. There were reported to be multiple layers of ceiling material that consisted of original plaster and lath attached directly to the dimensioned lumber ceiling joists, wood tongue and groove panel boards, and gypsum wallboard attached to previous layers (see ceiling example Photo 6 and Figures 1,2). This was a labor-intensive overhaul and the fire continued to smolder and burn in the attic area.

**Photo 6. Example photo of ceiling load in adjacent room.  
(NIOSH photo.)**

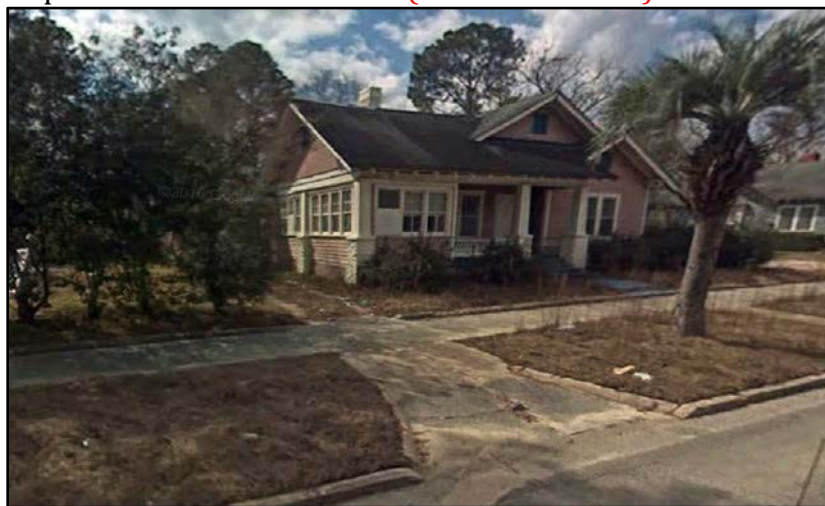
**Photo A**

Built upon a raised crawl space, the structural wood framing system incorporated conventionally full dimensioned 2 inch x 4 inch construction with limited fire stopping (balloon-frame like) with a cross-gable style roof. The low pitched cross-gable roof was constructed of full dimensioned wood rafters conventionally spaced with a 1 inch x 6 inch plank roof deck and asphalt shingle covering creating multiple roof lines and slopes. The three cross-gable roofs had louvered panels located at each end gable providing ventilation to the concealed roof underdeck attic space. Roof rafters extended beyond the roof edge creating extended eave lines. The perimeter walls were wood clad clapboard with a large allocation of double hung windows on all building sides characteristic of this house style. A typical entry porch and entry door was present on Side A with a glass enclosed porch addition constructed in 1958 added to the Bravo side. A small attached garage was present on the Bravo side. **(Refer to Photo A)**

Courtesy of Google Maps Street View-circa 2008
