**NIOSH**  
Fire Fighter Fatality Investigation  
and Prevention Program

November 25, 2014

## ***Career Fire Fighter Killed by Structure Collapse While Conducting Interior Search for Occupants Following 4<sup>th</sup> Alarm – Texas***

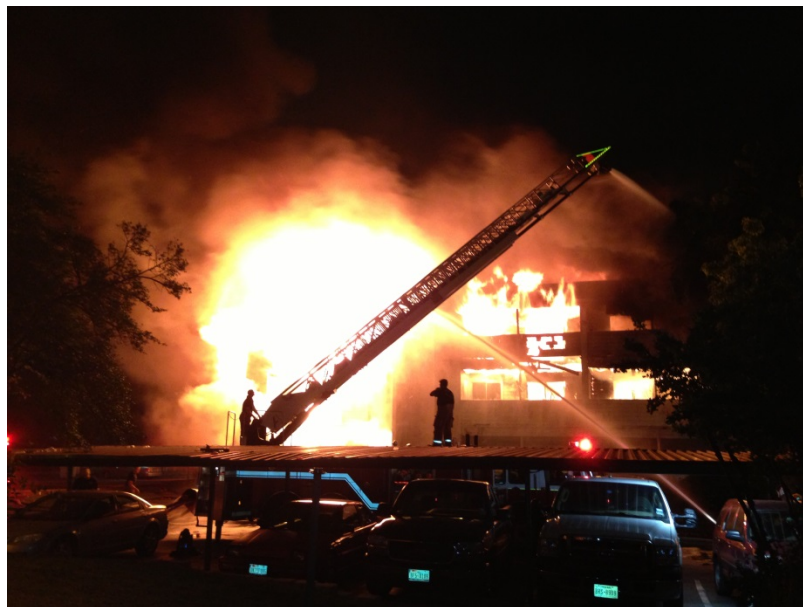
**Fire conditions at Side C prior to collapse**  
*(Photo courtesy of fire department)*

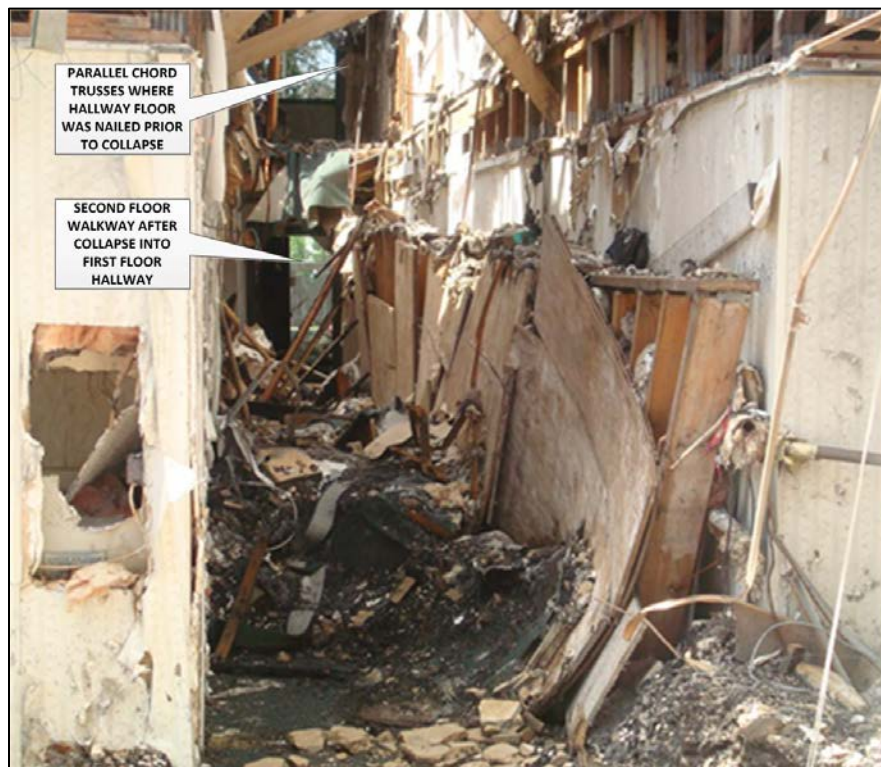
**Photo 1. Hallway support construction in collapse area.**  
(NIOSH Photo)

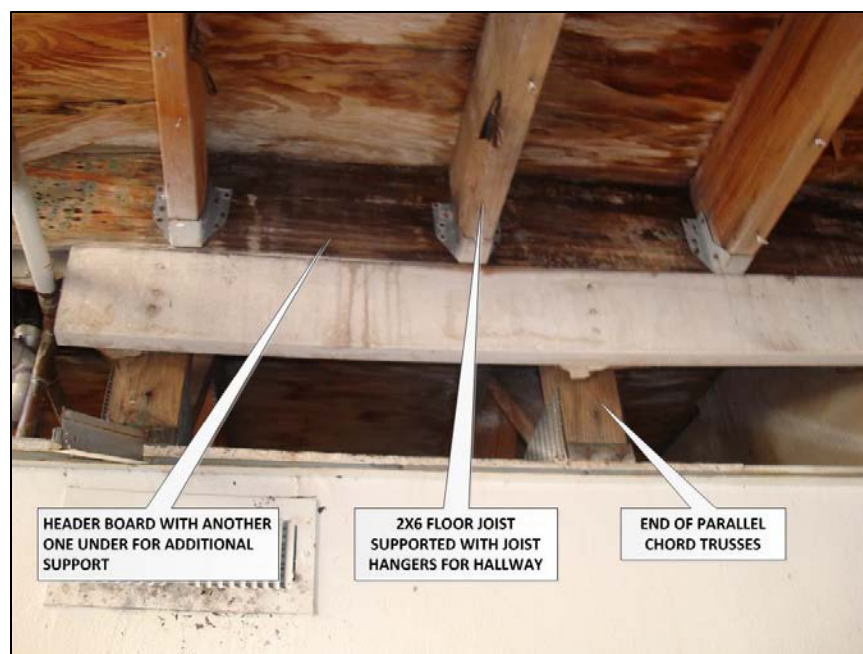
**Photo 2. Close-up detail of hallway support construction.**  
(NIOSH Photo)

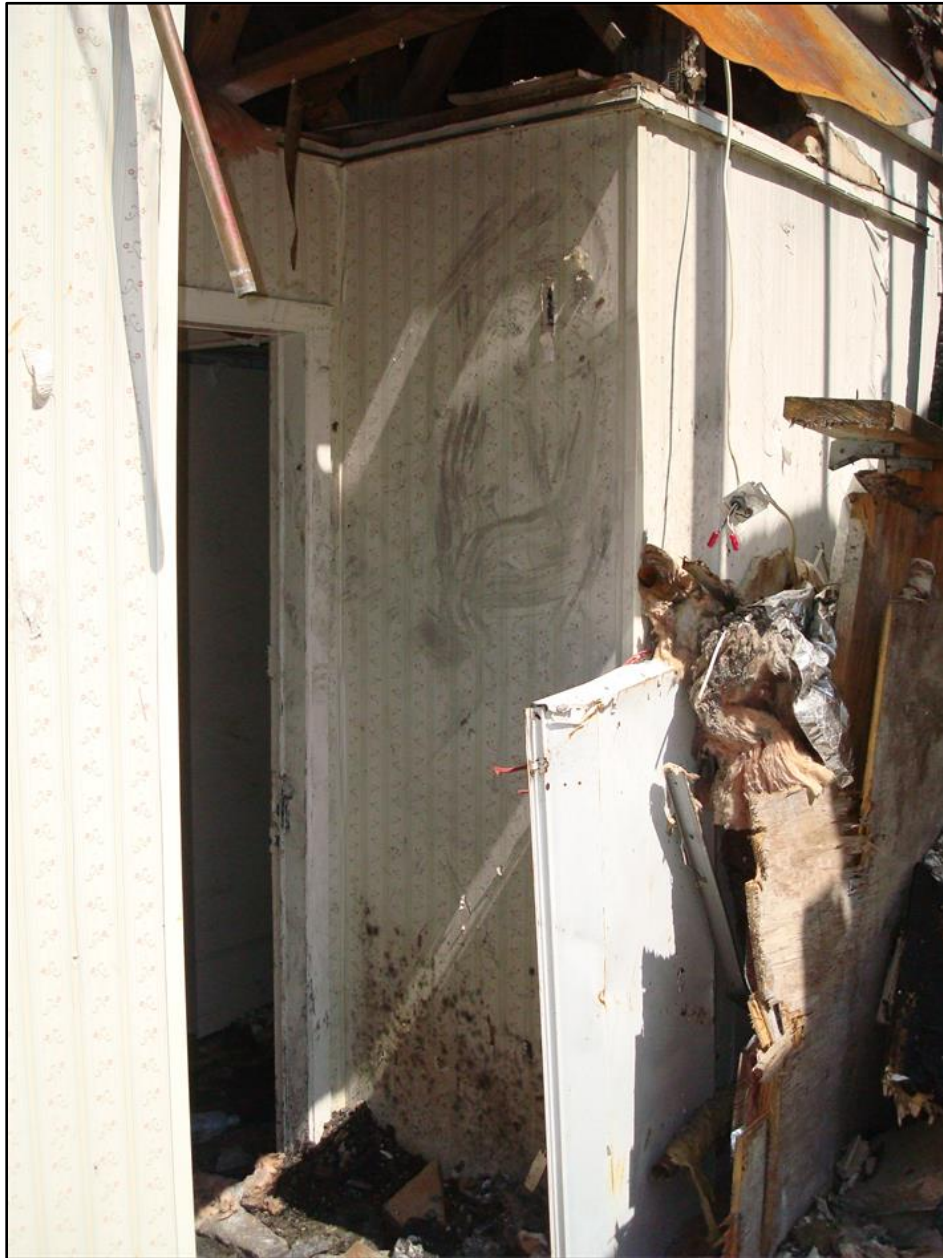
**Photo 3. Apartment entrance recessed where victim's partner was trapped after collapse.  
(NIOSH Photo)**

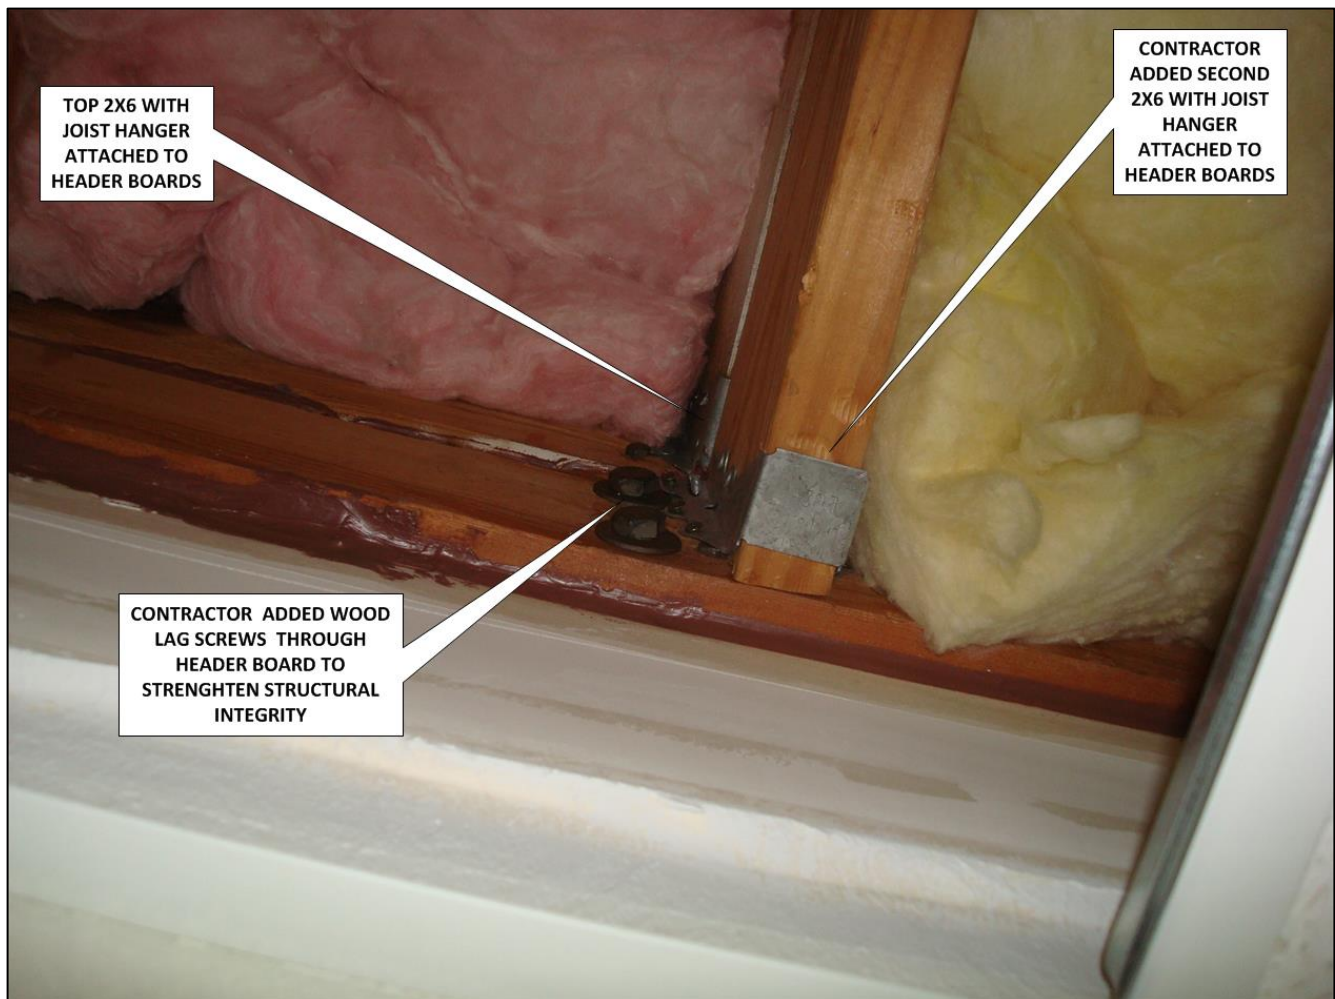
**Photo 4. Double 2x6 floor joists and lag screws added by contractor in an attempt to improve structural integrity within the apartment complex.**

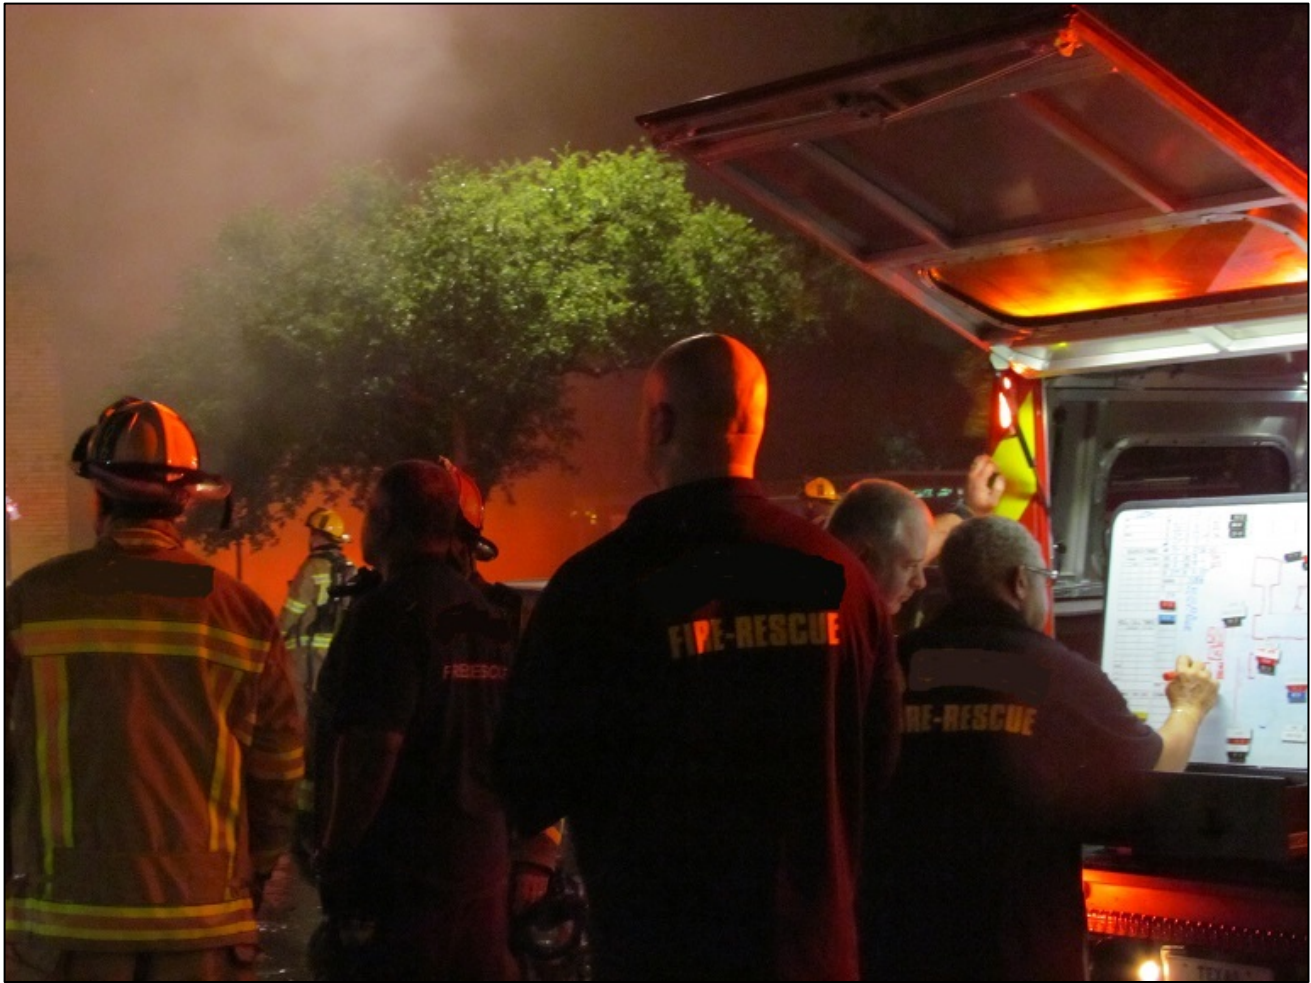
**Photo 6. Command Tech trying to fill in the command board at the back of the command vehicle (BC4) at approximately 0354 hours.**  
*(Photo courtesy of fire department)*

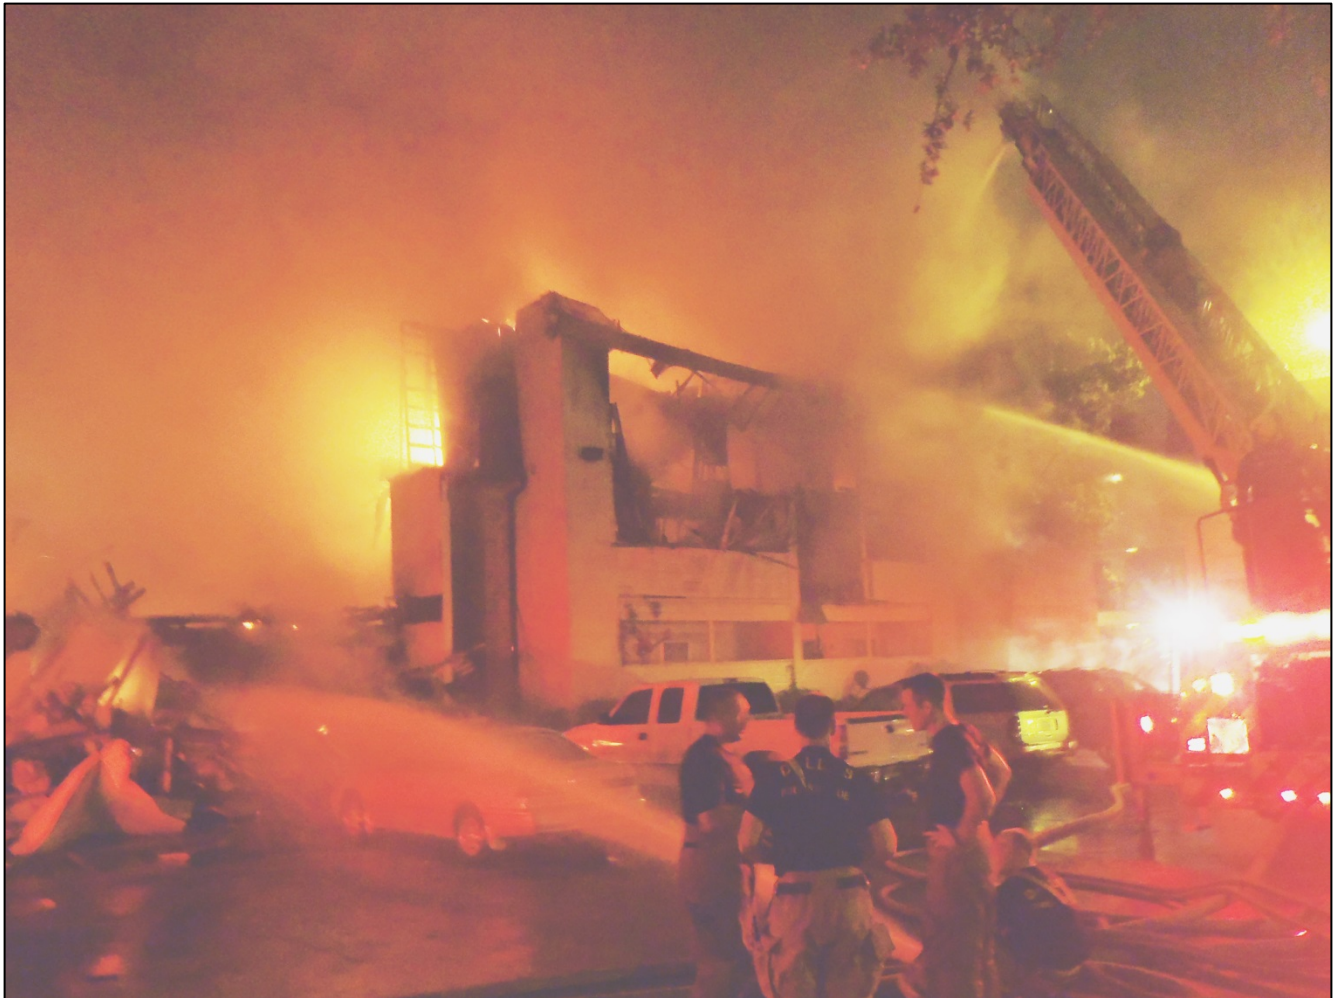
**Photo 8. Defensive fire conditions on Side C at approximately 0428 hours.**  
*(Photo courtesy of fire department)*

Fourth alarm companies were reporting to staging and the Command Post for assignments. Truck 53 (T53) arrived on the scene at approximately 0411 hours and reported to the staging area, however, the staging area was not staffed. The T53 officer radioed the IC who told him to report to the Command Post with his crew. T53 arrived at the Command Post at approximately 0420 hours and the IC ordered him to take his crew and evacuate Building 4. Note: There were reports being relayed over the radio of crew members still removing occupants from the buildings other than the fire building. There weren't any crews operating in the fire building at this time due to the operations still being defensive (Photo 8).

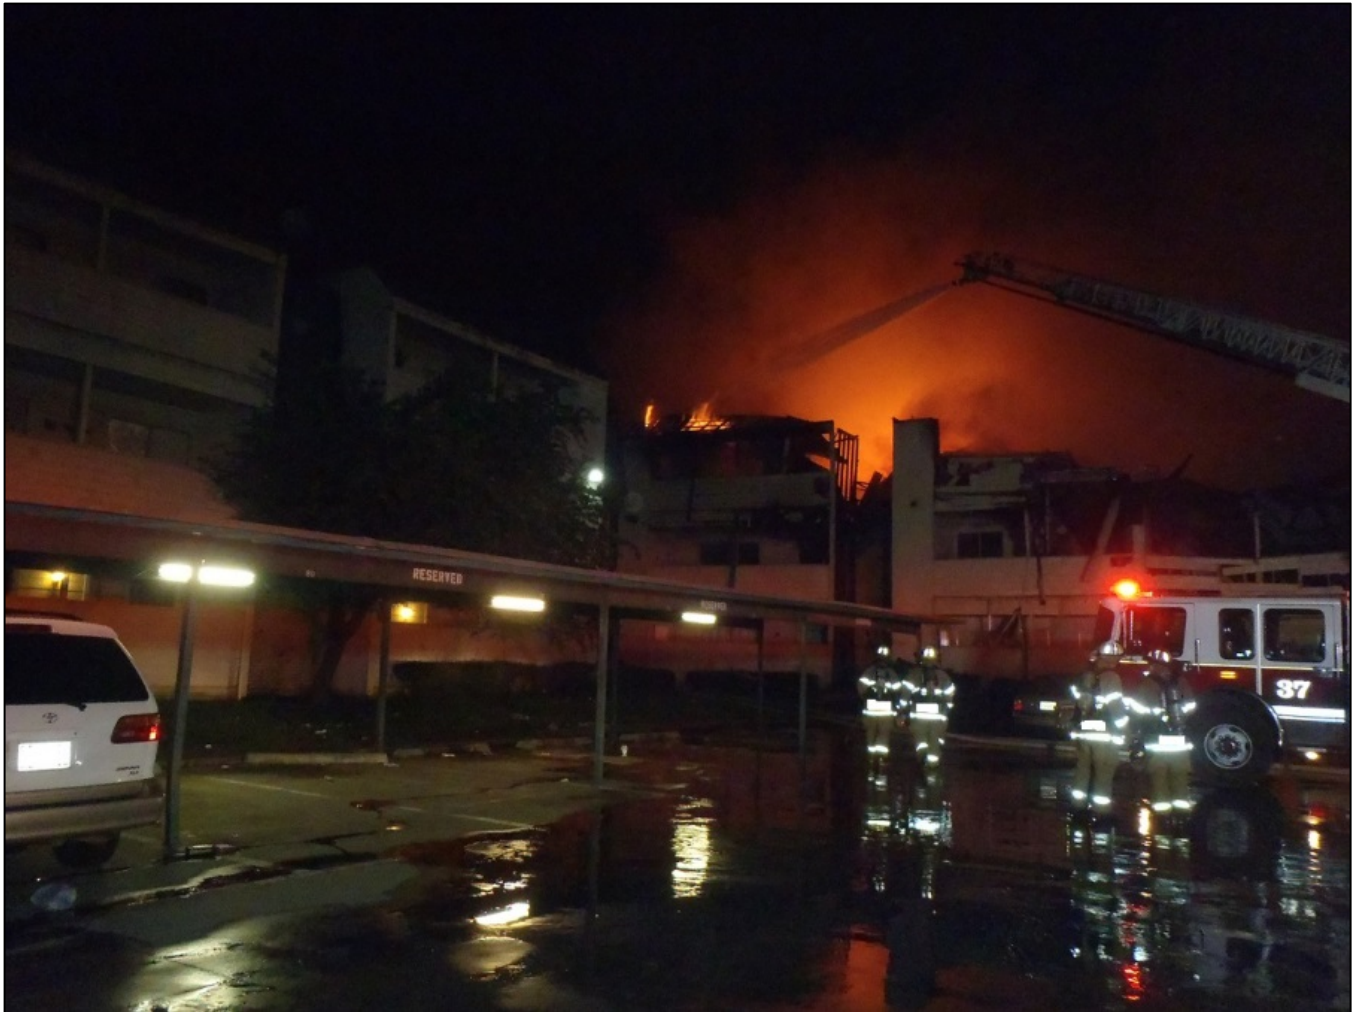
**Photo 9. T53 crew preparing to enter fire building from Side A for interior search at approximately 0444 hours, prior to the collapse.**  
*(Photo courtesy of fire department)*
