NIOSH
Fire Fighter Fatality Investigation
and Prevention Program

A Summary of a NIOSH fire fighter fatality investigation

Structure Fire Claims the Lives of Three Career Fire Fighters and Three Children—Iowa

Fatality Assessment and Control Evaluation Investigative Report #F2000-04

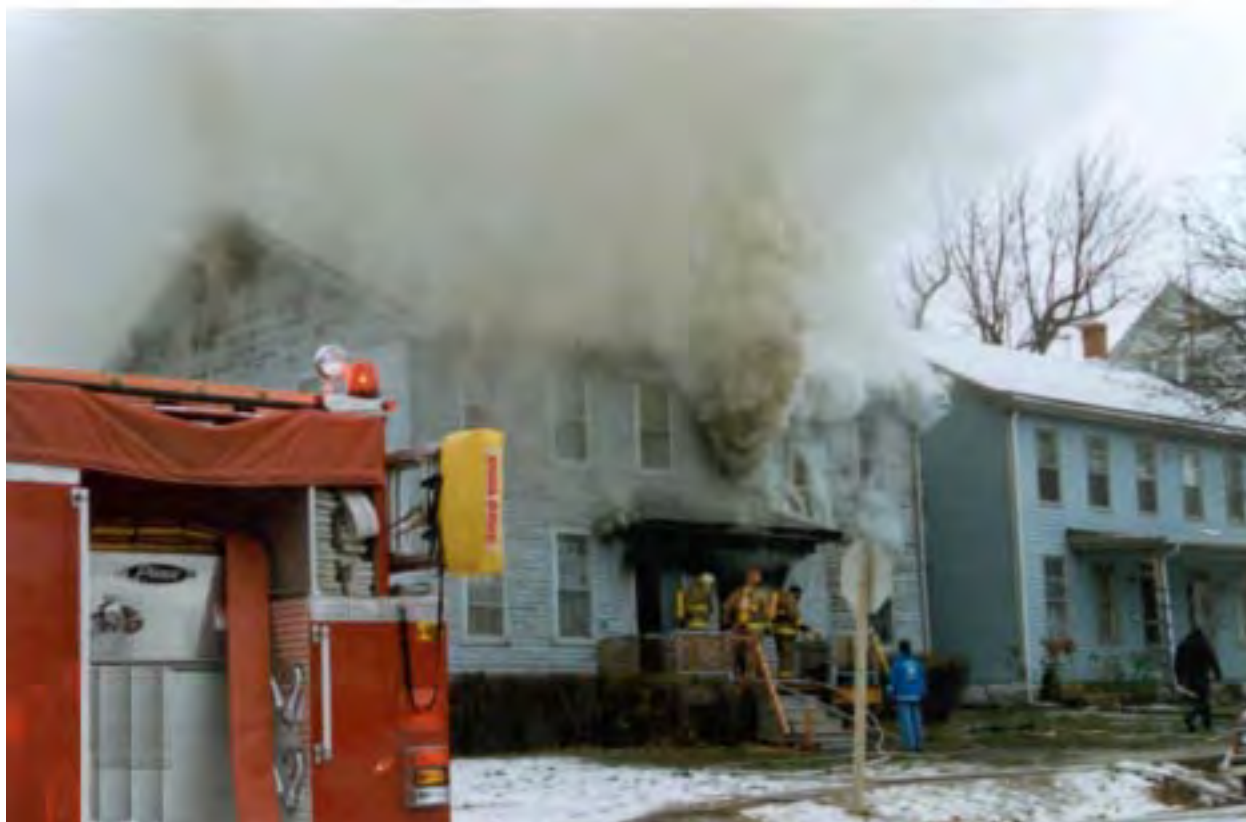
Photo 1. Front of Structure Where Fire Fighters Entered

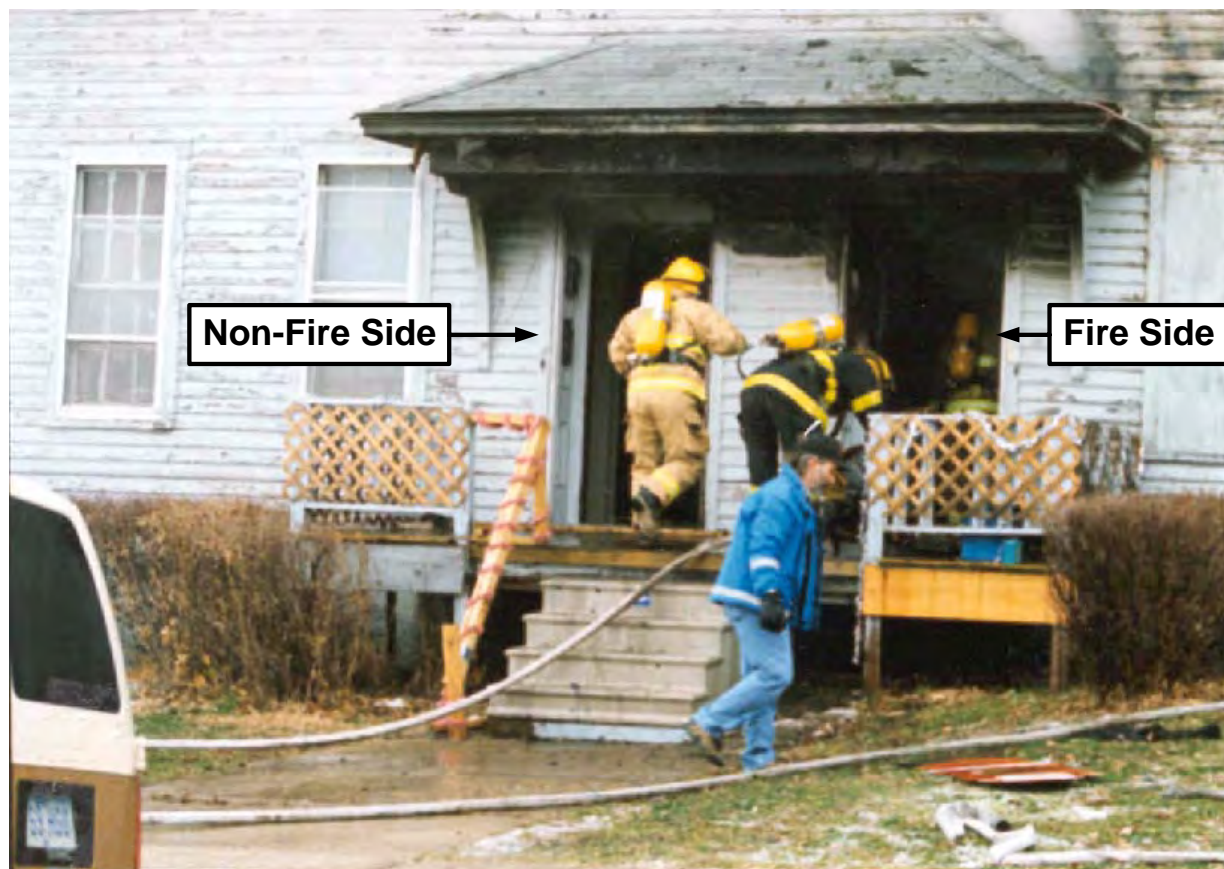
At approximately 0839 hours, the Chief returned to the scene and continued his role as IC. Shortly after the Chief returned to the scene, Engine 6 arrived with an Assistant Chief (Assistant Chief #1) and a Lieutenant. As the Lieutenants from Engines 3 and 6 and Assistant Chief #1 finished donning their protective gear, they were told by onlookers that there was the possibility of a civilian in the upstairs apartment on the non-fire

side of the building (Photo 2). *Note: The neighbor’s car was parked in front of the house, causing concern among onlookers that he was still inside the structure.* At this time the IC ordered the Lieutenant from Engine 3, the Lieutenant from Engine 6, and Assistant Chief #1 to form a three-man search-and-rescue team to search the apartment located on the top floor of the non-fire side.

Photo 2. Doors in Which Fire Fighters Entered

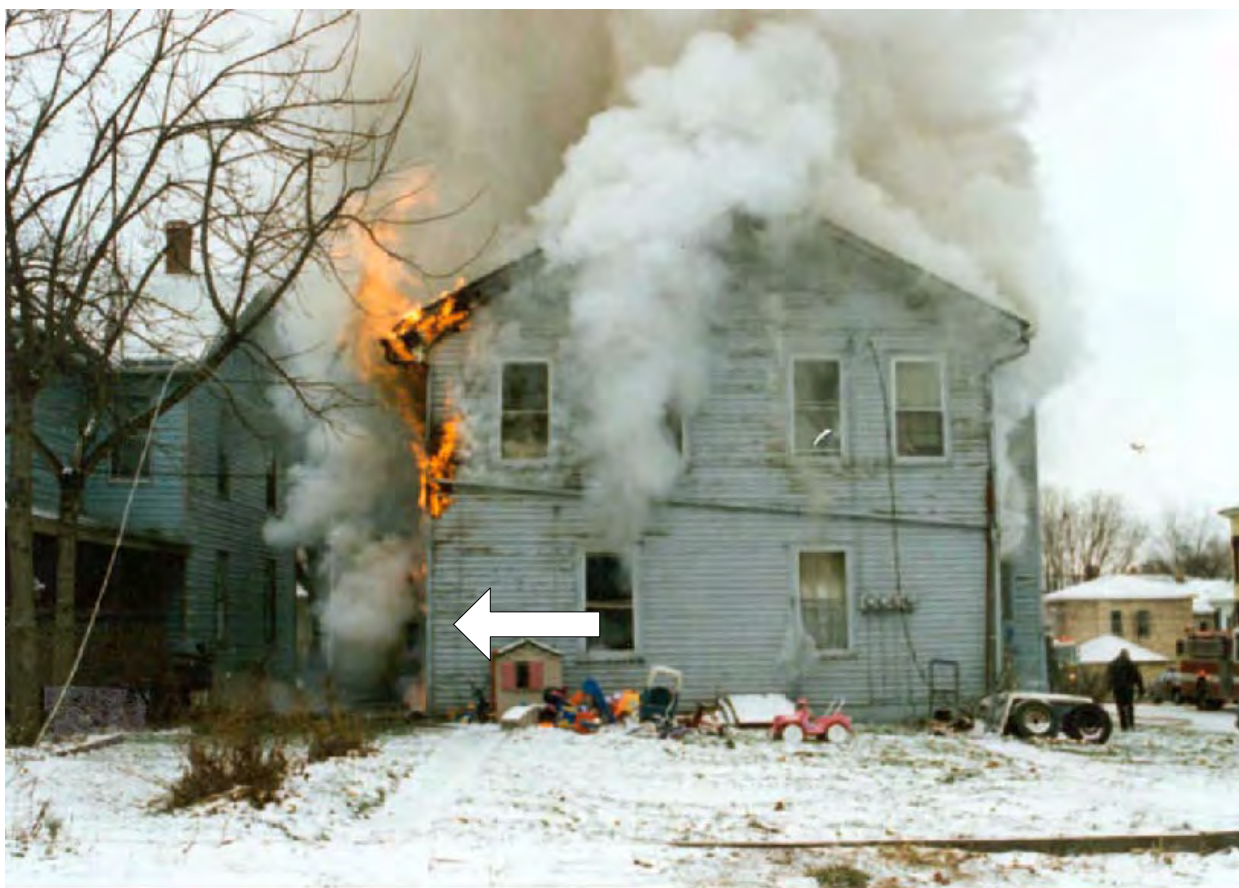
Due to the extreme heat inside the structure, the IC made the call to switch from a search-and-rescue operation to a defensive attack. The IC assigned Assistant Chief #1 the responsibility of keeping fire fighters out of the structure until it was deemed safe. At this time three additional fire fighters (Fire Fighters #5, #6, and #7) were transported to the scene by a police officer. Fire Fighter #7 was assigned to the rear of the structure with the Lieutenant from Engine 6 and Fire Fighter #2, to control the fire extension from the rear of the structure (Photo 3). Fire Fighter #5 was

Photo 3. *Rear of Structure* Note: Arrow indicates origin of the fire.

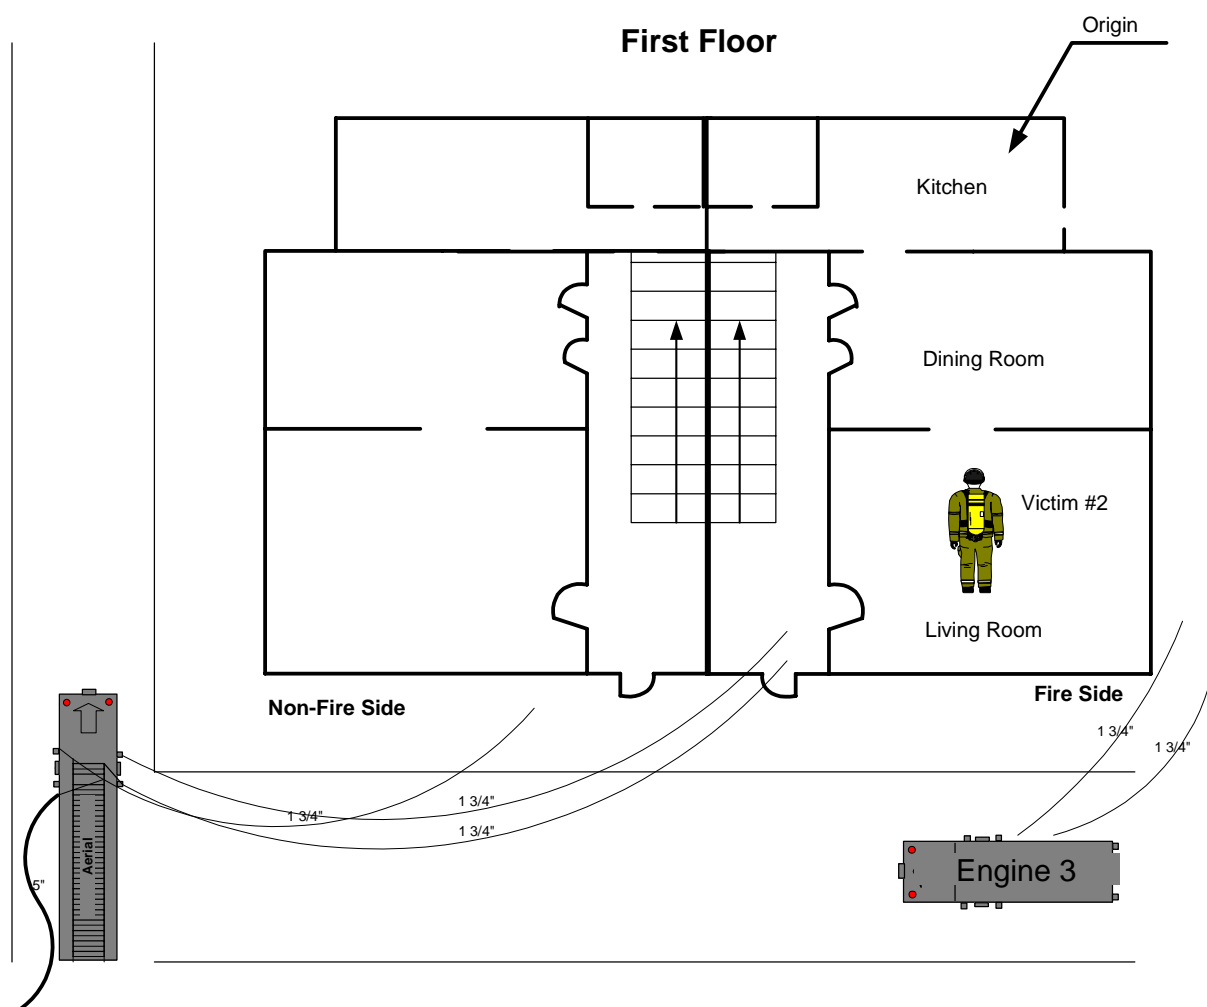
Figure 1. Overview of Incident Site: First Floor

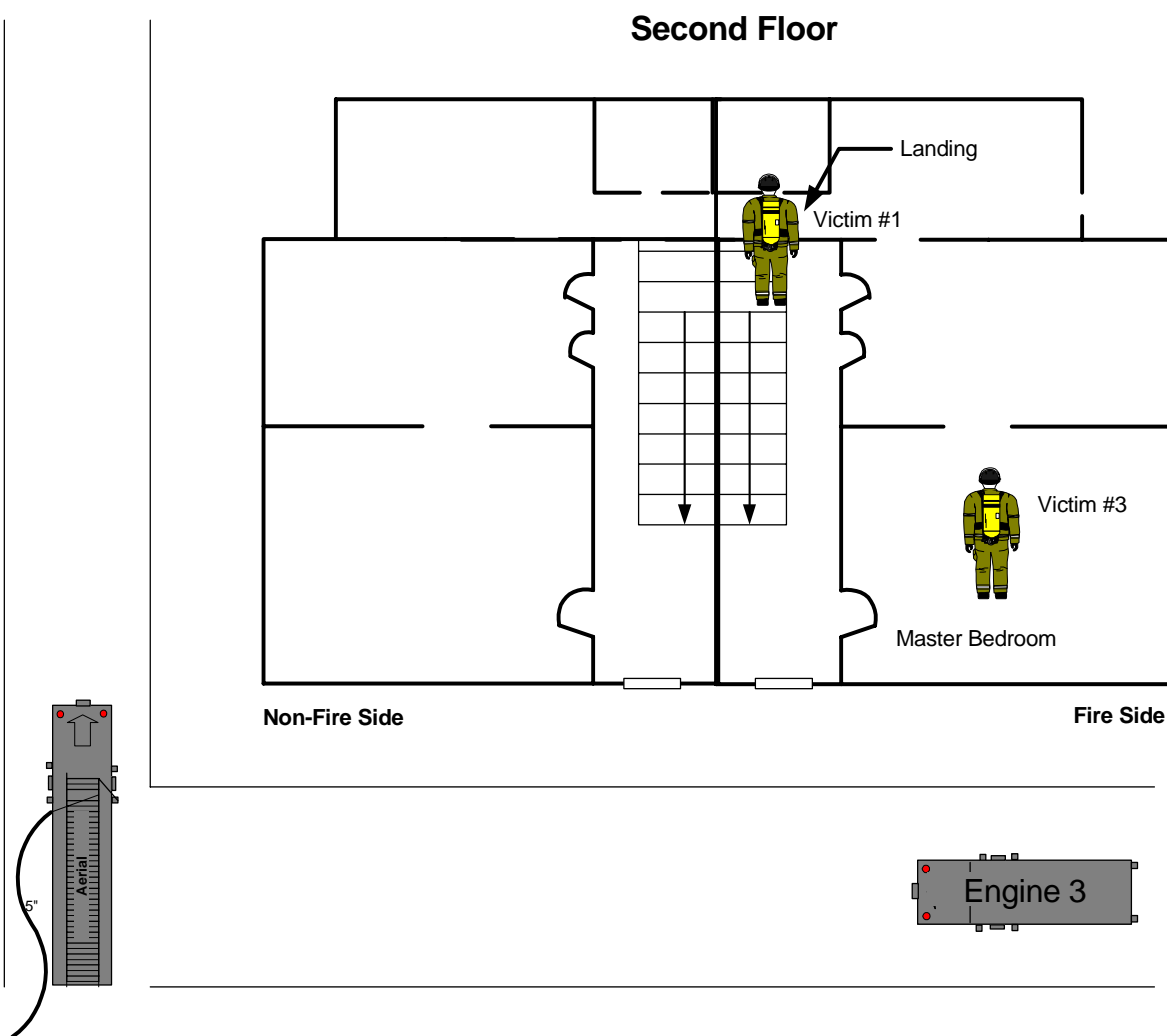
Figure 2. Overview of Incident Site: Second Floor
