County Garbage Collector Dies After Falling From Back End of Moving Garbage Truck

FACE 9109

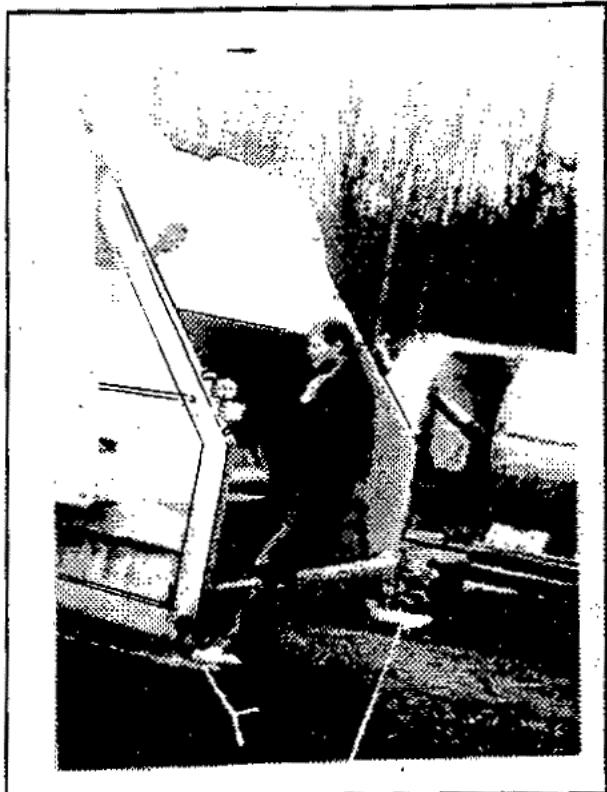
The victim and co-worker rode inside the truck cab to the designated pickup area, as required by department procedures. As they made pickups within these areas, the victim and co-worker stood on footrest platforms (measuring 12 inches by 8 inches) at the rear left and right ends of the truck (Figures 1 & 2). The platforms are 12 inches above the ground level, and have a surface consisting of a steel, machine-punched serrated grating. There are two handhold bars located about 4 feet above each platform. One handhold bar is welded horizontally on the side of the truck and the other is welded vertically on the back of the truck (Figures 1 & 2). On the day of the incident, the co-worker was wearing a hard hat. The victim was not wearing a hard hat because the department had not yet issued him one.

Figure 1 Foot-rest platforms and hand-hold bars.

Recommendation #1: Employers should ensure that garbage collectors ride inside the cab of the collection vehicle (or a separate transport vehicle) with secured seat belts, while traveling to and from collection areas.

Discussion: Garbage collectors should only ride on the back end of trucks (standing on designated footrest platforms) when making pickups between adjoining residences and businesses. According to written safety instructions by the county solid waste sanitation department, "Employees may ride on the back of the truck between collections (i.e. between houses). In any traveling not involving collections, such as to and from service center or to and from landfill, the employees will be ferried by designated solid waste personnel. Upon leaving designated collection routes, crews may not ride on the back of the vehicle to and from drop off points located more than 2 – 3 blocks from route." According to consensus standards from the National Safety Council, and the French National Technical Committee ("Public Employee Safety Guide, Refuse Collection" and "Urban Solid Waste Collection Operations: Accident Prevention," respectively), these safety instructions reflect standard operating procedures.

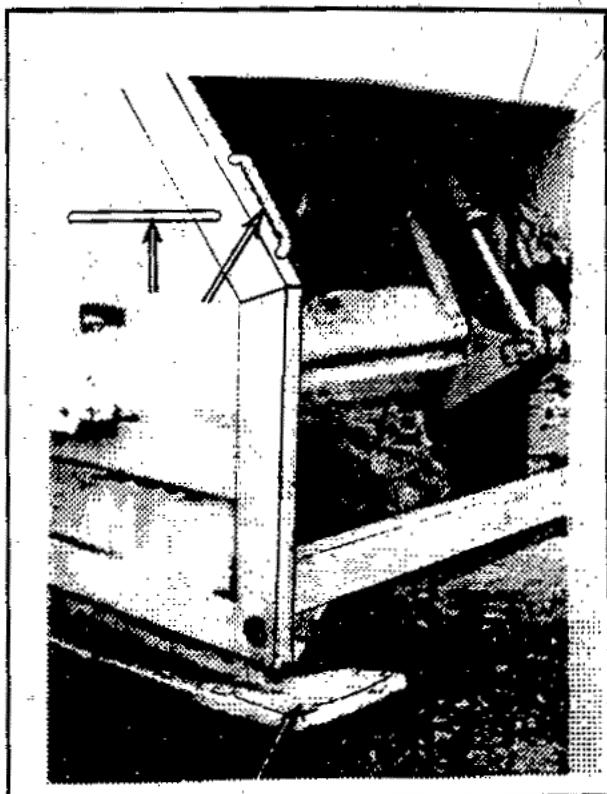
Figure 2 Foot-rest platform and hand-hold bars.

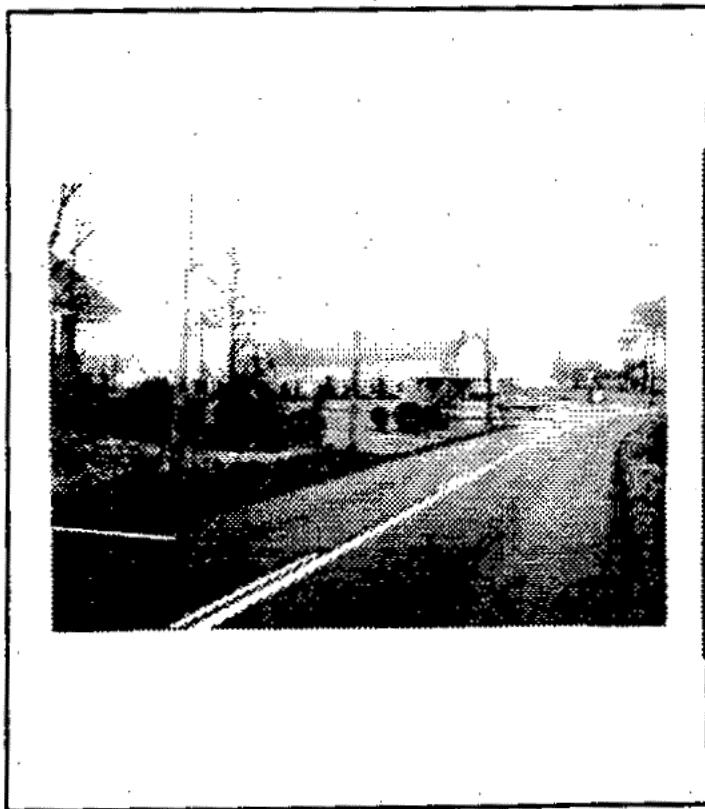
According to a police report, at 1:30 p.m. another vehicle (a van) was following about 50 yards behind the garbage truck. The van driver and his passenger saw the victim convulse, and then fall to the left of the platform. The truck driver looked in his left rear view mirror and saw the victim fall off the truck. When the victim hit the pavement he tumbled to a stop on the left hand side of the road (Figure 3).

Figure 3 Location of victim after falling.

Recommendation #3: Employers should ensure that garbage collectors wear approved protective helmets while on the job.

Discussion: Employees working under conditions where there is a possible danger of head injury from impact, or from falling or flying objects, should wear protective helmets. While OSHA has no legal jurisdiction over public employers, such as county solid waste sanitation departments, the OSHA General Industry and Construction Standards (29 CFR 1910.135 and 29 CFR 1926.100) serve as appropriate guidelines in this instance, especially concerning head protection. Protective helmets should meet specifications outlined in ANSI Standard Z89.1-1986, "Personnel Protection – Protective Headwear for Industrial Workers – Requirements." Protective helmets that meet the ANSI Standard provide impact attenuation (including the impact from some types of falls) by limiting the magnitude and concentration of impact forces. Currently, there are industrial protective helmets available that can provide a degree of head protection for falls of less than 10 feet.
