Welder Dies in Fall from Fork Lift

FACE 8945

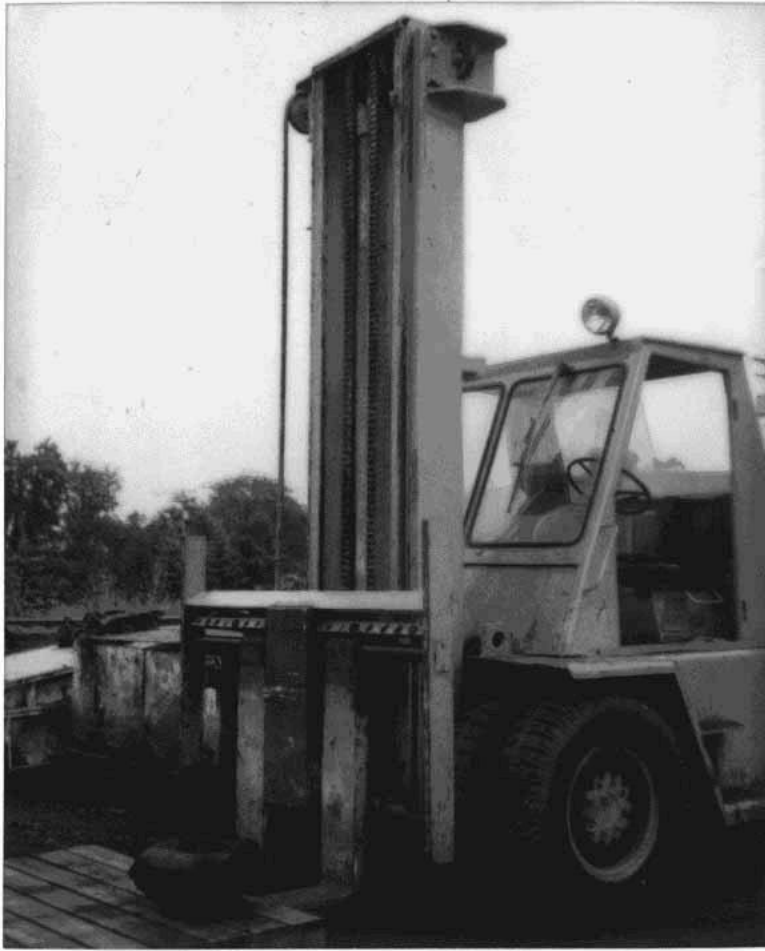
Figure.

The co-worker had just off-loaded a wheel set when he noticed that the fork carriage (assembly to which the forks or other attachments are mounted) was jamming on the mast (upright steel assembly consisting of hydraulic cylinders, inner channels, telescoping outer channels, chains, and guide rollers) (see [Figure](#)). The co-worker and victim decided to solve the

The victim noticed that a wear guard strip, attached to the side of the telescoping channel on the mast, had come loose and was binding against the guide roller. This caused the top of the fork carriage to jam approximately 8 feet from the ground. The victim, carrying a cutting torch, climbed up the carriage and stood on an angled, 6-inch-wide steel support to cut out a section of the wear guard strip as the co-worker observed. The victim then used a pry bar to move the wear guard strip away from the guide roller. As the strip dislodged from the roller guide, the carriage dropped approximately 1 foot.

Recommendation #1: Employers should review, revise where applicable, and enforce current safety programs.

Discussion: Although the company has a written safety program, including maintenance procedures for fork trucks, the procedure was not followed. If the victim and co-worker had informed the jobsite foreman of the fork lift problem, according to procedure, the truck could have been moved to the maintenance shop and repaired according to company maintenance procedures, thereby avoiding the incident. Employers should review, revise where applicable, and enforce the current safety program. The program should be clear and should emphasize the importance of following established operating procedures.
