REPORT#: 23CA002

REPORT DATE: July 25, 2024

Poultry Processing Production Worker Drowns in an Open Offal Wastewater Pit — California

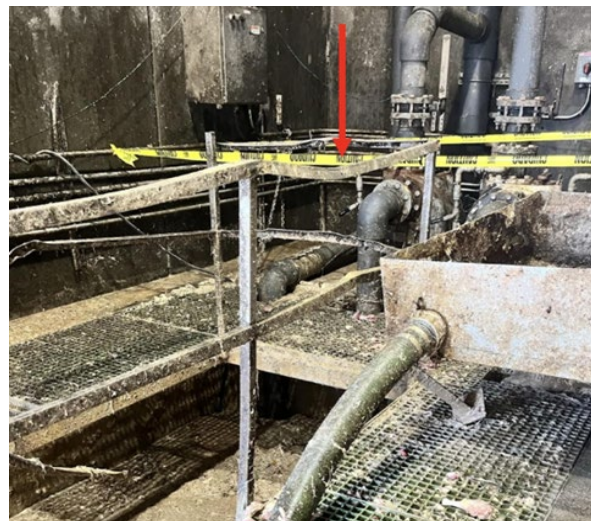
One week prior to the incident, the backhoe damaged the stainless steel guardrails surrounding the pit and they had not been repaired prior to the incident (Exhibit 2). There were no confined space warning signs on or around the pit. There were three newly installed trash pumps and one existing pump adjacent to the pit that was being used to process the offal wastewater.

Exhibit 2. One of the damaged guardrails (red arrow) surrounding the offal pit. Photo courtesy of the employer.

Recommendation #4: Ensure open offal pits are guarded and covered.

Discussion: At the time of the incident, photos showed that the guardrails protecting the open offal pit were damaged, and they did not completely enclose the pit. It was reported that the company's maintenance crew constructed the stainless steel guardrails and testing was not conducted to determine the applied live load limits. It is crucial that guardrails are designed, built, installed, tested, and maintained according to federal, state, and/or local regulations applicable to their jurisdiction. Cal/OSHA regulation is [§3209. Standard Guardrails](#) and federal OSHA requirement is [29 CFR 1910.29 Fall protection systems](#).

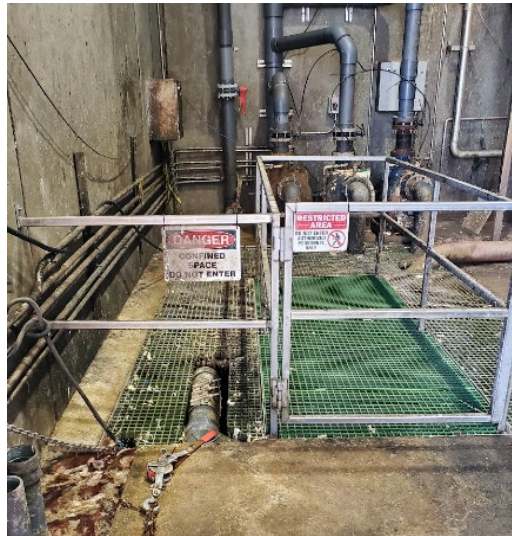
Exhibit 4. The new guardrails and floor grates that were installed after the incident.
Photo courtesy of the CA/FACE program.

On the day of the incident, a grate had been removed. The photo below (Exhibit 4) was taken on the day of the CA/FACE investigator's visit, and a new guardrail system and floor covering/grate had already been installed around the offal pit. According to federal OSHA requirement 29 CFR 1910.28 Walking-Working Surfaces (b) (3) (v) (A) when a hole (i.e., the offal wastewater pit) is not in use, the employer must ensure the cover is closed or a removable guardrail system is provided on the exposed sides. If materials are passing through the hole or work is being done in the pit, one feasible alternative is to have a hinged floor cover, which helps ensure that the cover will be replaced when work is done. On the day of the incident, if the pit

had been guarded on all open sides and a hinged floor hole cover was used, it may have been less likely the victim would have fallen into the pit and died.
