**REPORT#:** 22KY070

## Farm Services Driver Killed in Highway Crash—Kentucky

At 12:34 p.m., September 5, 2022, a 49-year-old farm services employee was killed when the light-duty pickup truck he was driving was struck by another vehicle. The driver was following his co-worker, who was driving a much larger truck. The larger truck became inoperable and had to stop in the right lane of the highway. The pickup truck was positioned behind the larger truck when it was struck from the rear.

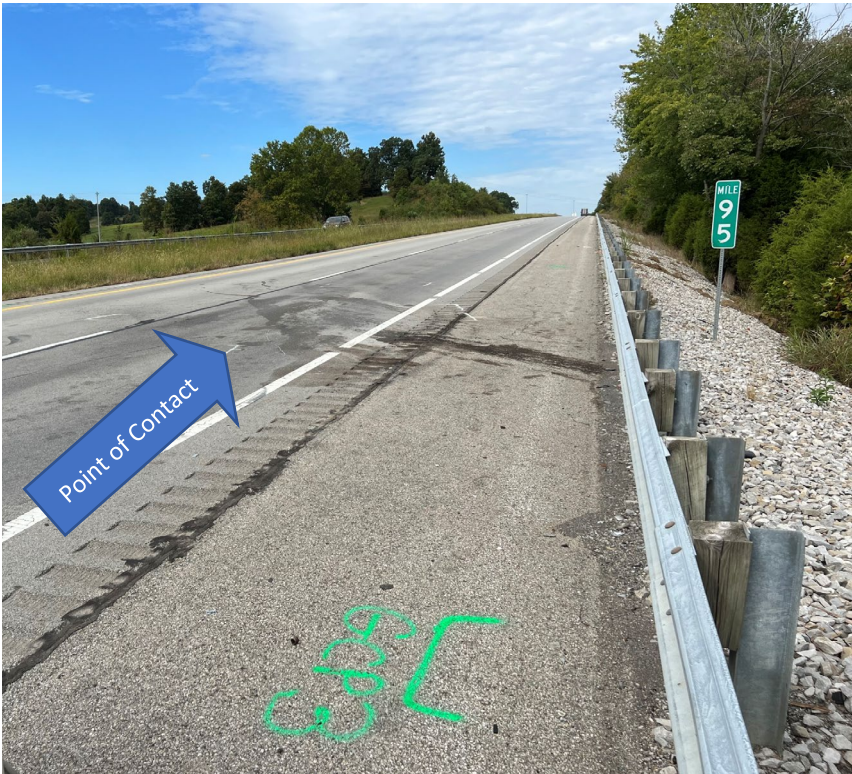
Photo 1. Incident Scene (Property of KYFACE)

used to enter onto the highway. The scene is shown in Photo 1. A blue arrow indicates the approximate point of contact of the crash.

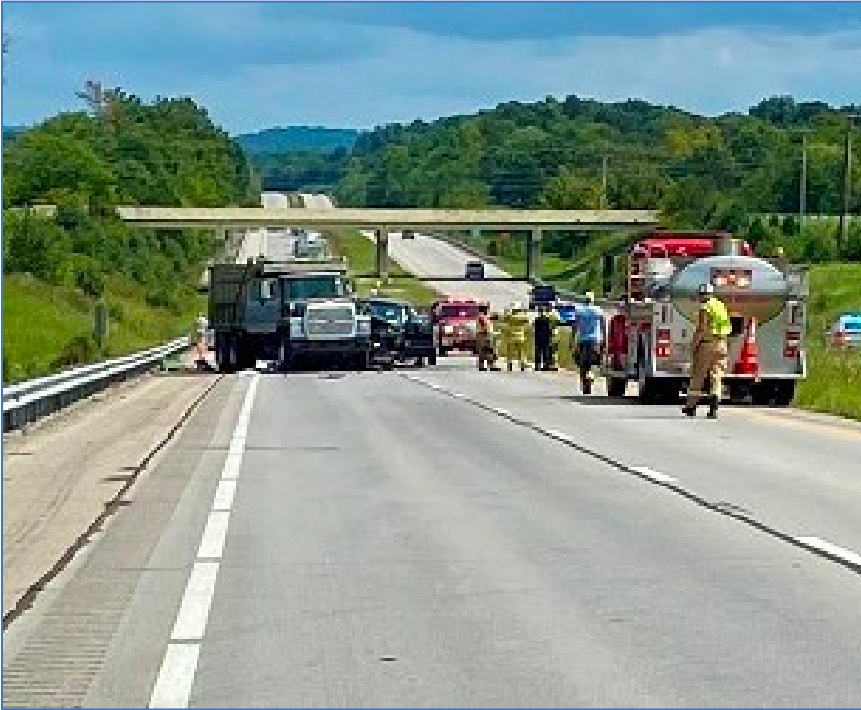
Photo 2. Incident Scene (Courtesy of Heritage Media of Kentucky, Inc.)

The two farm services vehicles were involved in making a delivery when the larger Ford LN truck began to experience mechanical problems that were reported by the driver to the employer as symptoms consistent with a lack of fuel, even though the truck's fuel gage did not indicate an empty gas tank. As a result, the Ford LN could no longer continue, requiring it to stop in the right (slow) lane of the highway. The smaller Nissan pickup truck had been following the larger truck and was positioned behind it in the right lane. Both vehicles were using their emergency warning lights (e.g., flashing hazard lights) at the time. The Nissan pickup truck was positioned in the roadway behind the larger truck when it was struck from the rear by the oncoming Ford F-350. Photo 2 shows the position of the three vehicles following the crash. The impact pushed the Ford LN truck onto the shoulder.

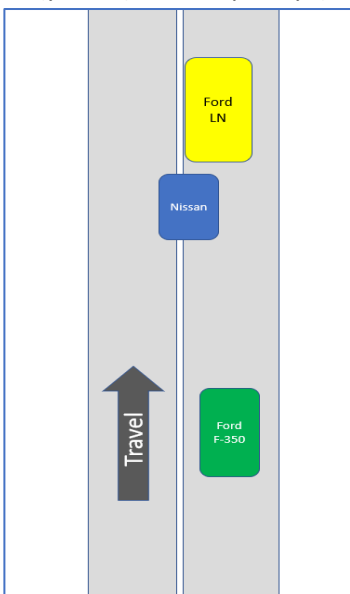
Graphic 1. (Property of KYFACE)

Just prior to the crash, the Ford F-350 was traveling westbound on the highway. The approximate locations of the Ford LN (yellow), Nissan pickup (blue), and Ford F-350 (green) prior to the crash are represented in Graphic 1.

When possible, vehicles that are stopped or stranded should be located so that they are shielded from traffic. In this case, the smaller Nissan truck should have been positioned in front of the larger Ford LN, which would have shielded the smaller truck with the larger truck from impact. Although the Ford LN truck involved in this incident could not be driven to the shoulder, in cases when a vehicle experiencing mechanical problems can be driven onto the shoulder, the Kentucky Driver's Manual ([KDM, 2021](#)) directs drivers to activate their vehicle's emergency warning lights (which the Ford LN and Nissan drivers had done) and park their vehicle on the shoulder as far to the right as possible.

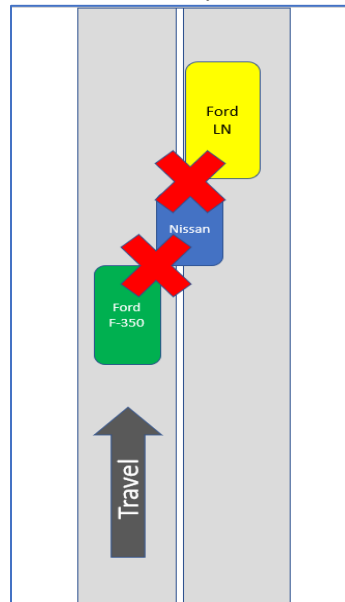
Graphic 2. (Property of KYFACE)

Upon approaching the scene, the Ford F-350 was traveling in the right lane. As it neared the two stopped farm services trucks, the Ford F-350 (green) was not able to avoid the Nissan pickup truck (blue) and it crashed into the Nissan pickup truck from the rear, pushing it into the Ford LN (yellow). The points of impact are depicted with red Xs in Graphic 2. The driver of the Nissan pickup was killed, while the other drivers were uninjured. The speed of the Ford F-350 at the time of the crash was not classified as excessive, according to the police accident report. Post-incident drug screens of the drivers who survived the crash indicated the presence of methamphetamine for the larger truck driver and delta-9 THC for the driver of the third vehicle.
