REPORT#: 22CA004

REPORT DATE: September 29, 2023

Contract Agricultural Worker Died After Being Engulfed by Tons of Nuts — California

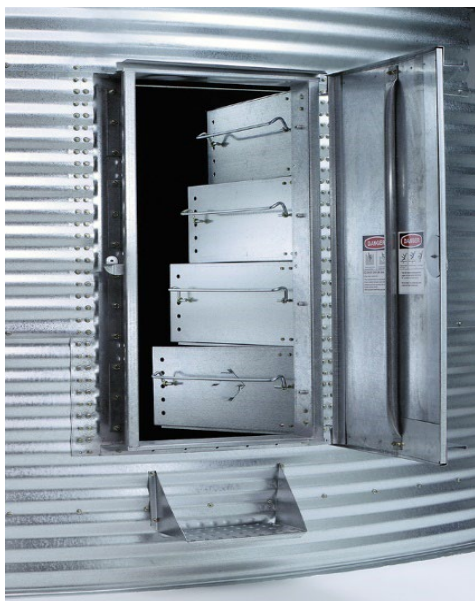
Discussion: In this case, the victim had opened the outer access door to a silo that was filled near capacity. Inward swinging doors (Exhibit 5) are a safety feature that ensures if the silo is filled with product, the pressure on the doors from the weight of the product prevents the doors from opening. If the silo had been fitted with inward swinging access doors, this incident may have been prevented.

**Exhibit 5. Inward swinging silo access doors.
Photo courtesy of Brock Grain Systems.**

Recommendation #4: Ensure that storage silos are fitted with inward swinging inner access doors.
