REPORT#: 22KY011

Roofing Worker Dies from Fall—Kentucky

SUMMARY

At 1:30 p.m. on March 28, 2022, a 36-year-old Hispanic roofer suffered a fatal fall while installing roofing on a two-story apartment building. The worker fell approximately 18 feet to a sidewalk below and died on the scene due to injuries suffered from the fall.

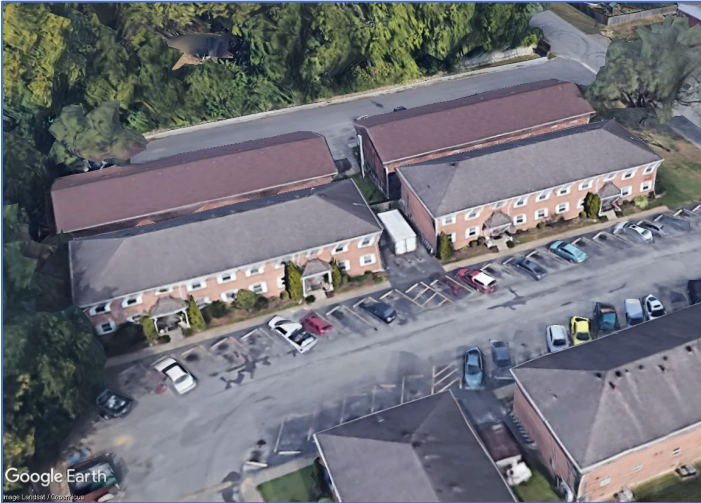
Photo 1. Apartment complex (Google Earth Pro)

The scene was a complex of two-story apartment buildings, as shown in Photo 1. Each building comprised two blocks of four apartment units, with each fourplex being accessed by an entry covered by a portico. Sidewalks lined the front of each apartment building, as did parking lots. At the time of the incident, the roofing subcontractor had positioned materials, equipment, and work vans in the parking lot adjacent to where the fatal fall occurred. The roofing subcontractor had also hung yellow caution tape to indicate work areas, as shown in Photo 2.

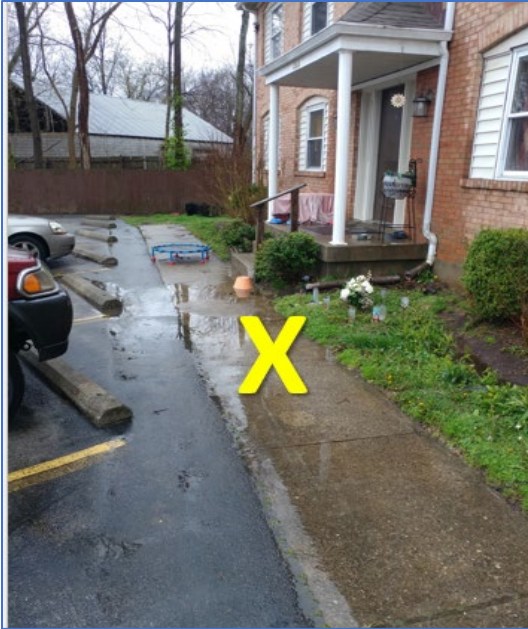
Photo 3. Location of fall indicated by yellow X (photo property of FACE)

On the day of the fatal incident, the roofers began work at approximately 8:00 a.m. They stopped for lunch, during which the roofers descended from the roof and went to an area behind the apartment building for their break. The deceased worker returned to the work area at the front of the apartment building alone and ascended to the roof. He fell shortly thereafter. There were no eyewitnesses to his fall. He was found unresponsive by his coworkers, at a location

indicated by a yellow “X” in Photo 3. (Note: Weather conditions on the date of the fatal incident differ from those seen in Photo 3 because the photo was taken later.)

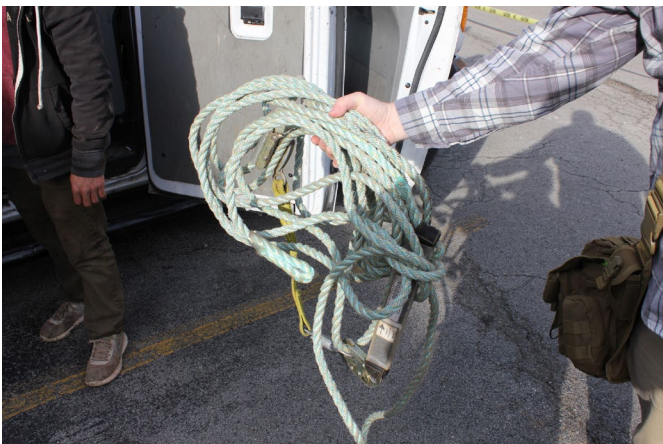
Photo 4. Fall protection gear (courtesy of KyOSHA)

The deceased worker was not protected against falling by fall protection equipment (fall protection harness, ropes, anchorage) nor using other means of fall protection at the time of his fall. According to the Kentucky Department of Workplace Standards, Division of Compliance (KyOSHA), the roofing subcontractor was aware of the nature of fall hazards and had provided fall protection equipment at the worksite for workers to use. Some of the fall protection equipment was stored in the roofing subcontractor’s van and is shown in Photo 4 and Photo 5.

Discussion: This fatal incident might have been prevented with the use of fall protection. The deceased worker was not using personal fall protection equipment, although it was available. Personal fall arrest systems (PFAS) are commonly used for fall protection with residential roofing work. PFAS are made up of an anchor point (A), a connecting device (C), and a body harness (B) worn by the worker, as shown in Image 1. Employers should, at a minimum, provide and ensure that workers at height use PFAS as required by OSHA ([n.d.](#)) under 29 CFR 1926, Subpart M. To help employers, the agency produced Protecting Roofing Workers ([2015](#)), which provides detailed guidance on applicable regulations and the means to safeguard roofing workers from falls.

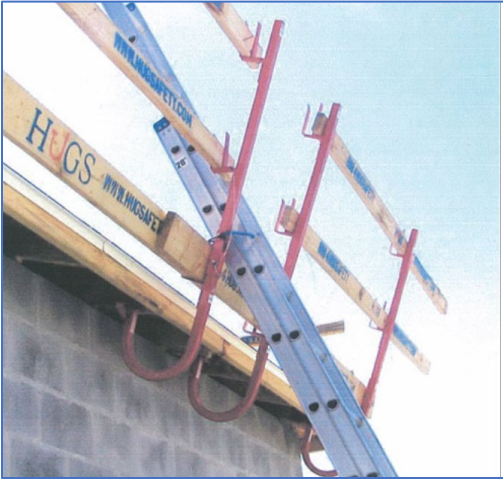
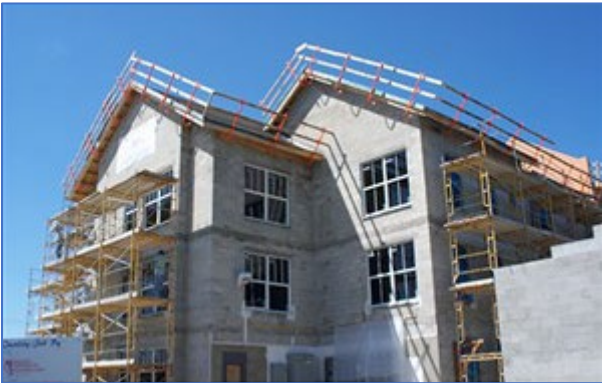
Guardrail systems have been developed for residential roofing work. Guardrail systems allow workers greater range of movement and are less cumbersome than PFAS in some situations, although PFAS may be needed during guardrail system installation or leading-edge work. In other situations, a combination of guardrails and PFAS may be preferable. Examples of guardrail systems are shown in Images 2–4.

Image 2. Hugs (2023)

Image 3. Hugs (2023)

Image 4. Raptor (2023)
