**REPORT#:** 22KY046

## Demolition Laborer Dies in Fall Through Skylight

## State **FACE** Program

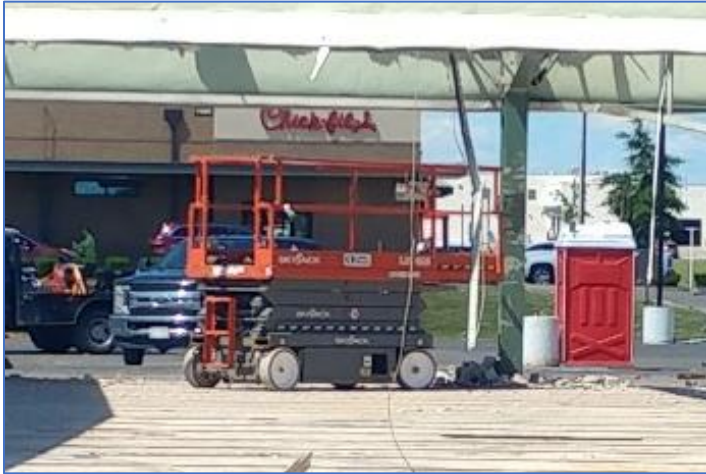
Equipment noted at the scene included two scissor-style personnel lifts used for roof access by employees. A boom-style lift, an excavator, and a skid-steer were used for material handling. One of the scissor lifts used by the deceased employee to access the roof, or a similar type, is shown in Photo 1.

Photo 1. Scissor lift (Property of FACE program)

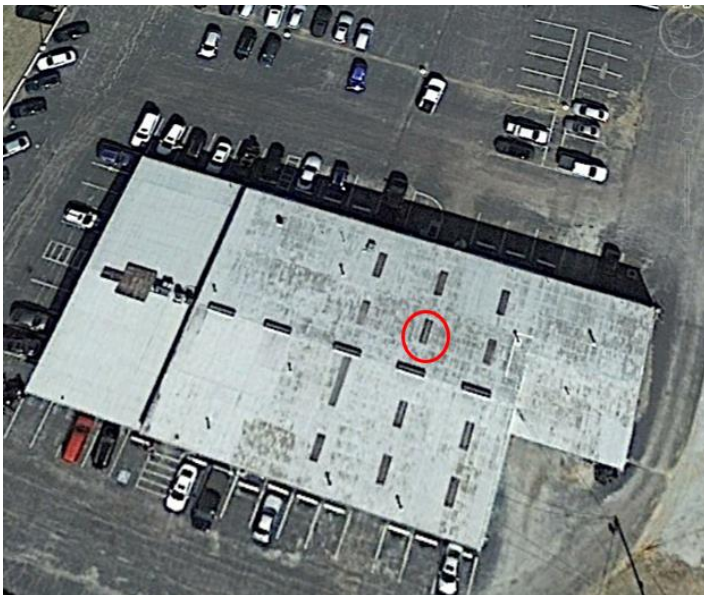
The scene was an older structure that formerly housed an automobile dealership and attached maintenance garage. A showroom had been located in the front portion, with a garage in the rear. The garage was approximately 19 feet high from grade and was undergoing demolition on the day of the fatal incident. A newer building had been built behind the older structure, and the older structure was being razed. The older structure was underlaid by a concrete pad and surrounded by an asphalt lot. The roof was constructed of corrugated metal with a low-slope pitch (defined under [29 CFR 1926.500\[b\]](#) as a roof having a slope less than or equal to 4 in 12 [vertical to horizontal]). Photo 2 provides a Google Earth [[2023](#)] photo of the building as it appeared on March 6, 2021, with an overhead view of the roof with skylights in place. The skylight involved in the fatal incident is indicated with a red circle.

Photo 2. Google Earth view of building on March 6, 2021

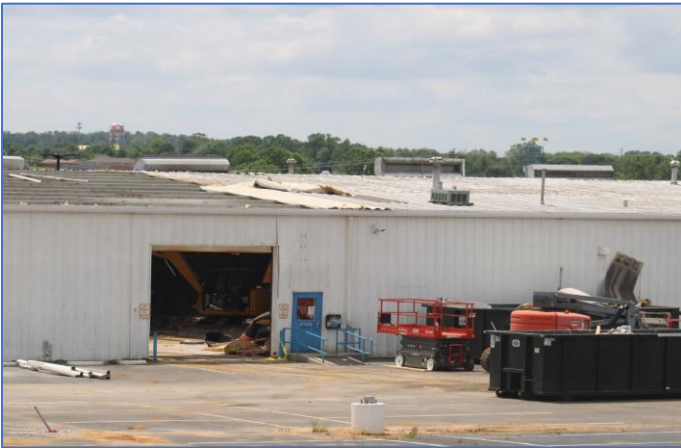
On the day of the fatal incident, four employees began work at approximately 9:00 a.m. These employees were tasked with removing sections of the garage roof. At the time of the incident, a portion of the roof had already been removed, as shown in Photo 3. Progression of the demolition work is shown in Photo 4.

Photo 3. Building undergoing demolition on day of fatal incident (Courtesy of KyOSHA)

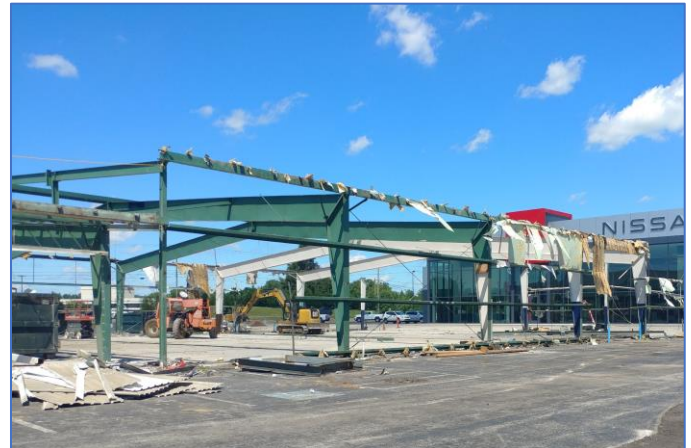
Photo 4. Building framework remaining at time of FACE site visit (Property of FACE program)

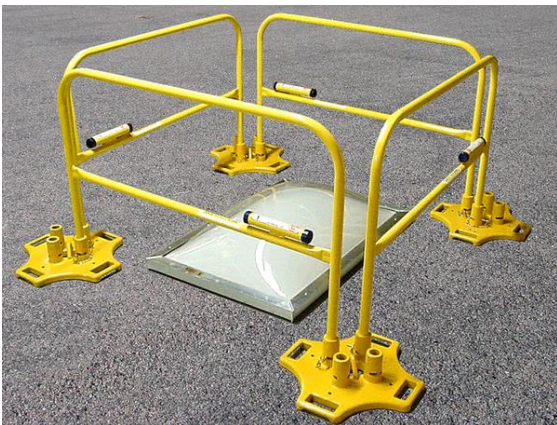
Examples of protective systems for skylight railings and covers are shown below in photos 6 and 7, respectively.

Photo 6. [Blue Water-Roof Hatch & Skylight Fall Protection Safety Rails](#), Colorado Safety Supply Company [2023]

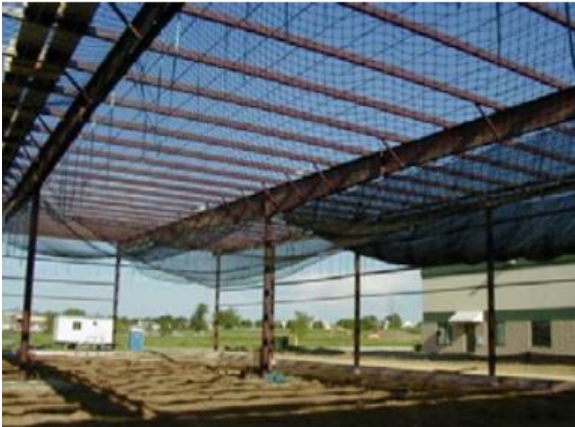
OSHA's [Fall Protection in Construction \[2015\]](#) provides detailed guidance on the various forms of fall protection and their proper use. Photos 8 and 9 provide examples of safety net systems and personal fall arrest systems, respectively.

Photo 8. Safety net system [[OSHA, 2015](#)]

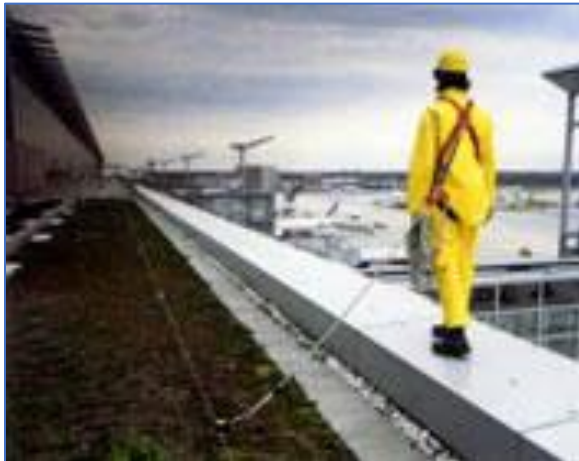
Photo 9. Personal fall arrest system [[OSHA, n.d.](#)]
