REPORT#: 21CA003

Farm Laborer Died When Struck by a Tomato Harvester — California

State **FACE** Program

Fatality Assessment & Control Evaluation

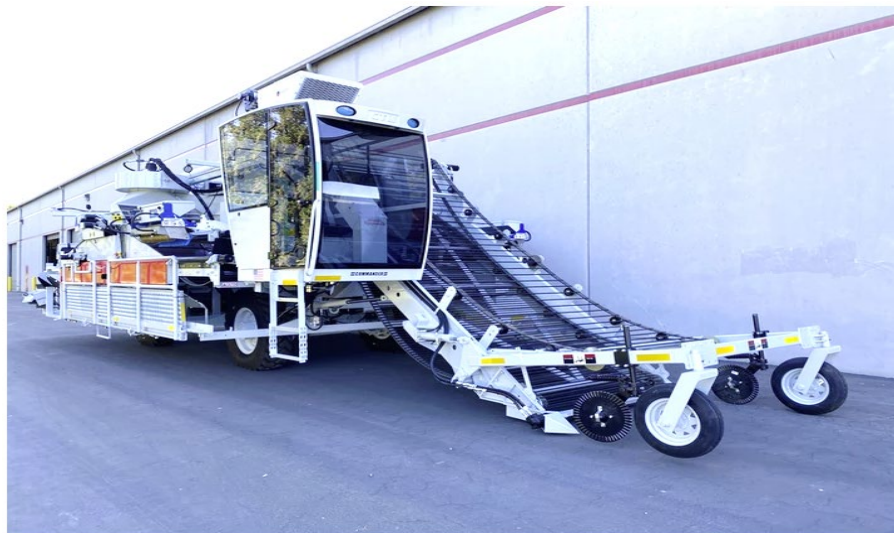
**Exhibit 1. A tomato harvester machine (similar model, not actual used in incident).
Photo courtesy Westside Equipment.**

The primary piece of equipment involved with this incident was a Westside Equipment Company Commander tomato harvester (Exhibits 1-3). The tomato harvester was a tractor-based piece of agricultural equipment that was approximately 37 ft. long x 12 ft. wide x 11 ft. high and weighed about 32,000 pounds (16 tons). It operated by lifting and slicing tomato vines onto a conveyor that fed the tomatoes and vines through a series of blades, conveyers, shakers, and air pressure. The tomatoes were separated from the vines and crossed a worker-attended sorting station before being conveyed overhead to an open-top trailer pulled alongside the harvester by a tractor (Exhibit 2). The tomato plant vines and leaves, once separated from the fruit, were ejected as mulch from the rear of the harvester. The harvester was driven by an operator in an enclosed cab at the front of the machine. It had platforms on both sides where workers (known as sorters) stood to manually remove any residual debris, vines, or unripe/damaged tomatoes from the conveyor prior to the tomatoes being transferred to the trailer (Exhibit 4). During operation, the harvester was very noisy, making communication between the sorters and the operator difficult. It also could possibly generate a large amount of dust, depending on the conditions in the field at the time of harvesting.

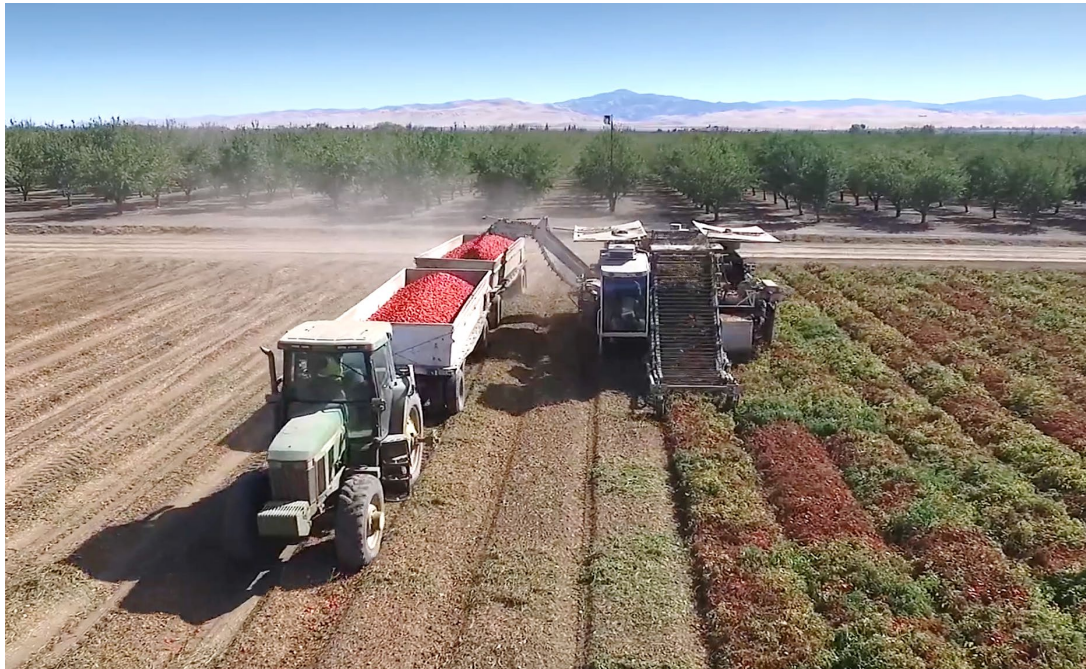
**Exhibit 2. A tomato harvester (on right) during the harvesting process.
Photo courtesy Westside Equipment.**

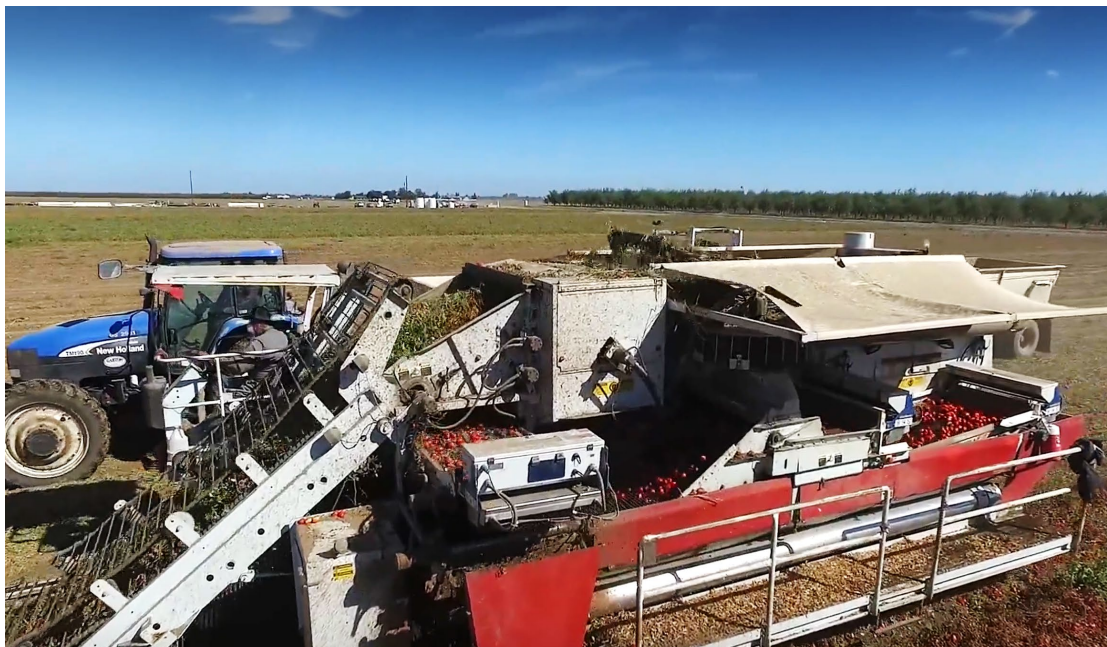
**Exhibit 3. Close-up of a tomato harvester during the harvesting process.
Photo courtesy Westside Equipment.**

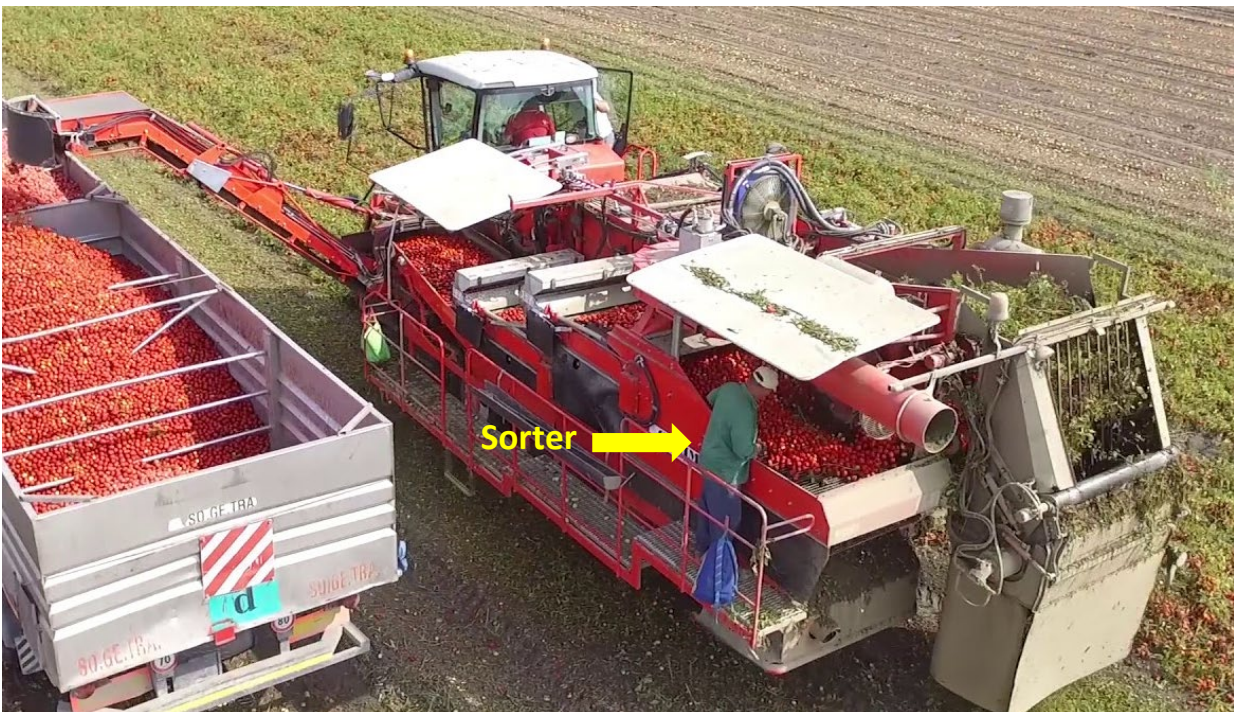
Exhibit 4. Tomato harvester showing sorter's typical position during harvesting.
Photo courtesy corima s.r.l.

adjacent tractors, and minimal lighting over the sorting conveyor (Exhibit 4 shows the sorters' working position on the platform).

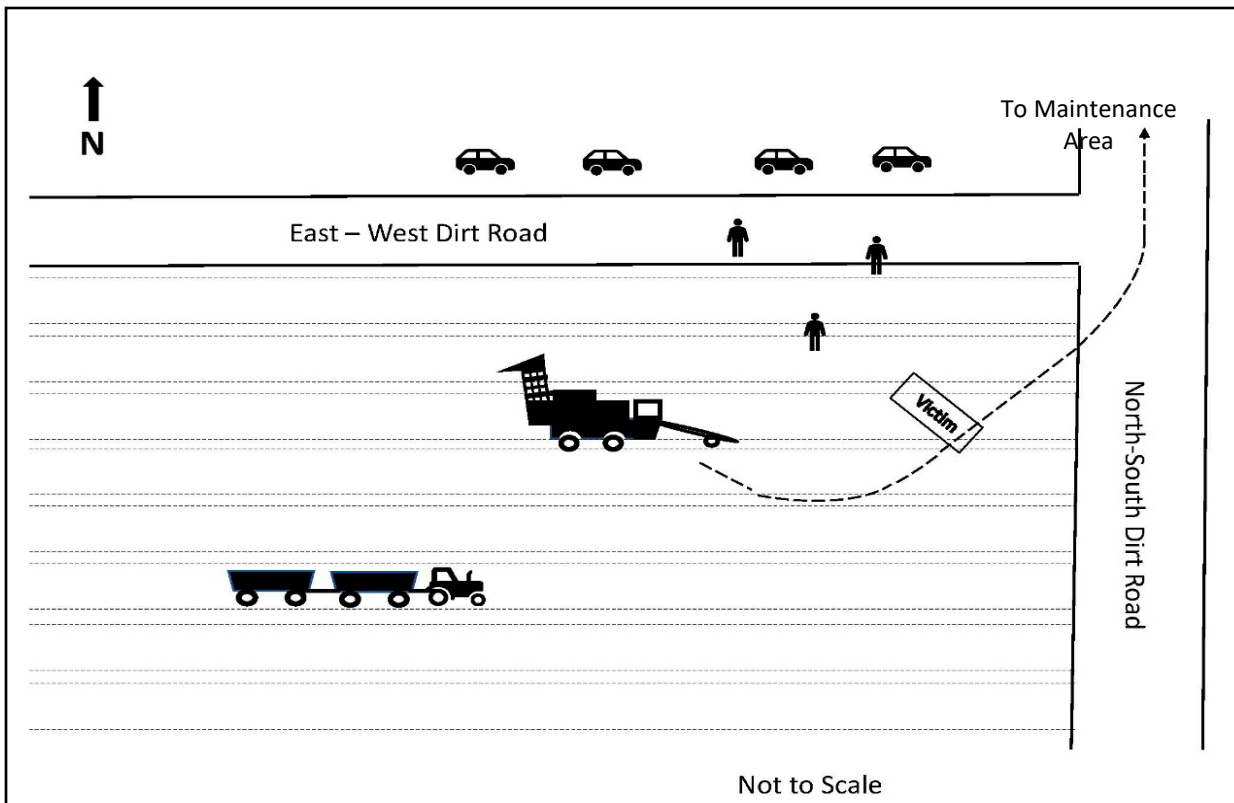
The incident scene was an approximately 150-acre tomato field located in Central California. The crew consisted of one harvester operator and one tractor driver, who were employed by the farmer, and two sorters and an additional tractor driver employed by the labor contractor. When the crew was finished with their shift, they drove out of the field (dirt row) onto a north/south dirt road and proceeded to the maintenance area about $\frac{3}{4}$ of a mile away. The victim's body was found near the end of a row by the north/south dirt road (Exhibit 5).

Exhibit 5. The incident scene.

At approximately 4:30 a.m., the harvester operator called a halt to work and told the crew to return to the maintenance area to clean the harvester prior to ending the shift. The maintenance area was about ¾ of a mile away, accessible by a dirt road. The crew walked to the edge of the field where their vehicles were parked, and the harvester operator swung the harvester onto a dirt road that led to the maintenance area (Exhibit 5).

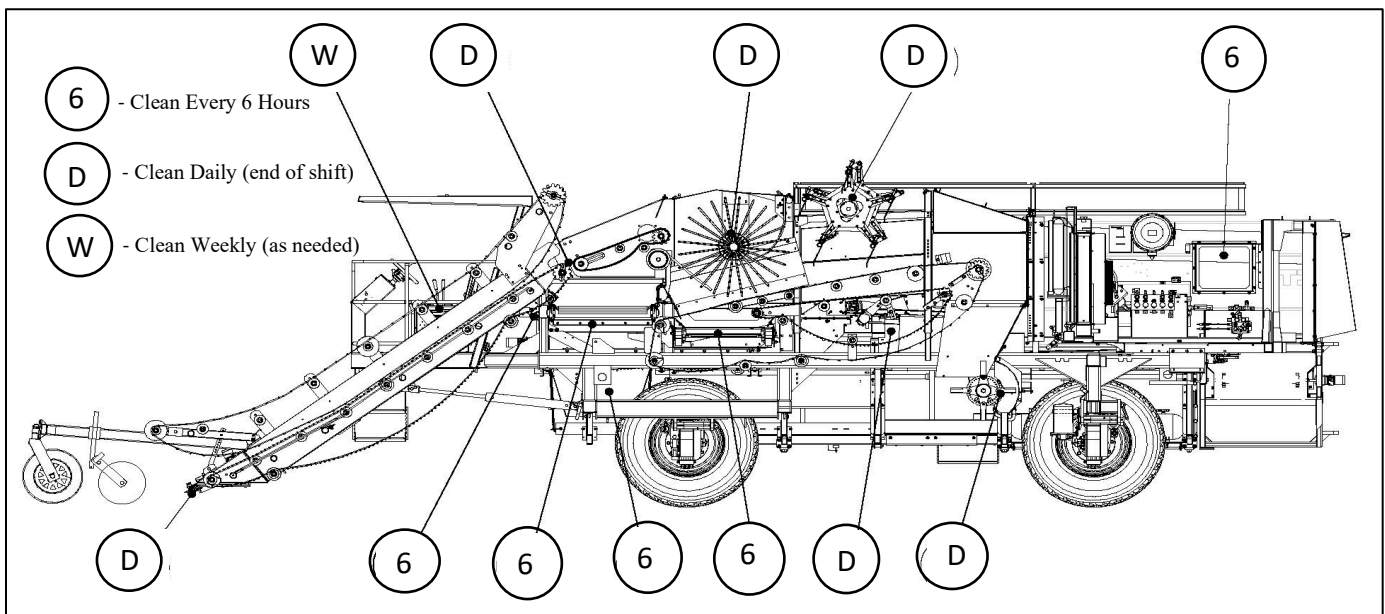
As the incident was not witnessed, it is unknown if the victim was underneath the harvester cleaning debris or was in the field when he was struck and run over by the harvester. The victim may have been relatively unfamiliar with end-of-shift cleaning procedures and may have thought he needed to clean the harvester *prior* to returning to the maintenance area. If this were the case, the victim would have likely been underneath the harvester removing debris when the operator, not seeing him and assuming he had left the field with the other workers, engaged the harvester, and ran over him. Alternatively, the victim may have been walking in the harvester operator's blind spot (to the left of the header chain) when he was struck and then run over.

Exhibit 6. Harvester schematic detailing machine cleaning areas.
Illustration courtesy of Westside Equipment Company.
