**FATALITY ASSESSMENT AND CONTROL EVALUATION PROGRAM  
(CA/FACE)**

A farm laborer died after he was caught in the  
rotating feed roller of a brush shredder

Case Report: 21CA002

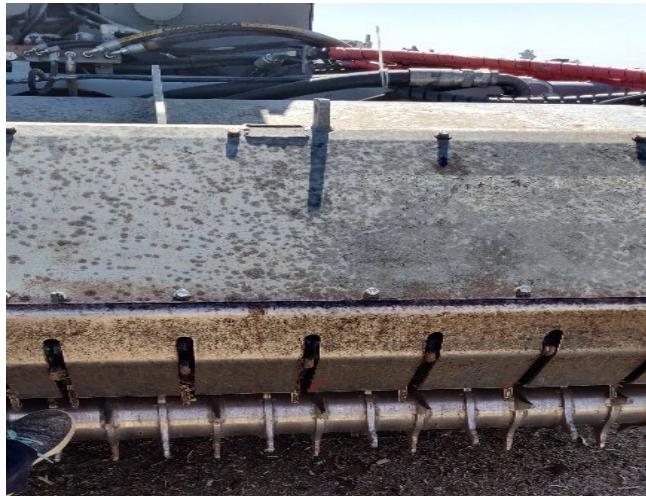
The brush shredder in this incident was hydraulically-powered and had a rotating feed roller equipped with a row of approximately five-inch teeth (Exhibit 1). The forward rotating motion of the teeth grinds and shreds branches. The operator controls the direction of the feed roller with a forward switch and reverse switch. The reverse switch is used to eject jammed branches stuck in the teeth. The feed roller is in a raised position when not in operation and is lowered to

Exhibit 1. Roller and shredder teeth.

Discussion: Machines with OPSS have sensors that detect operator presence. An OPSS provides a fail-safe condition when an equipment operator is no longer in the driver's seat. These safety devices set off an alarm, turn off one or more power sources, and/or apply the brakes to the machine when the operator leaves the seat with the engine on or in gear. If this shredder was designed or retrofit with an OPSS, the blades would not have been able to turn and pull the victim into the shredder mechanism.

It is possible that the victim exited the cab to attempt to dislodge branches that could not be ejected using the reverse/forward blade mechanism. It could not be confirmed if, under usual operations, brush can remain jammed in the feeder despite reversing the blades. On this machine, there was continued power to the blades if the operator exited the cab while the machine is running. In this incident, brush may have become jammed in the blades and the victim may have been trying to kick these branches loose. He may have lost his balance and was pulled into the roller.

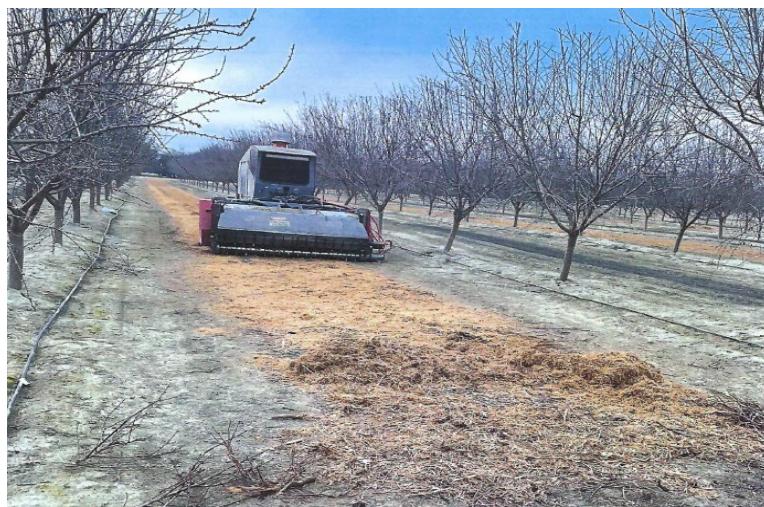
The incident scene is an almond farm in the Central Valley of California. The incident took place in the center of one of the multiple rows of almond trees (Exhibit 2).

Exhibit 2. The brush shredder in the almond field.

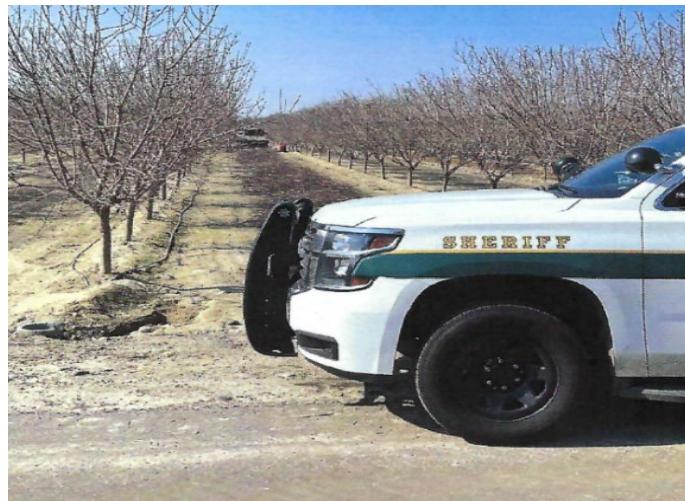
The next morning on Sunday, February 7, 2021, at approximately 9:45 am, the contractor went to the incident site and found the victim in the middle of a row of almond trees caught in the blades of the brush shredder (Exhibit 3). First responders were notified and found the victim deceased upon arrival.

Exhibit 3: The sheriff arriving at the incident scene.

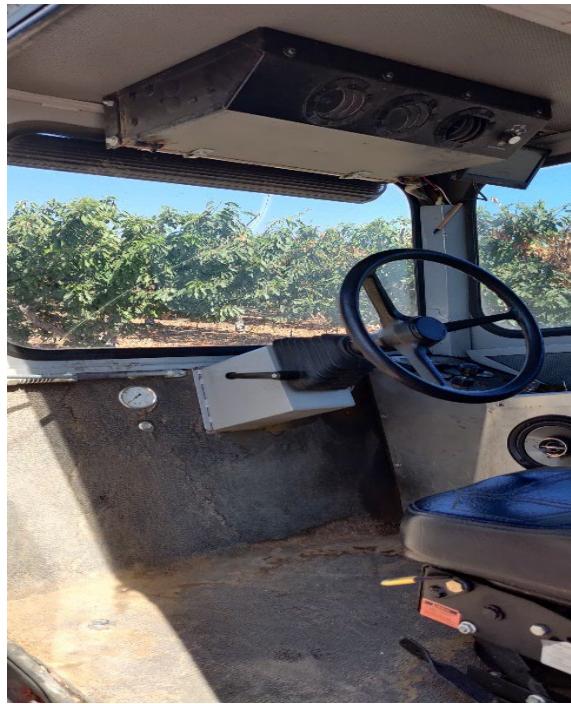
- **Location of Labels:** Labels should be visible from a distance not obstructed by other parts of the machine. Wider machines may benefit from having two labels, one on each side. Labels should be on both the inside of the cab and the outside of the shredder. Exhibit 4 shows that there were no safety warning labels inside the brush shredder involved in the incident.

Exhibit 4. No warning labels were posted on the inside of the cab.

**Recommendation #3: Post clearly visible and language-appropriate safety warning labels both inside the cab and on the outside of the shredder above the feed roller.**

If there were clear and highly visible warning labels on the brush shredder involved in this incident, the victim might have heeded the warnings to not stand in front of the rotating feed roller.

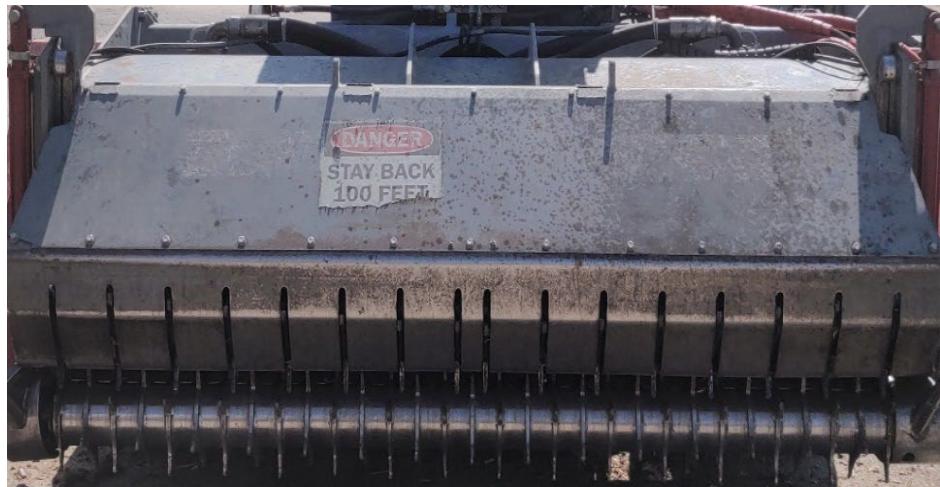
- **Periodic Inspection of Labels:** All labels fade with time. It is important to periodically inspect the labels and replace those that are fading. Exhibit 5 shows the fading label on the outside of the brush shredder involved in this incident.

- **Training:** Employers should train workers on how to recognize and interpret posted safety labels. Languages used on the labels should be understandable to workers. Figure 5 shows that the label on the machine involved in the incident was only in English.

Exhibit 5. Faded warning sticker on the front of the shredder.
