State **FACE** Program

REPORT#: 2020OR02

REPORT DATE: Sept. 01, 2021

Farm Worker Crushed in ATV Rollover During Herbicide Application on a Hillside - Oregon

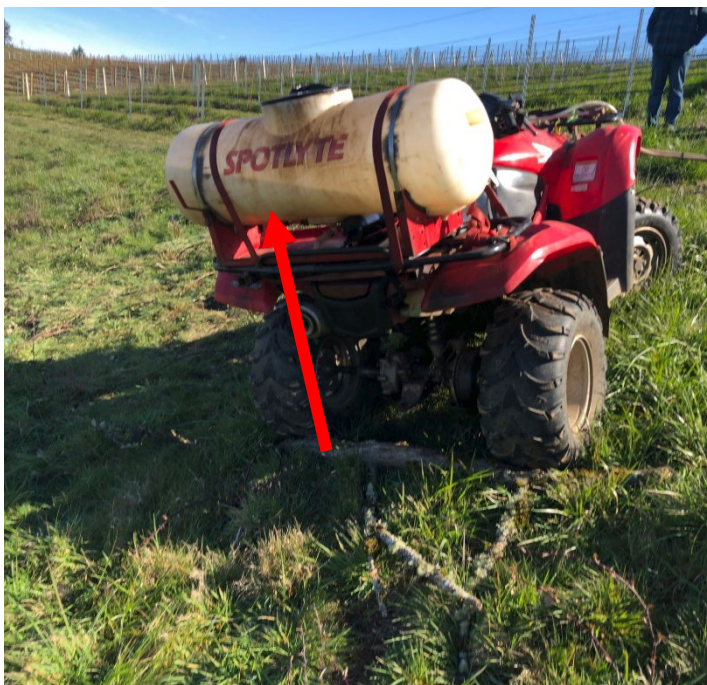
A 20-gallon Spotlyte™ Model SL-6800-60 polypropylene pressurized tank was secured to the cargo area of the ATV (See Image 2). The Spotlyte™ broadcast sprayer system operates at 60 PSI and distributes 1.4 gallons per minute of aerosolized liquid. The ATV involved in the incident had been modified so that the main hose from the tank connected to a y-valve in which two hoses led to spray nozzles secured to metal booms on either side of the front of the vehicle (See Image 3). The booms were attached to a metal frame on the front of the ATV by a metal spring with carabiner-type fasteners at either end of the spring (See Image 3). The decedent had mixed the chemicals at the chemical mixing area of the field service garage. The chemical manufacturer procedures specify partially filling the tank with water through the fill port on top of the tank, adding the chemicals, then topping off the tank and closing the fill port.

Image 2. Spotlyte™ tank attached to cargo area of ATV involved in incident. Note the liquid level in the tank indicates the slope of the terrain (red arrow).

The ATV manual states the load limit for the ATV involved in the incident is 485 pounds, which includes the rider, cargo and accessories (page 48). The load limit for the rear cargo area is 133 pounds (page 48). The dry weight of the broadcast sprayer system was 39 pounds, confirmed by the OR-FACE investigator via a phone call to a local distributor (Prima Industries, Newberg, OR), who took a new unit out of the box and weighed it. The weight of herbicide mixture in a full tank was estimated at 207-211 pounds by the OR-OSHA SCO and the OR-OSHA Lab Manager (total weight of sprayer plus mixture = 246 to 250 lb.), based on the safety data sheets for each of the products used by the decedent on the day of the incident. The vineyard manager stated the tanks are filled completely at the chemical mixing area, prior to herbicide application. Therefore, when the decedent left the field garage to apply the herbicide in the lower field section, the spray system and payload in the rear cargo area likely exceeded the manufacturer's weight limit for the rear cargo area by 113-117 pounds.

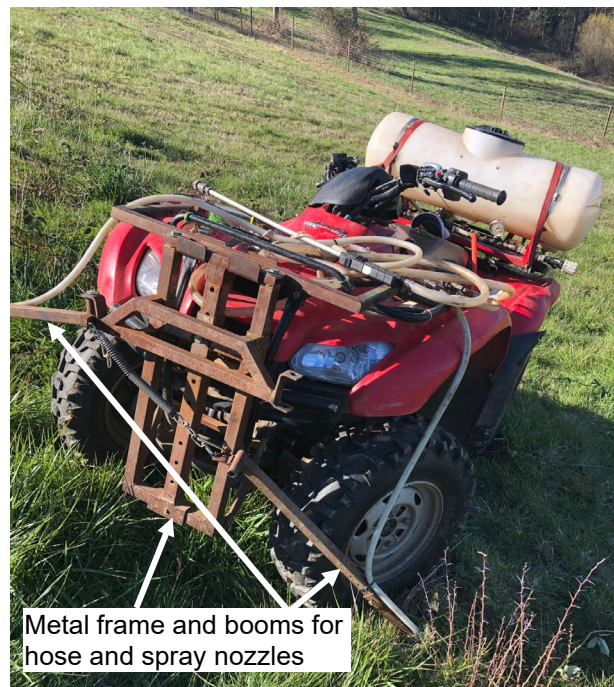
Image 3. Front view of ATV modified with herbicide sprayer apparatus.

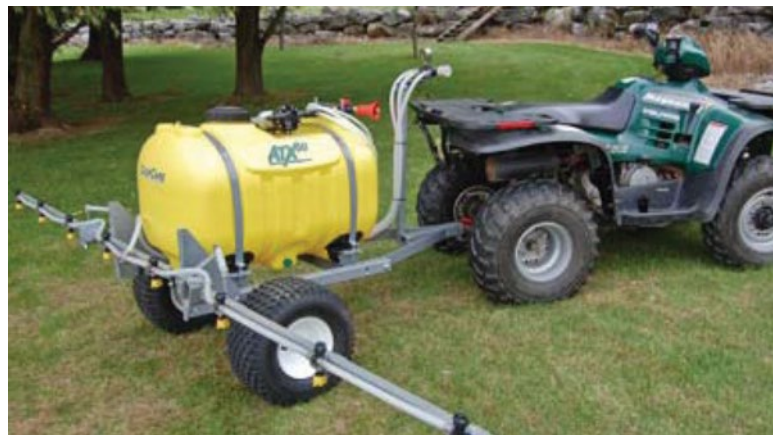
Image 4. spraying system mounted on a trailer, hitched to an ATV. (Photo credit: OSHA, 2015).

Vehicle loading is another critical factor of operator safety. Oregon rules for ATV use in agriculture specify “Do not overload any vehicle. Keep loads stable and well balanced.” (OAR 437-004-3410(3)(a)(I)). Rigid mounted equipment in the ATV cargo area changes the center of gravity of the vehicle and can increase the risk of a side overturn (USDA, 2021). Liquid loads, like the spray tank payload in use in this incident, present additional challenges. When working on sloped terrain, the weight of the liquid shifts to the downhill side, creating potentially greater vehicle instability (SAIF, 2015). Using a trailer-mounted tank (**Image 4**) is more stable alternative to an ATV-mounted tank. The ATV involved in the incident was rated for 850 pounds of tow load capacity, which was over 4 times more load capacity than front and rear cargo areas combined. Towing a trailer-mounted tank also puts the chemical emissions behind the worker, rather than in front of the worker in this incident.

performance. The employer did not check the ATV user manual to assess if the ATV sprayer systems exceeded the manufacturer's load limit, which it did. In the current case, the ATV with a cargo-area mounted tank would have needed to be consistently underfilled to stay within load limits. The cargo-mounted system, with fluid and weight shifting over the rear wheels of the ATV, was also a much less stable and less safe option than a trailer mounted system for the task and terrain.
