REPORT#: 18MI027

School Crossing Guard Struck by Vehicle

Michigan Fatality Assessment and Control Evaluation (FACE) Program

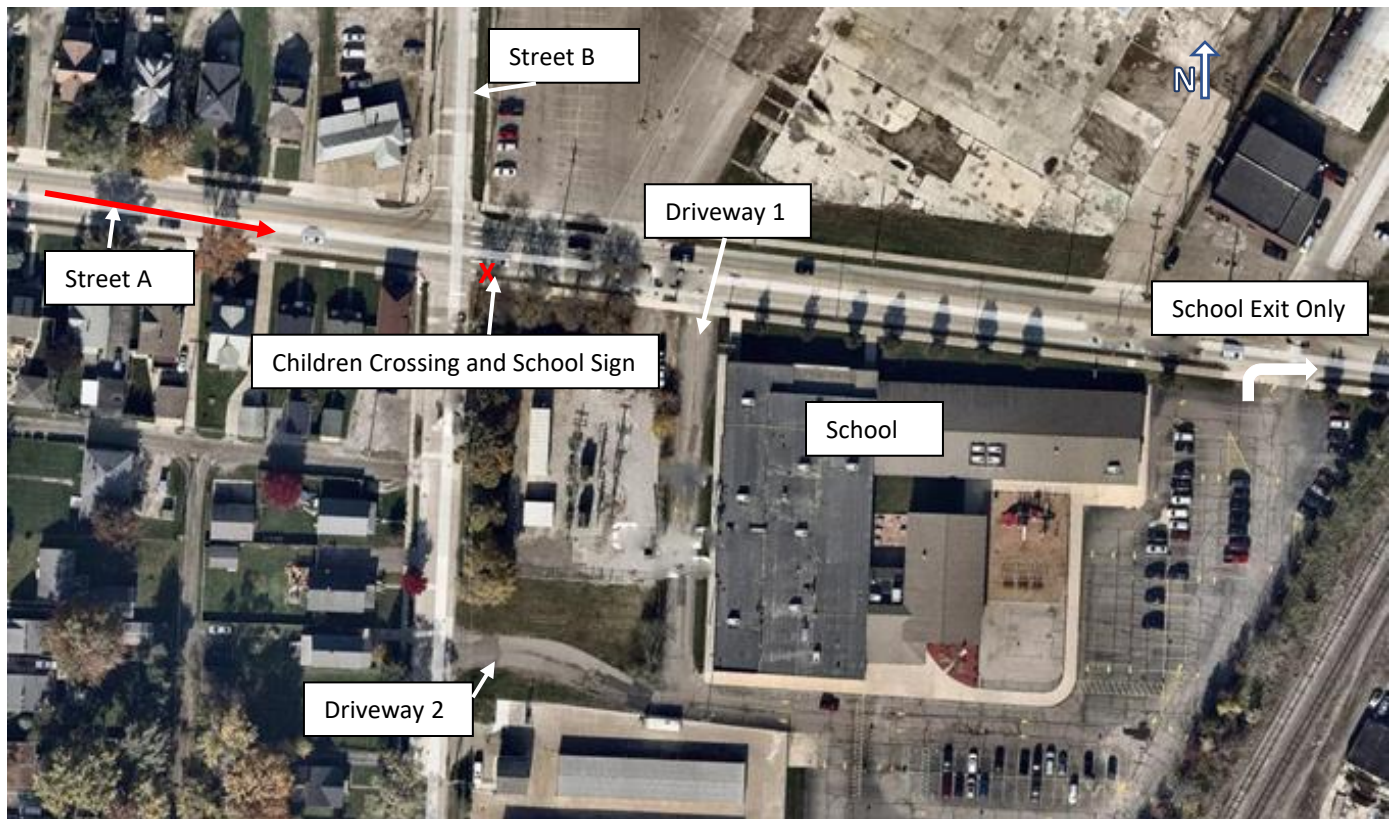
Photo 1. Overview of incident area. Red X shows location of incident. Photo courtesy of Google Maps. Note: crosswalk hash marks on east side of intersection on Street A. Red arrow shows direction of vehicle travel.

The school had two vehicle entrances, Driveway 1 accessed by Street A and Driveway 2 accessed from Street B.

Street A was a heavily traveled east-west two-lane street with a center turn lane and a posted speed limit of 35 mph. The location where the decedent was struck by the minivan was near the intersection of Street A and north-south Street B (See Photo 1). Streets A and B were cement and were dry at the time of the incident. Street A had the right of way. Street B was a two-lane roadway with a stop sign at the intersection. Each roadway edge had cement curbs separating the roadway from grass and sidewalks.

At the time of the incident, the decedent was providing crossing services for students walking south on Street B, crossing the hashed-painted crosswalk located on Street A. Just to the east of this crosswalk across Street A were a Children Crossing and School sign. Photo 2 shows the signage present at the incident scene; the sign was relocated after the incident. Photo 3 shows the incident scene and the actual location of the signage at the time of the incident. There was no other school signage on Street A west of Street B.

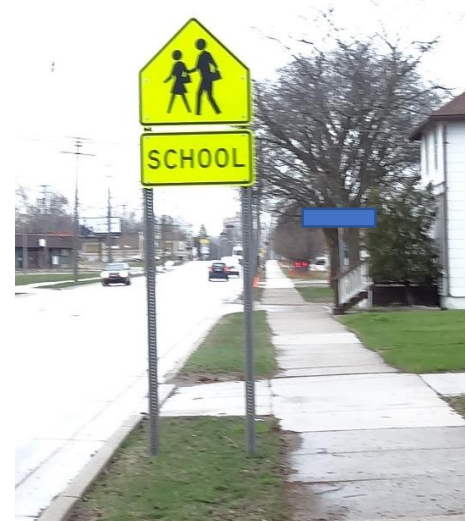
Photo 2. Children Crossing and School sign originally east of the crosswalk on Street A. The sign was relocated to west of the intersection after the incident.

- The crosswalk lines on the cement were removed in consultation with school staff, the sheriff and county road commission.
- School staff are permitted only in designated student drop off and parking areas. One crossing guard stationed at exit driveway to permit student access to/from school.
- Closed Driveway 2. Added fence to block access, and planted grass (Photo 5). Only one (Driveway 1) entrance to school.
- Relocated the School Crossing signage west of Street B (See Photo 2)

Discussion: The interviewee indicated that the school crossing sign originally at the crosswalk was moved to its current location after discussion with the appropriate entities (Photo 2). The signage as shown in Photo 2 was not the signage required by Part 7 of the MMUTCD. Part 7, Section 7B.12 requires a school crossing assembly to be installed at established marked crosswalk(s) or as close to it as possible as per section 257.613a of the Michigan Vehicle Code. The school crossing assembly shall consist of a School (S1-1) sign supplemented with a diagonal downward pointing arrow (W17-7P) plaque to show the location of the crossing (See Figure 2). Municipalities should ensure school signage is selected and installed according to the requirements of the MMUTCD.

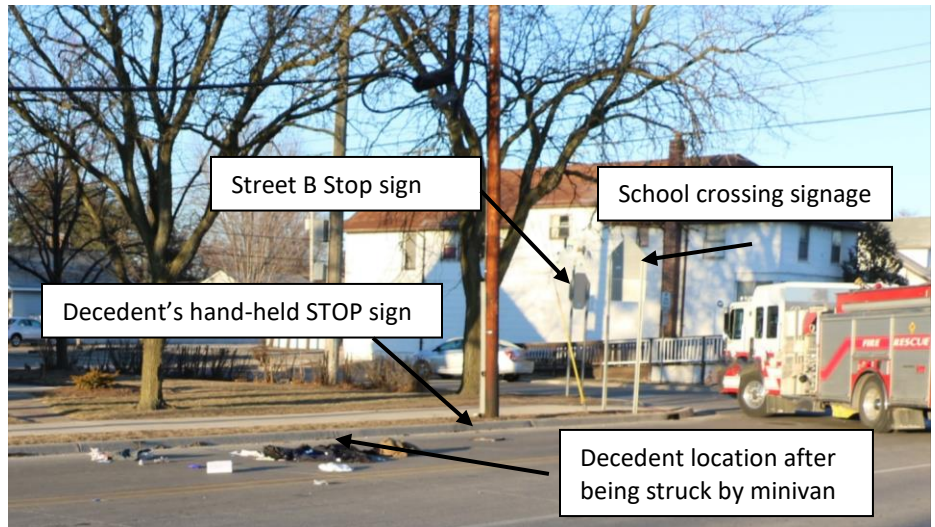
Photo 3. Overview of incident scene showing location of school signage and decedent after she was struck by the minivan

When emergency workers arrived, the decedent was laying in the eastbound travel lane. Her head was positioned to the southeast and her feet were positioned to the northwest along with debris from the scene. West of the decedent’s location in the eastbound lane were: small pieces of glass shards, a Duracell battery near the southern curb, several black pieces of plastic, white/red plastic and her hand-held stop sign.

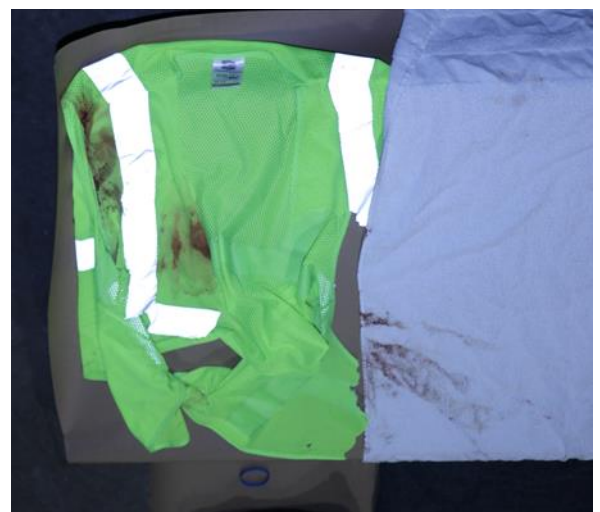
Photo 4. Class II (Type R2) safety vest worn by decedent

Responding emergency personnel removed several items of clothing from the decedent. Police noted a safety vest (Photo 4), black winter coat, grey gloves, black jacket, and a blue sweater. A towel, blankets, a black communication radio and a chrome whistle were located under the clothing on the cement.

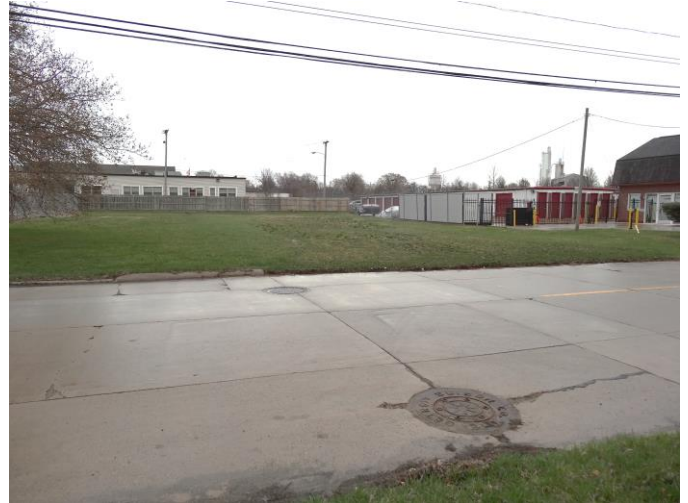
Photo 5. Driveway 1 no longer utilized as school entrance

- The school no longer provides crossing guard services for Streets A and B.
- Students are not permitted to cross Street A from the north or south without parental assistance.

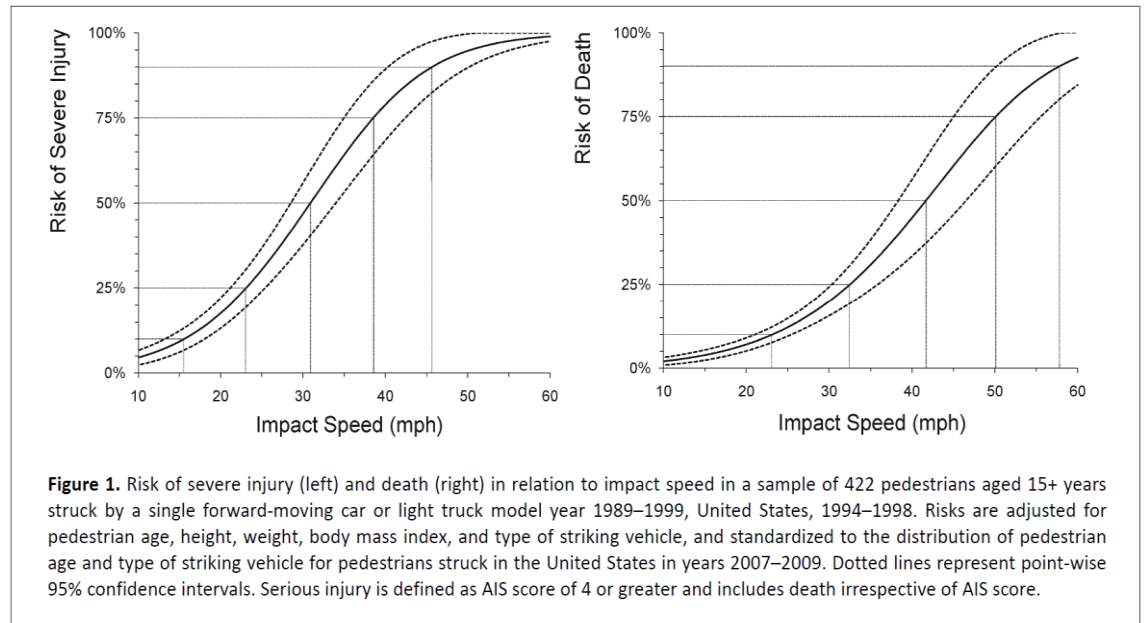
Discussion: The likelihood that the decedent would have sustained fatal injuries would have been reduced if the speed limit in the school zone was no more than 20 mph, rather than 35 mph. The AAA Foundation for Traffic Safety study estimated of the risk of severe injury or death for pedestrians struck by vehicles in the United States using data from a federal study of crashes that occurred in the United States in years 1994 – 1998 in which a pedestrian was struck by a forward-moving car, light truck, van, or sport utility vehicle. Risks were standardized to represent the average risk for a pedestrian struck by a car or light truck in the United States in years 2007 – 2009. Analysis determined that the average risk of severe injury for a pedestrian struck by a vehicle reached 10% at an impact speed of 16 mph, 25% at 23 mph, 50%

at 31 mph, 75% at 39 mph, and 90% at 46 mph. The average risk of death for a pedestrian reached 10% at an impact speed of 23 mph, 25% at 32 mph, 50% at 42 mph, 75% at 50 mph, and 90% at 58 mph. (See Figure 1).
