**REPORT#: 20KY006**

## Farmworker Dies in Grain Bin Engulfment

### SUMMARY

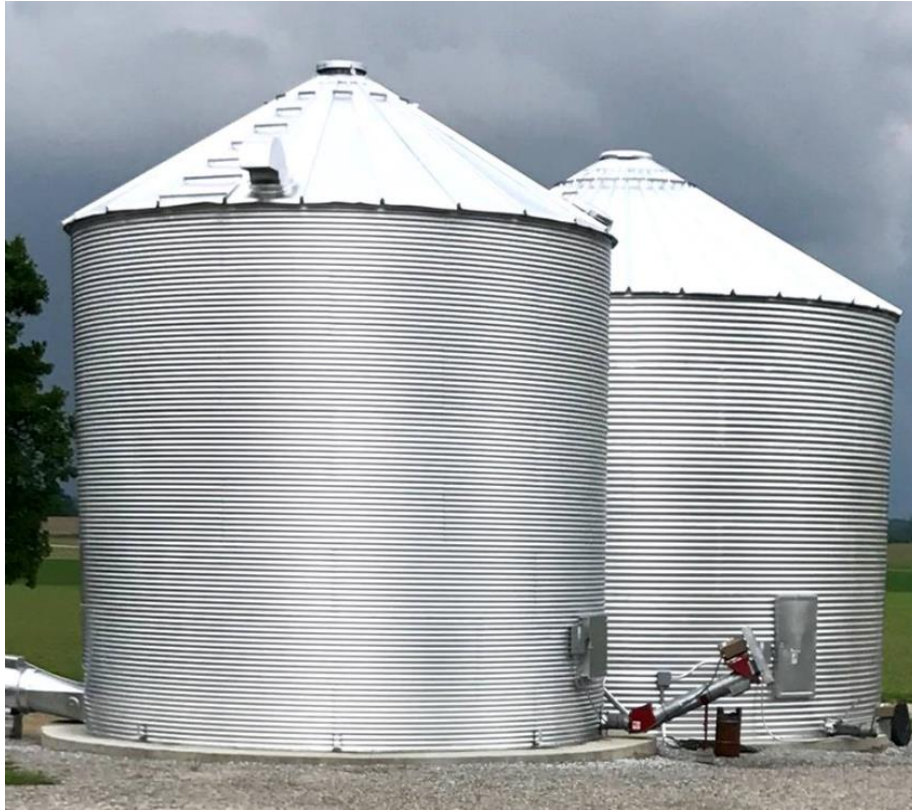
The incident occurred on the company's farm within a large grain bin. The capacity of the bin was 80,000 bushels - approximately 745,000 gallons. At the time the incident occurred, the bin contained approximately 60,000 bushels of corn. The grain bin was equipped with a center, bottom-mounted auger at the base of the bin in the center position.

Photo 1. Image depicting grain bin configuration similar to involved grain bin. (*Grain Bin Photo*. (n.d.).

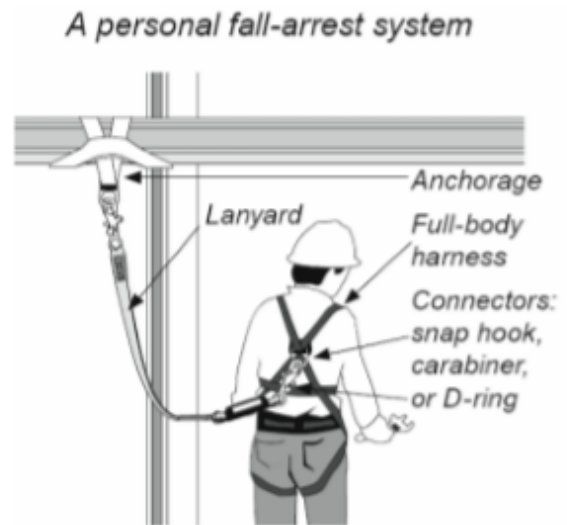
**Use at least one of the following whenever workers are exposed to a fall of 6 feet or more above a lower level:**

- Guardrails on ladders, roofs and platforms
- Safety Net Systems
- Fall Arrest Systems

Diagram 2. Informative diagram showing proper guidance on fall protection for grain bin entry. (*Grain Handling Safety Coalition, 2016*)

***Recommendation #3: Employers should require employees to utilize adequate fall protection when entering a grain bin is necessary.***

Discussion: Although fall protection harnesses were available, the victim was not utilizing fall protection when the incident occurred. According to OSHA standard 1910.28(b)(1)(i), Employer must ensure that each employee on a walking-working surface with an unprotected side or edge that is 4 feet (1.2 m) or more above a lower level is protected from falling by one or more of the following: Guardrail systems; Safety net systems; or Personal fall protection systems, such as personal fall arrest, travel restraint, or positioning systems (*OSHA, 2016*).

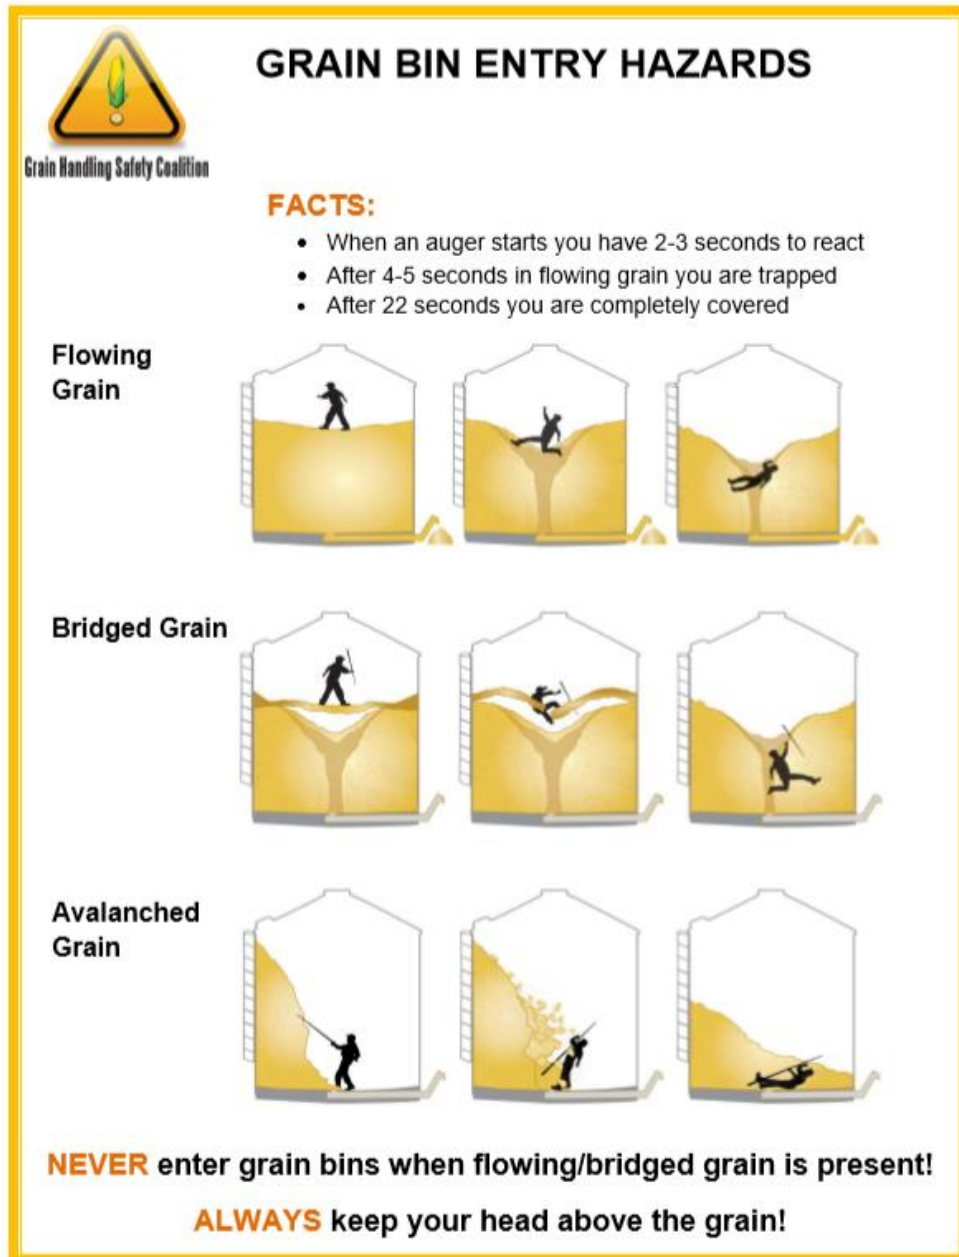
Diagram 3. Diagram depicting dangers associated with grain bin entry (Grain Bin Entry Hazards, 2015).

Employers should train their employees on the dangers associated with grain bin entry, many free training resources are available through the [Grain Handling Safety Coalition](#). Resources available include videos, picture library, policy templates, posters and handouts like the one below:
