MIFACE Investigation Report: #13MI020

SUBJECT: Roofer Falls From Roof Edge When He Stepped on Insulation Overhang

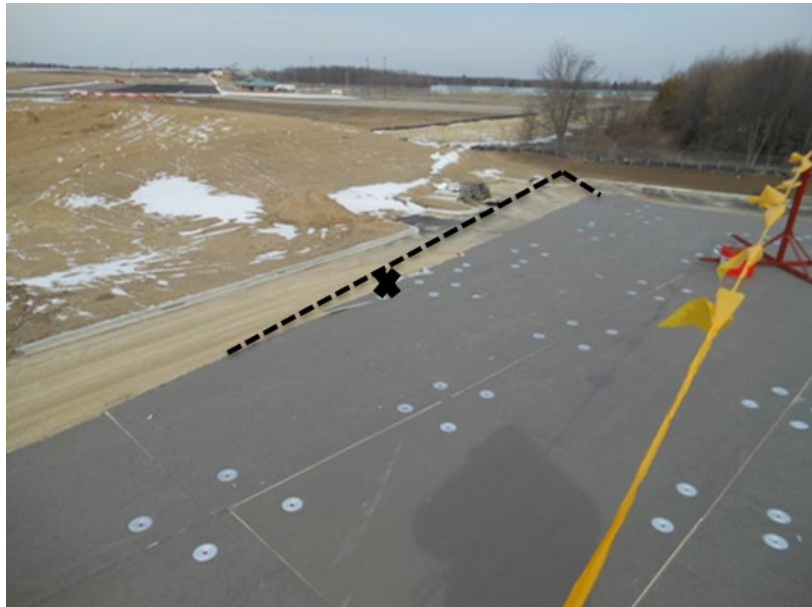
In the winter of 2013, a male roofer in his 40s died when the cantilevered 2” rigid roof insulation he stepped on broke, causing him to fall approximately 26 feet to the frozen ground. The firm had a fall protection program including a safety monitor, warning line, and personal fall arrest system (PFAS). The foreman had dual responsibilities: installing insulation and acting as the warning line’s safety monitor. The decedent was not wearing fall protection while working

Figure 1. Roof location where decedent fell

- Employers should ensure that workers are protected against falling while working at an elevation. This includes, but is not limited to, maintaining the integrity of an established warning line system and ensuring the use of personal fall arrest equipment.

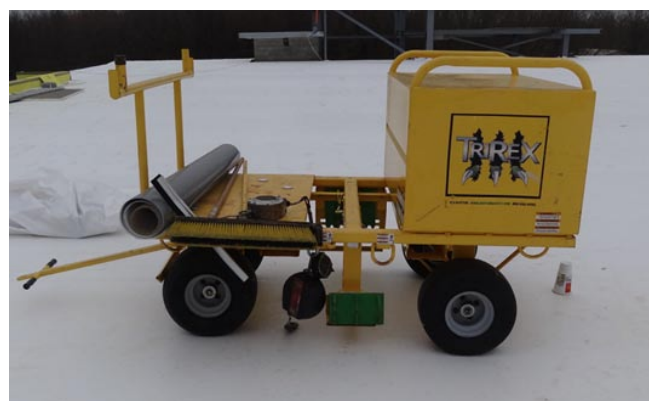
On site, the firm had a mobile fall protection cart which had locking pins for the wheels so it could be utilized on different sections of the roof (Figure 2). Additionally, the firm used a reusable roof anchor designed for use on steel roofs of 24-gauge or thicker if mounted with a minimum of 10 #8, ¾-inch long sheet metal screws per side on raised ribs of roof panel with pull in the long axis (Figure 3).

Figure 2. Fall arrest cart located on upper level

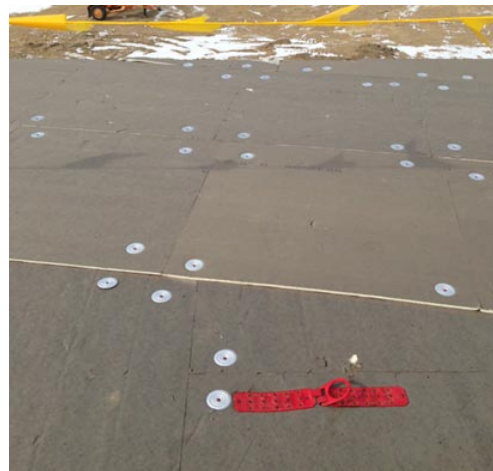
Three days prior to the incident, the firm had completed work on the main roof level. Work ended that day due to inclement weather. Work began the following Monday on the lower roof level. There was a 4-foot difference in height between the two roof levels. The firm did not have a tool box talk the day of the incident. Workers moved the warning lines to the approximately 65-foot by 75-foot lower roof, leaving a range of six feet to 16 feet away from the roof edge. Spacing between the warning line support posts was 15 feet and the height of the warning line ranged between 36” to 39” above the roof. The mobile fall cart was left on the upper roof due to the height issue. The workers installed the reusable anchor on the lower roof in accordance with the manufacturer’s instructions.

Figure 3. Roof anchor located inside of the warning line on northwest roof corner

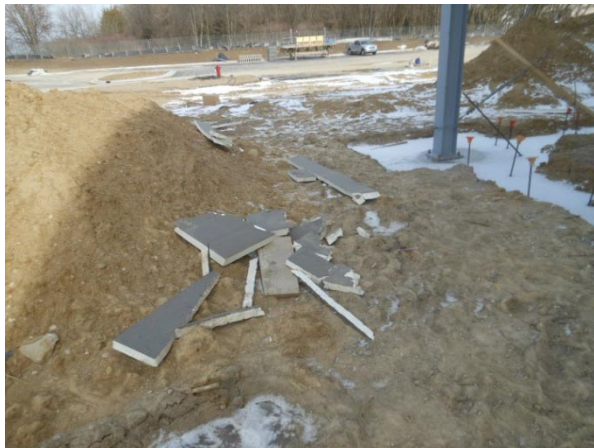
Shortly after Coworker 1 left the roof, the decedent apparently wanted to help Coworker 1 finish trimming the insulation. With his harness in a bucket within the warning line area on the roof, the decedent proceeded outside of the warning line (Figure 4). Coworker 2 was on the roof working near the decedent. "Out of the corner of his eye", he saw the decedent stand up and unknowingly step onto a piece of tapered insulation that extended past the roofline. The cantilevered insulation was unable to support the decedent's weight and broke, causing the decedent to fall approximately 26 feet to the frozen ground below (Figure 5).

Figure 5. Two-inch rigid foam insulation which broke when decedent stood on it
