NJ FACE INVESTIGATION REPORT

FACE 15-NJ-07

Mechanic Dies After Being Crushed Under Electrical Cabinet

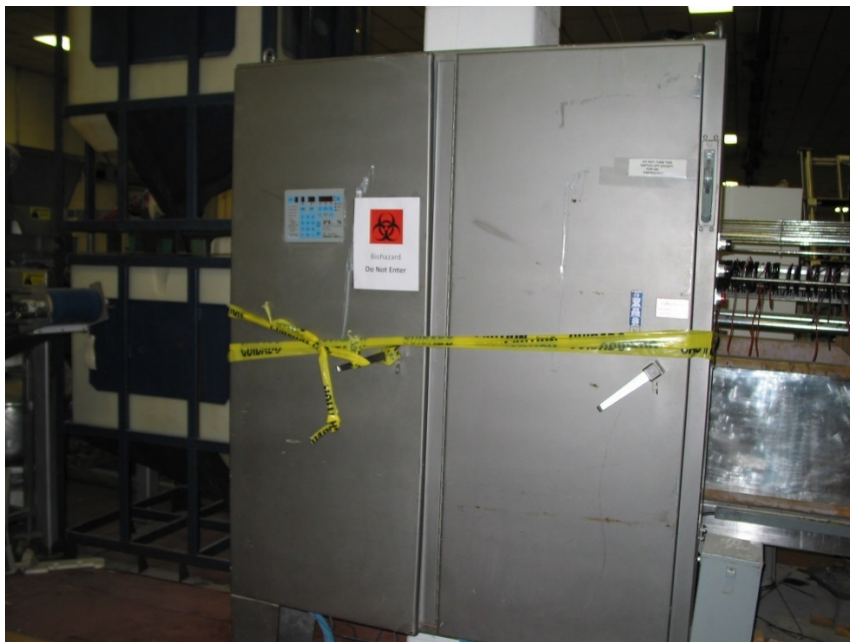
On the day of the incident, the victim arrived at 3:00 am for his shift. In addition to his normal duties as a mechanic, he was tasked with removing any salvageable parts from a large electrical cabinet. The cabinet measured 61-inches-wide, by 87-inches- high, by 12.5-inches-deep, and weighed 993.5 pounds (see Figure 1). The cabinet was located in a section of the plant reserved for storage of decommissioned equipment. The company had been recently sold, and the new owner decided to scrap all the equipment in this area. Employees were assigned to remove working parts to be used as possible replacement/spare parts for equipment still in service.

FIGURE 1: Front view of electrical cabinet upright.

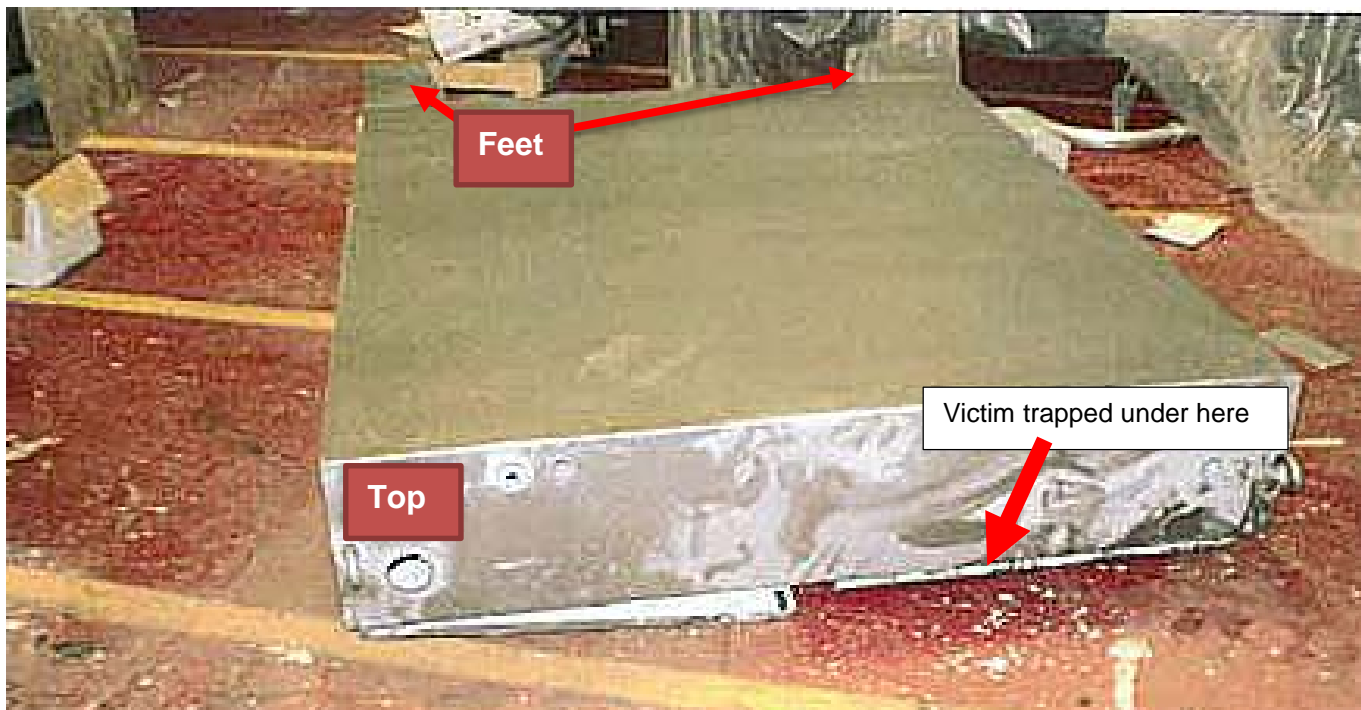
Near the end of his shift, the victim was working alone removing electrical circuit boards and other components from the cabinet. To reach some of the higher components inside the cabinet, he had to stand on the bottom shelf. Although there were no witnesses, it is believed (based on his position underneath the cabinet) that while he was standing on the bottom shelf and removing components, the cabinet tipped over and trapped him underneath as it crashed to the ground (Figure 2). The plant safety manager heard the noise of the crash and immediately ran over and, unsuccessfully, tried lifting the cabinet off the victim. He then radioed for help and five employees rushed to the scene. One employee called 9-1-1 while another drove a forklift over to help free the victim. The forks were placed under the electrical cabinet, two workers and the safety manger stabilized the cabinet on the forks while the other

FIGURE 2. Incident scene; cabinet fell forward crushing the victim underneath.

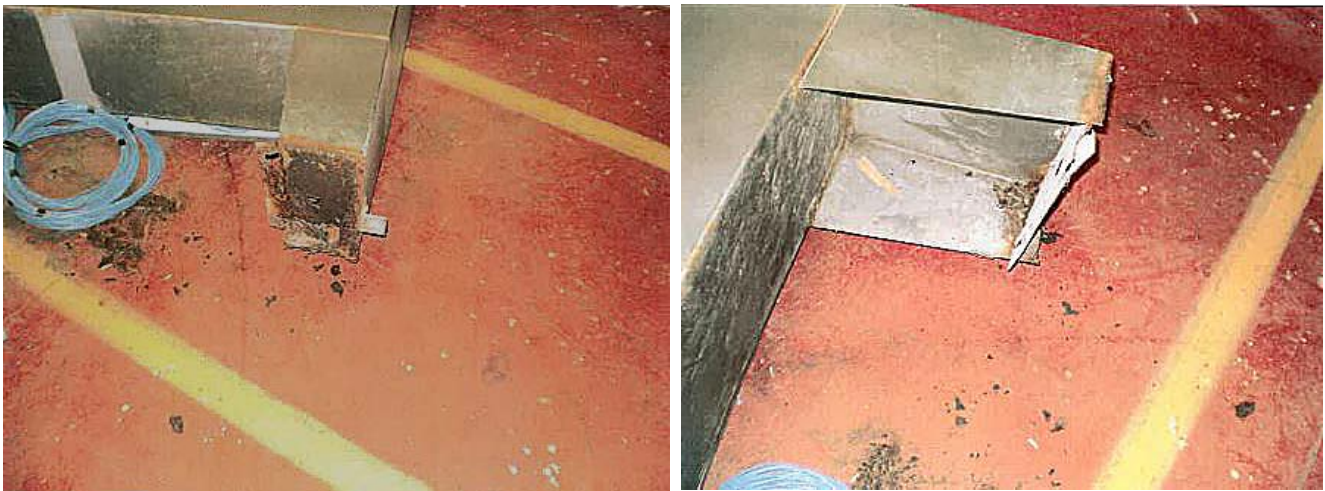
FIGURE 3. Views of cabinet foot at incident scene.

Discussion: As per 29 CFR 1910.176(b) (Materials Handling and Storage), storage of material should not create a hazard, and should be stable against sliding or collapse.² As noted in Recommendation #1 above, the metal feet that supported the cabinet were in poor condition. It is believed that when the victim was standing on the cabinet, the feet collapsed causing the unit to tip over. NJ FACE

Recommendation #2: Prior to working on any object with a potential tipping hazard, proper support and structural integrity should be ensured.

recommends that all structural components be inspected prior to starting work, especially if there is a potential tipping hazard.

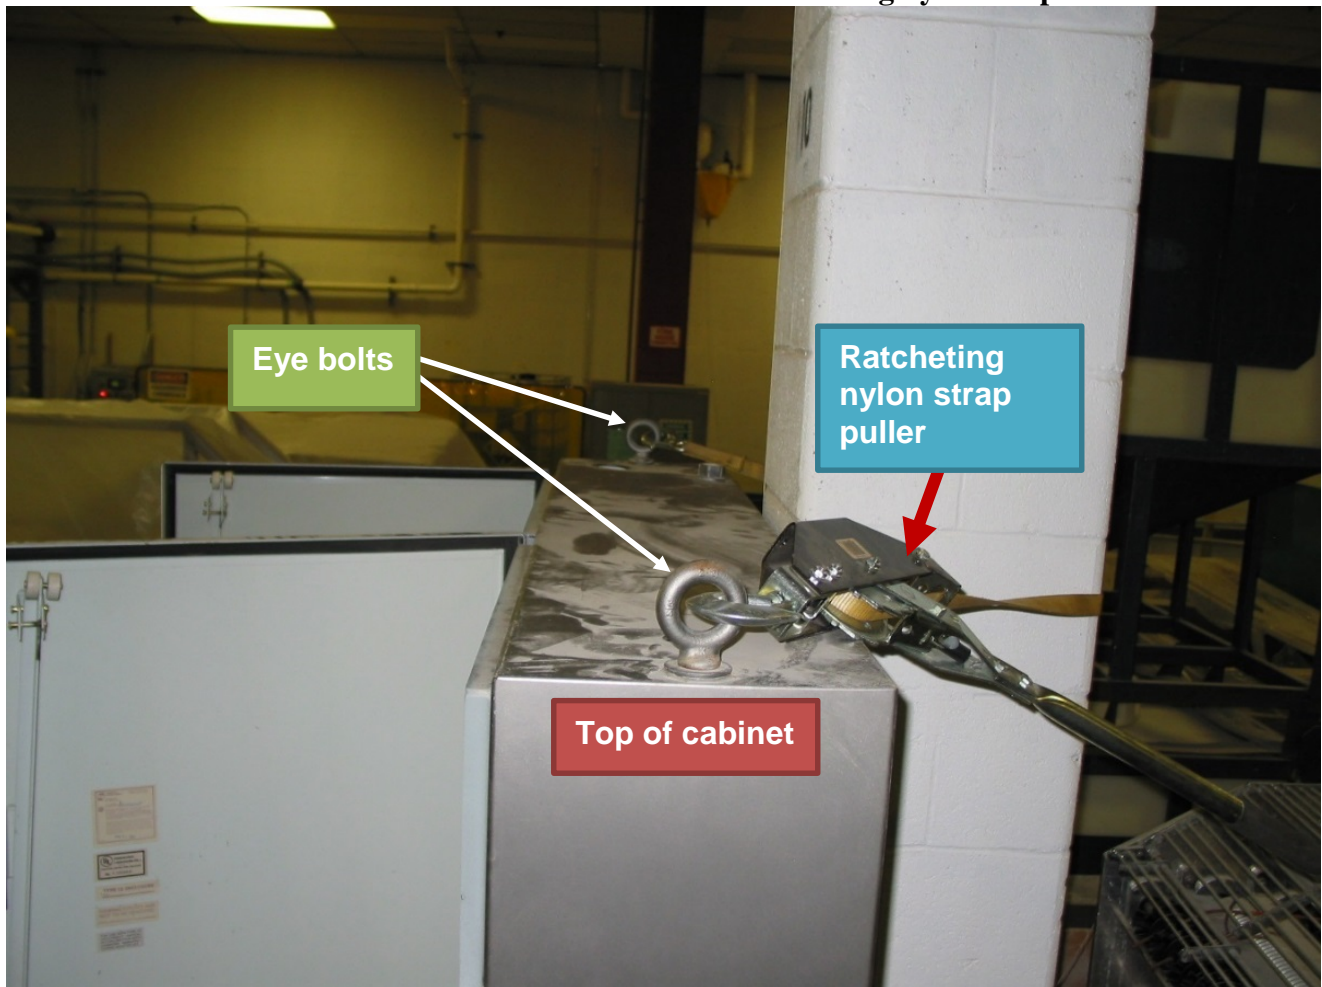
FIGURE 4. Electrical cabinet anchored to concrete column using nylon strap.

Recommendation #3: Any object with a potential tipping hazard should be adequately anchored to a permanently fixed point, such as wall or column.

Discussion: 29 CFR 1910.176(b) also notes that items should be secured against collapse. Any free standing object with the potential for tipping over should be anchored or attached to a wall or structural column. In this case, after the incident the employer secured the cabinet to a concrete column using a nylon strap attached to eye bolts affixed to the top of the cabinet (Figure 4). An in-line ratcheting nylon strap puller was used to tighten and maintain the tension on strap.
