NJ FACE INVESTIGATION REPORT

FACE 12-NJ-021

Laborer Killed after being Struck by a Slab of Concrete that had been Lifted

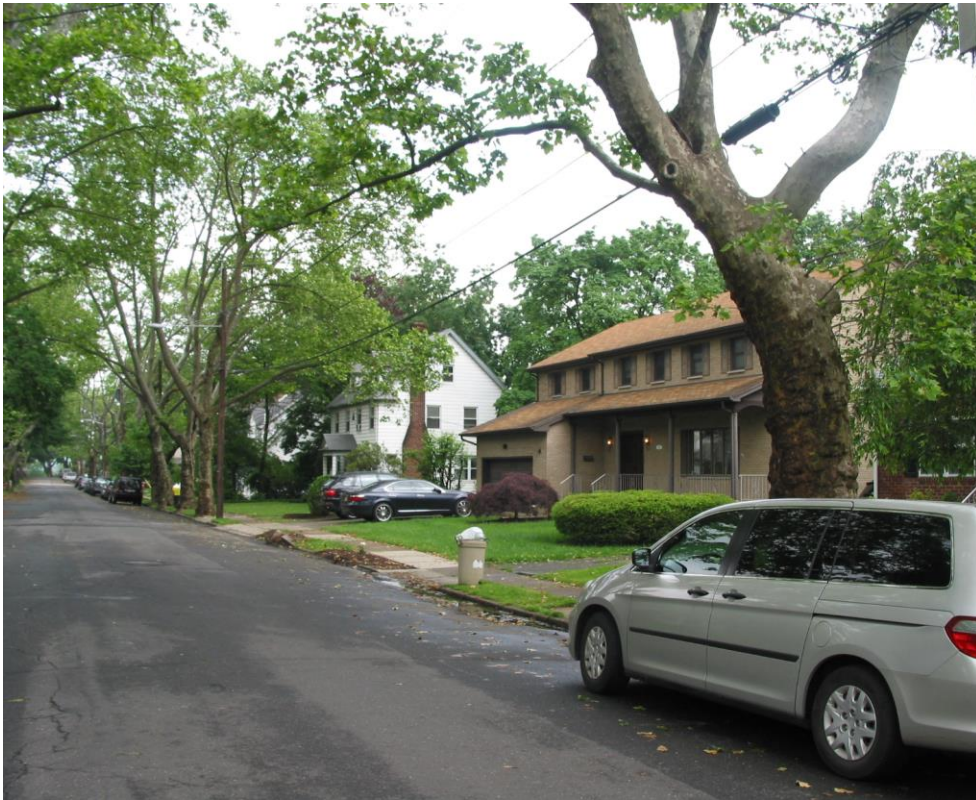
FIGURE 1. Incident site, a heavily treed residential neighborhood in NJ.

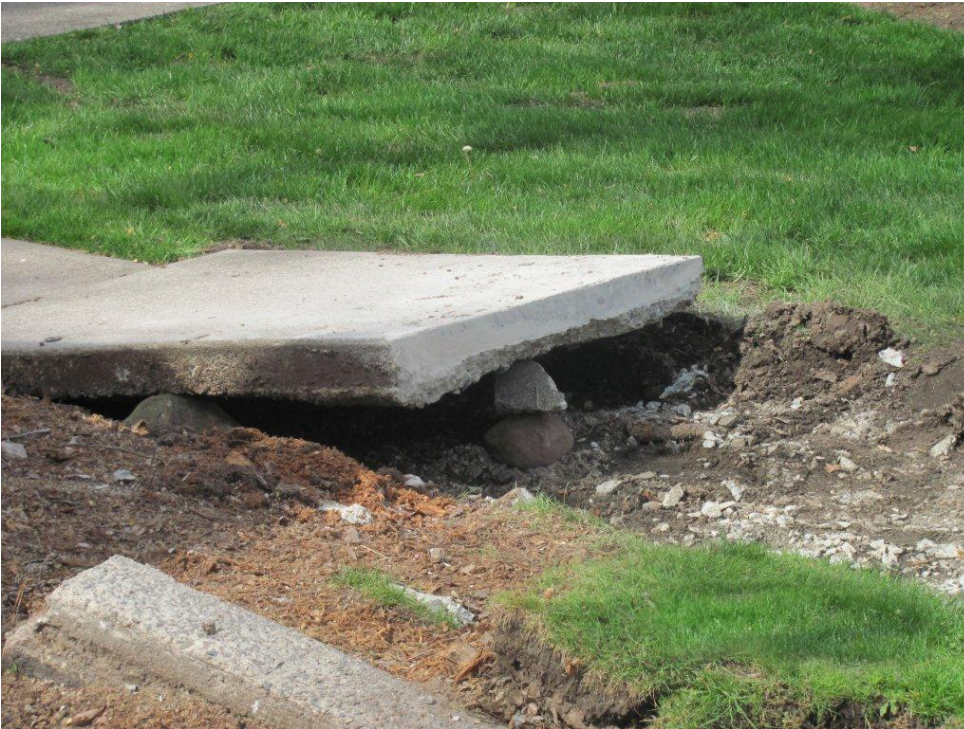
FIGURE 2: Sidewalk slab propped-up by stones.

If the method utilized during this incident continues to be used, NJ FACE makes the following additional recommendations: 1) use wood or small cement blocks in good condition to prop-up the slab; 2) ensure that the chain and hooks can handle the approximate load of the slab; 3) employ tag lines when moving the slab to keep workers clear of the hazard; 4) take extra care when using a skid-steer loader to lift and move heavy objects (according to onsite interviews, the skid-steer loader made “jerky” movements and it was difficult to move the slab smoothly).

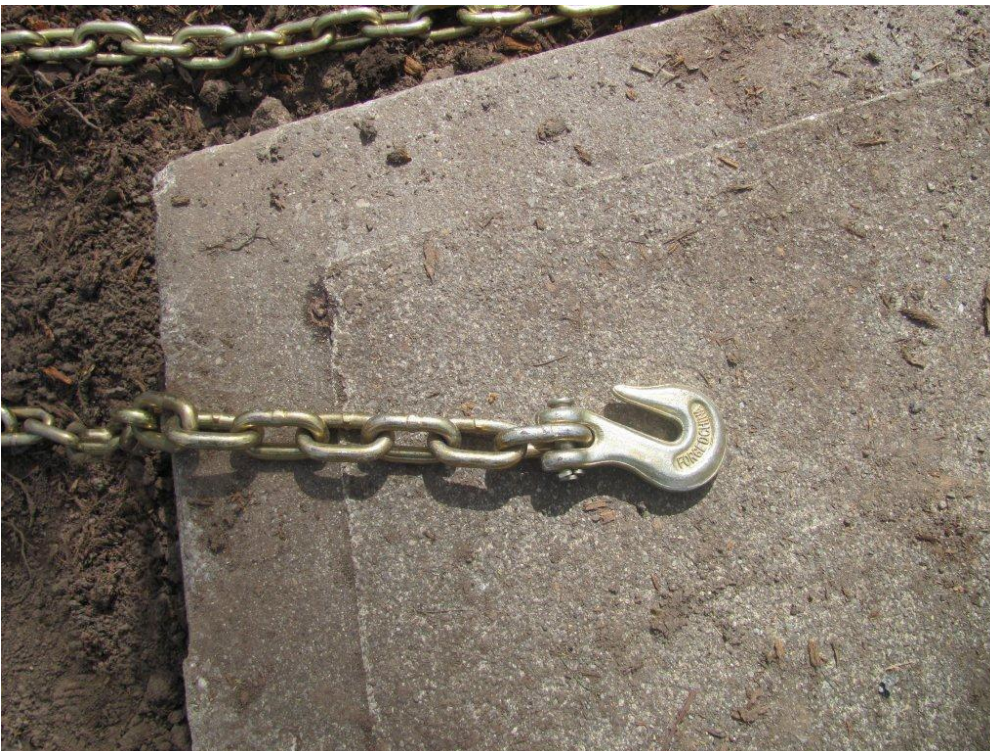
FIGURE 3. Chain with two-inch pelican hook used to lift the slab.

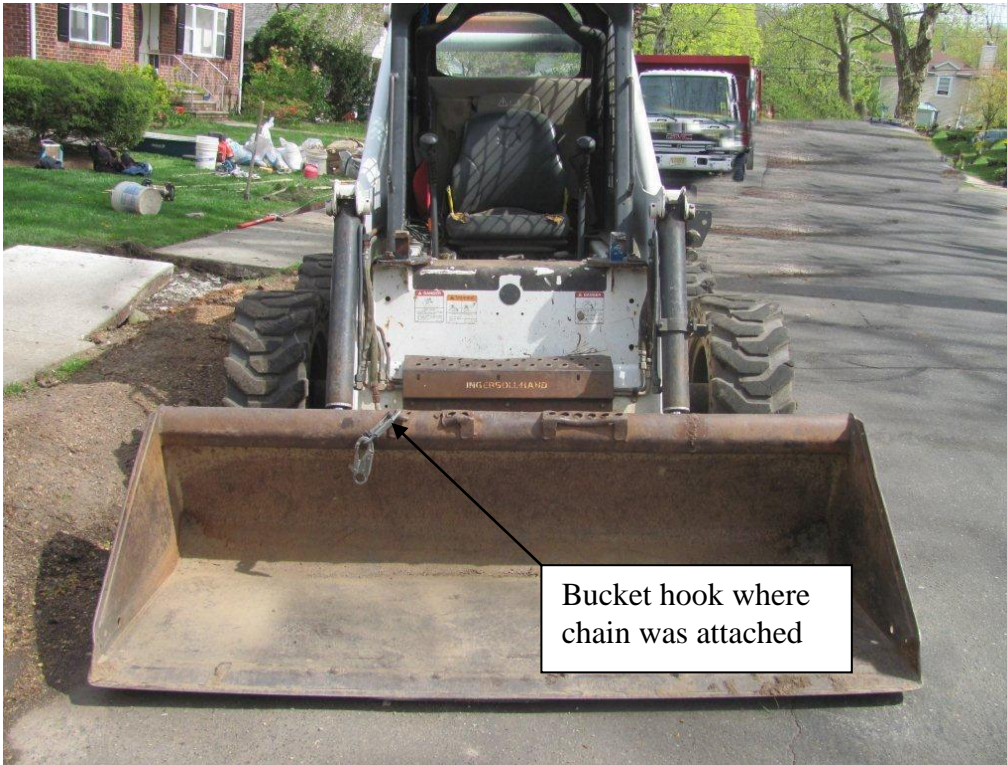
FIGURE 4. Skid-steer loader; note bucket hook where chain was connected.

Many safer alternatives exist for re-grading the ground beneath concrete slabs. The important commonality between them is that the slab is never suspended off the ground. One alternative is to raise the concrete by cutting/jacking and filling (also known as slabjacking or mudjacking). This process is accomplished by drilling small holes into the concrete (or lifting the concrete using specialized jacks or pry bars) then pressure injecting (or hand-filling) material underneath the slab to fill the gaps, leveling the concrete.²⁻³ Another method is to pry the concrete up and place metal rollers between wood boards underneath; the slab can then carefully rolled away, the soil re-graded, and the slab rolled back into place.⁴
