Fatality Investigation Report

OR 2006-44-1

Young warehouse worker killed by backing forklift

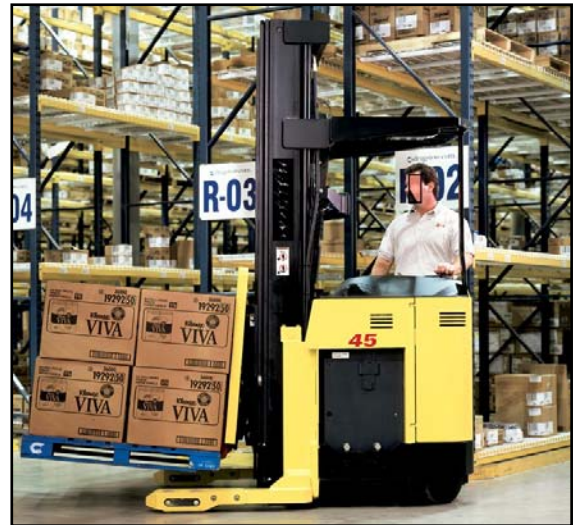
A narrow-aisle stand-up lift truck was backing down a warehouse aisle with a loaded pallet when the warehouse clerk in this incident walked into the aisle (stock photo of similar equipment).

The operator generally stands sideways on a narrow-aisle stand-up forklift during operation (see cover photo). This particular forklift was not equipped with mirrors or any warning device, such as a back-up alarm or a flashing light, as these were offered as options by the manufacturer at the time of purchase.
