**SUBJECT:** A Roofing Supervisor Dies When He Falls Through a Skylight

**SUMMARY**  
**California FACE Report #11CA004**

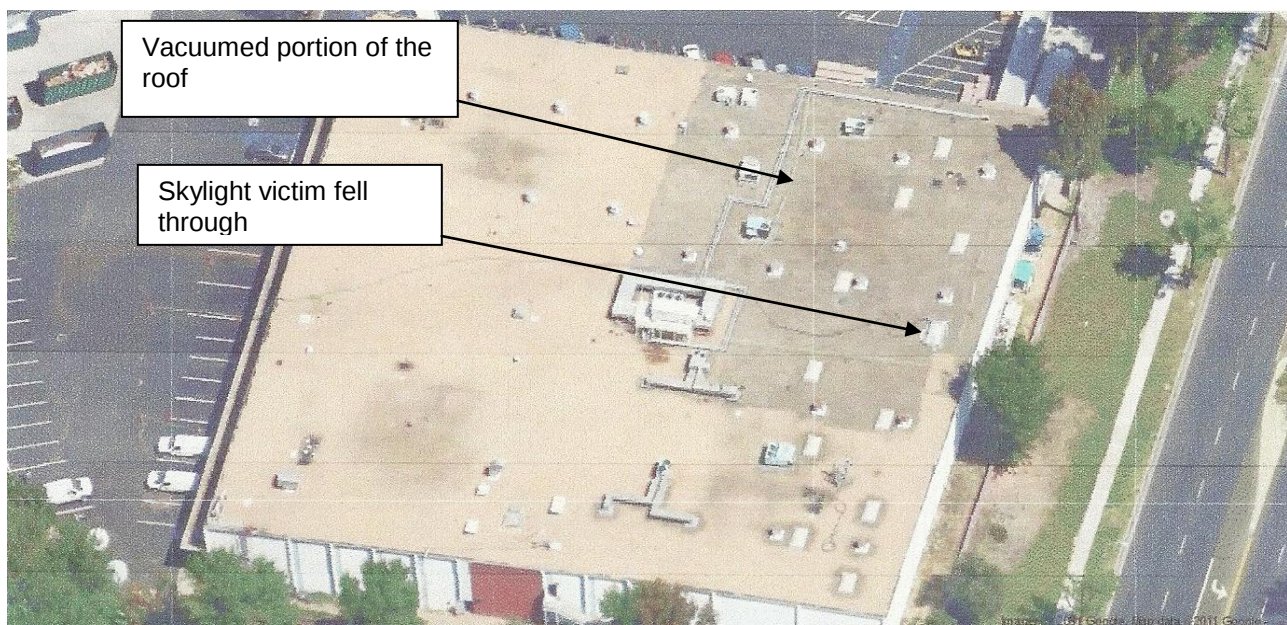
The location of the incident was a large industrial flat roof of a warehouse that measured approximately 150 feet long and 150 feet wide (**Exhibit 1**). The roof housed many air conditioning units, skylights, vents, and other plumbing and electrical fixtures.

**Exhibit 1. The warehouse rooftop where the incident occurred showing the vacuumed portion of the roof.**

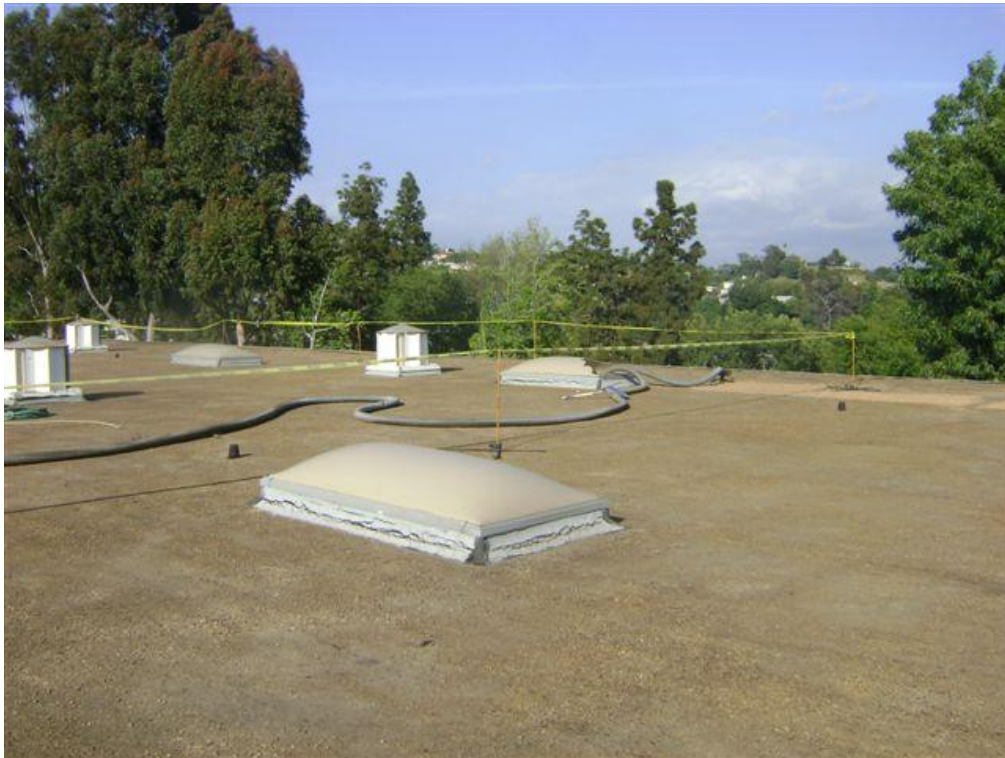
**Exhibit 2. The work area on the roof.**

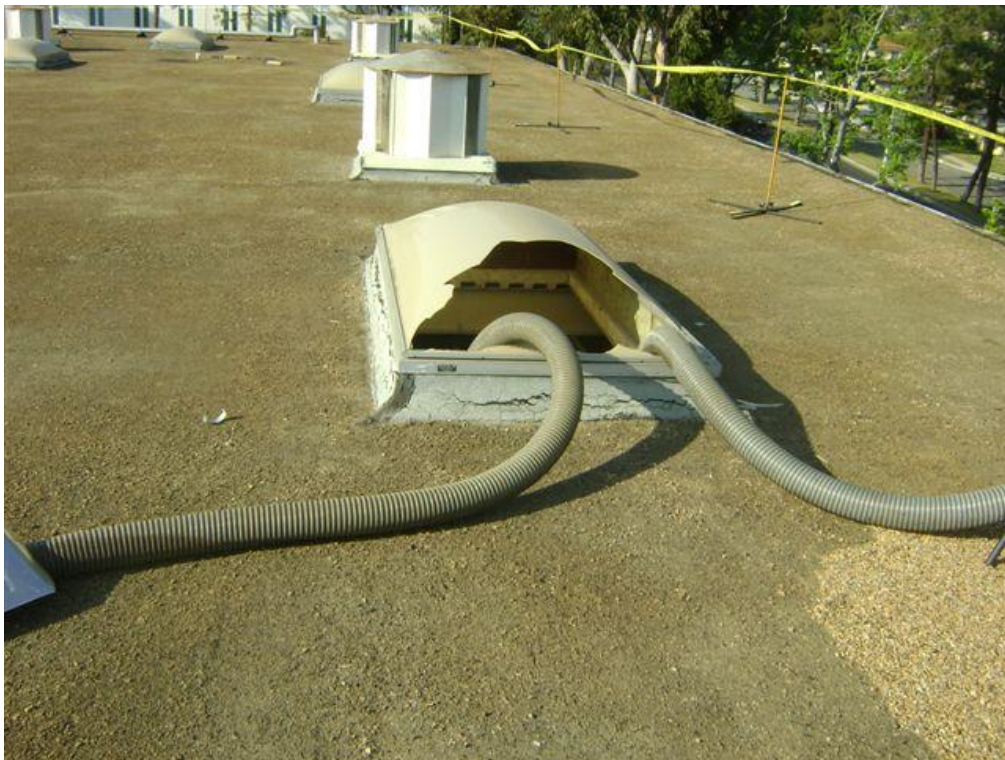
- The victim was working within six feet of an unguarded skylight.

**Exhibit 3. The skylight the victim fell through.**

**Recommendation #1: Fall protection measures such as skylight screens or covers, guardrails, or a personal fall protection system are used for employees working within 6 feet of a skylight.**

- Skylight screens or covers capable of withstanding the impact of a worker plus the weight of his/her equipment.
- Guardrails around the skylight with a top and midrail and a vertical height within the range of 42 inches to 45 inches from the upper surface of the top rail to the floor. The rails should be able to withstand a live load of 20 pounds per linear foot applied either horizontally or vertically downward at the top rail.
- A personal fall protection system consisting of a body harness, lanyard, connectors, and anchor points.

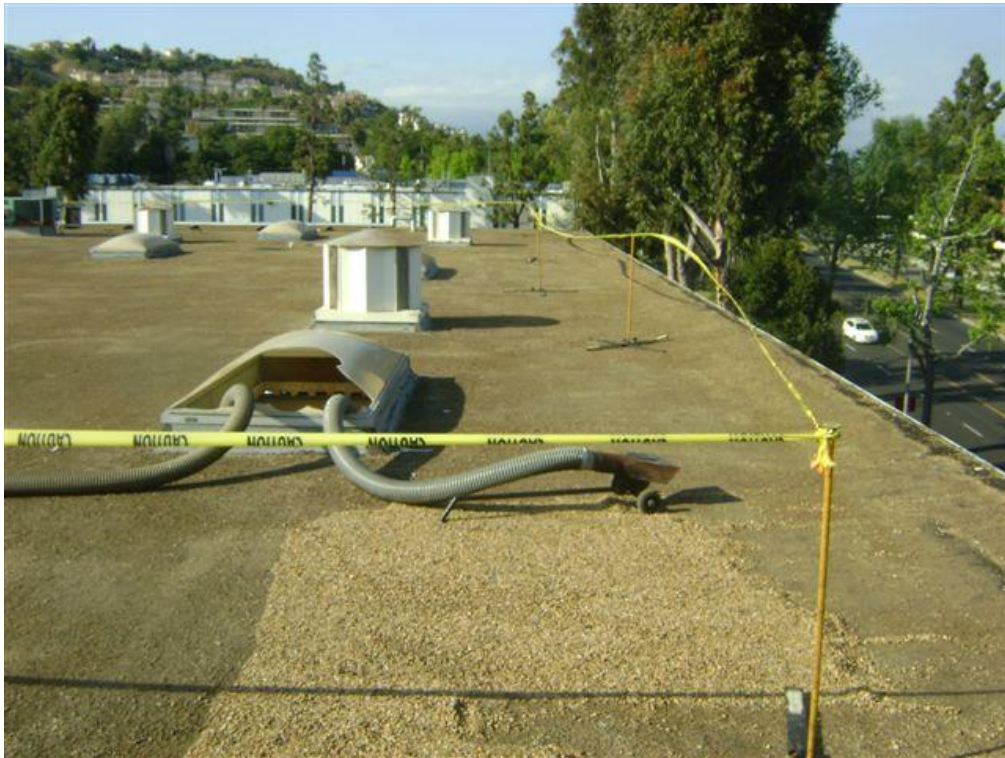
Discussion: In this incident, the victim was trying to prevent worker #2 from tripping and falling, by moving the vacuum hose out of his way. When he moved the vacuum hose he either tripped or lost his balance and fell through the skylight. Most skylights should be considered a “roof opening” and a risk for serious injury and death if workers should trip, fall, and break through. Therefore, in order to prevent falls through skylights, employers should implement and maintain a fall protection program that includes any one of the following:

**Exhibit 4. The incident scene.**

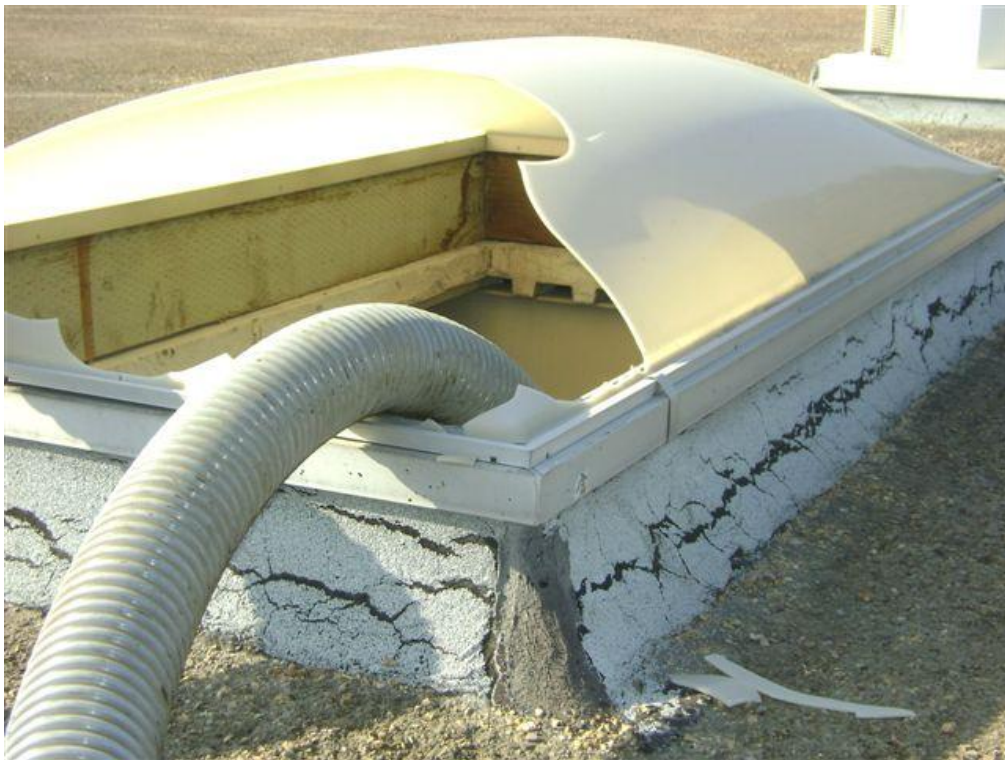
**Exhibit 5. The base of the skylight.**
