**SUBJECT:** A Horticulture Nursery Owner Dies When He Slips and Falls off a Tractor

**SUMMARY**  
**California FACE Report #10CA007**

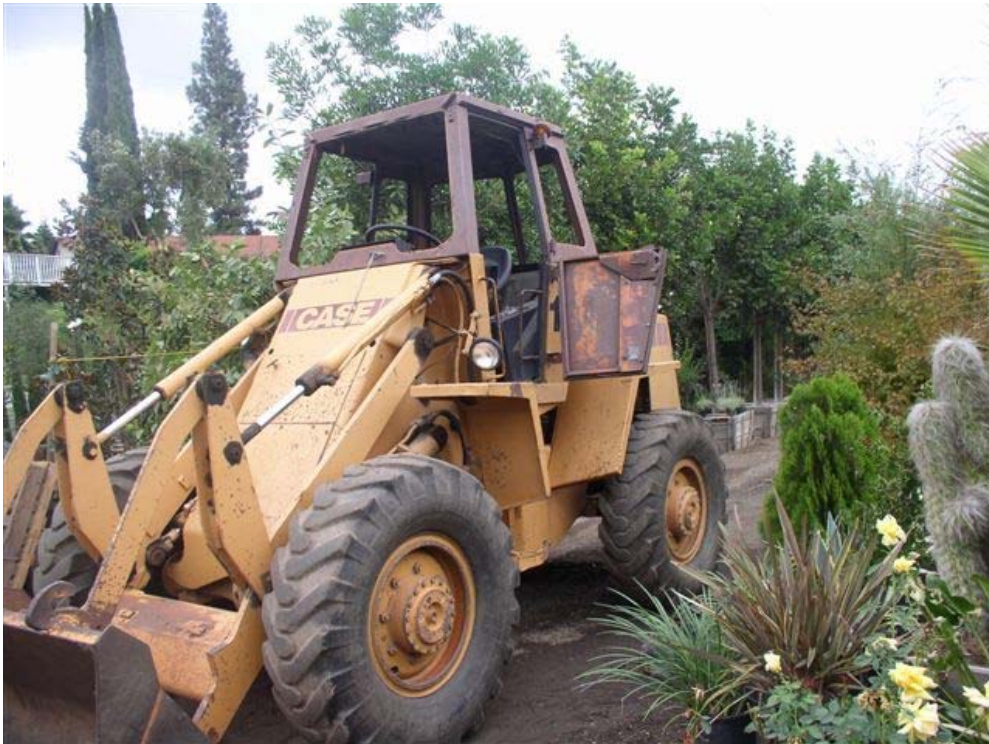
**Exhibit 1. The articulating front end loader tractor involved in the incident.**

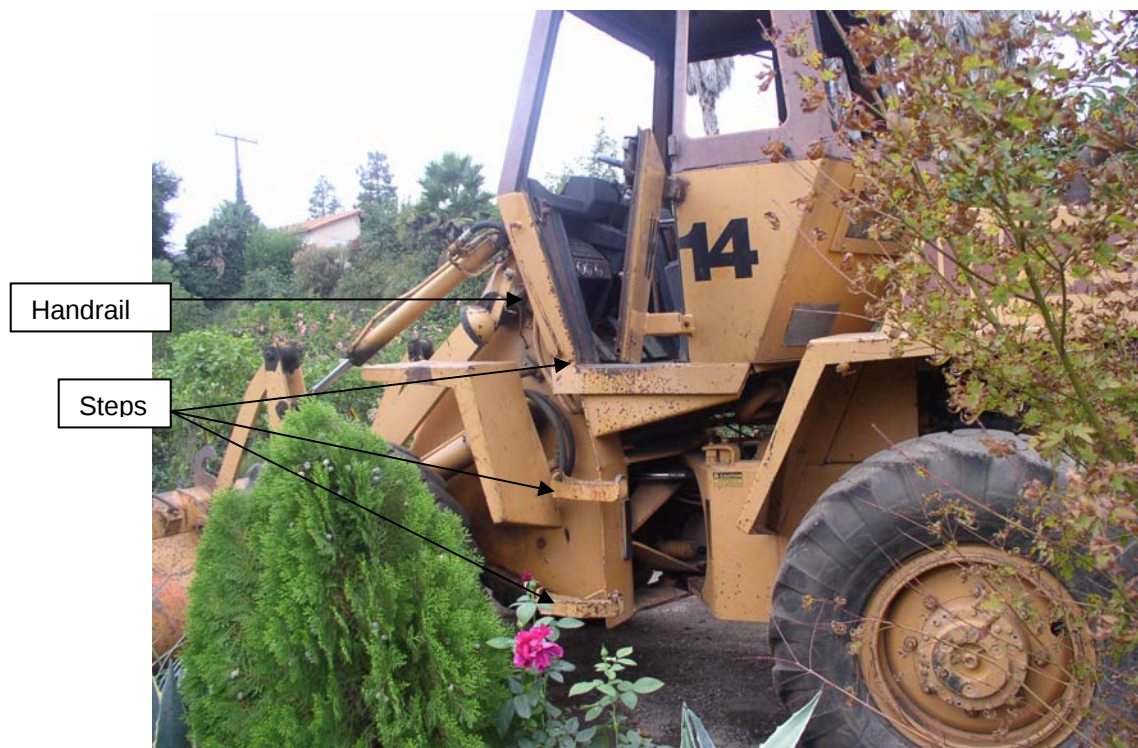
**Exhibit 2. The stairs and handrail used to gain access to the cab.**

Discussion: In this incident, the victim climbed down from the elevated tractor, which required him to place his foot on the steel steps attached to the tractor cab. This maneuver posed a risk of slipping, especially as it may be difficult to visually see these surfaces when climbing backwards. When the victim was exiting the tractor, the evidence suggests that his cowboy boots slipped off the steel steps and he fell to the ground below. When climbing off or onto a tractor, non-skid or non-slip resistant footwear should be worn to reduce the risk of slip and falls. A work shoe or boot should be selected based on the surface material, the tread design, and the contact area. Had the victim been wearing slip or skid resistant footwear, he may have had secure contact with the steel steps, thereby preventing his fall to the ground below.

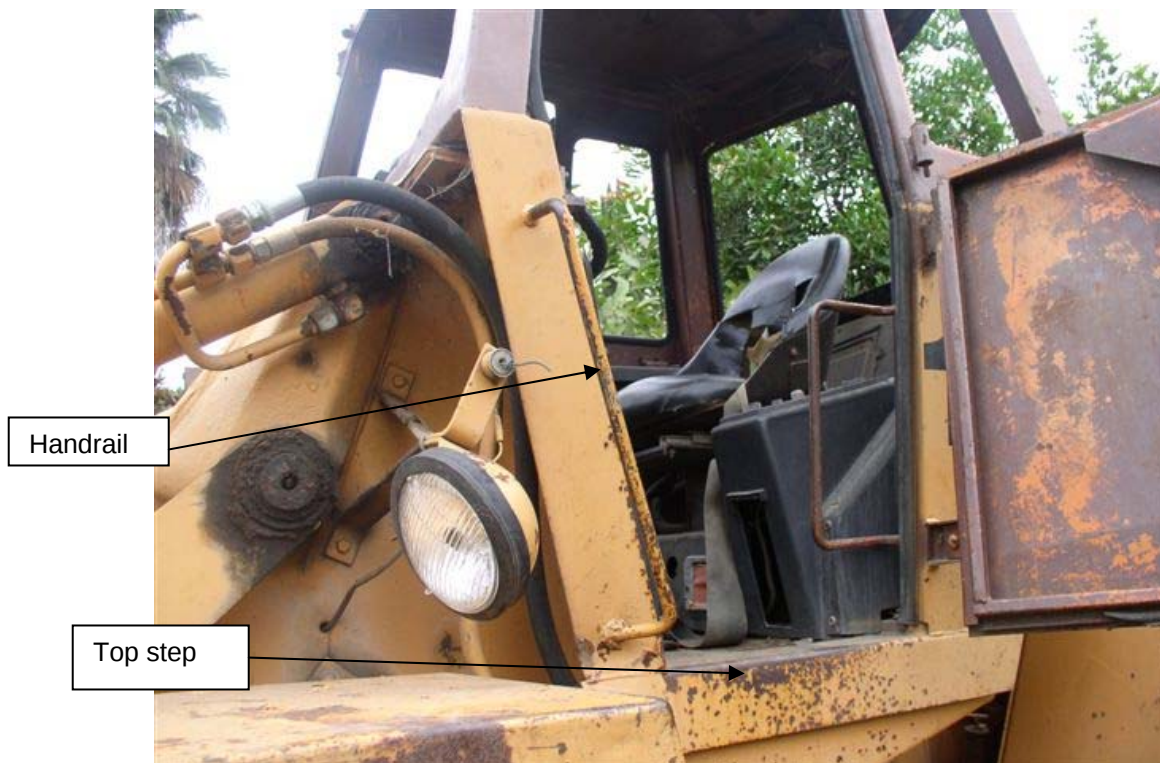
**Exhibit 3. The entrance to the cab of the tractor showing the top step and handrail.**
