# **Municipal Solid Waste Collector Dies after Falling from Solid Waste Vehicle Hopper Area**

**Incident Number: 10KY006**

**Kentucky Fatality Assessment and Control Evaluation (FACE) Program**  
**Incident Number: 10KY006**  
**Release Date: January 11, 2011**  
**Subject: Municipal Solid Waste Collector Dies after Falling  
from Solid Waste Vehicle Hopper Area**

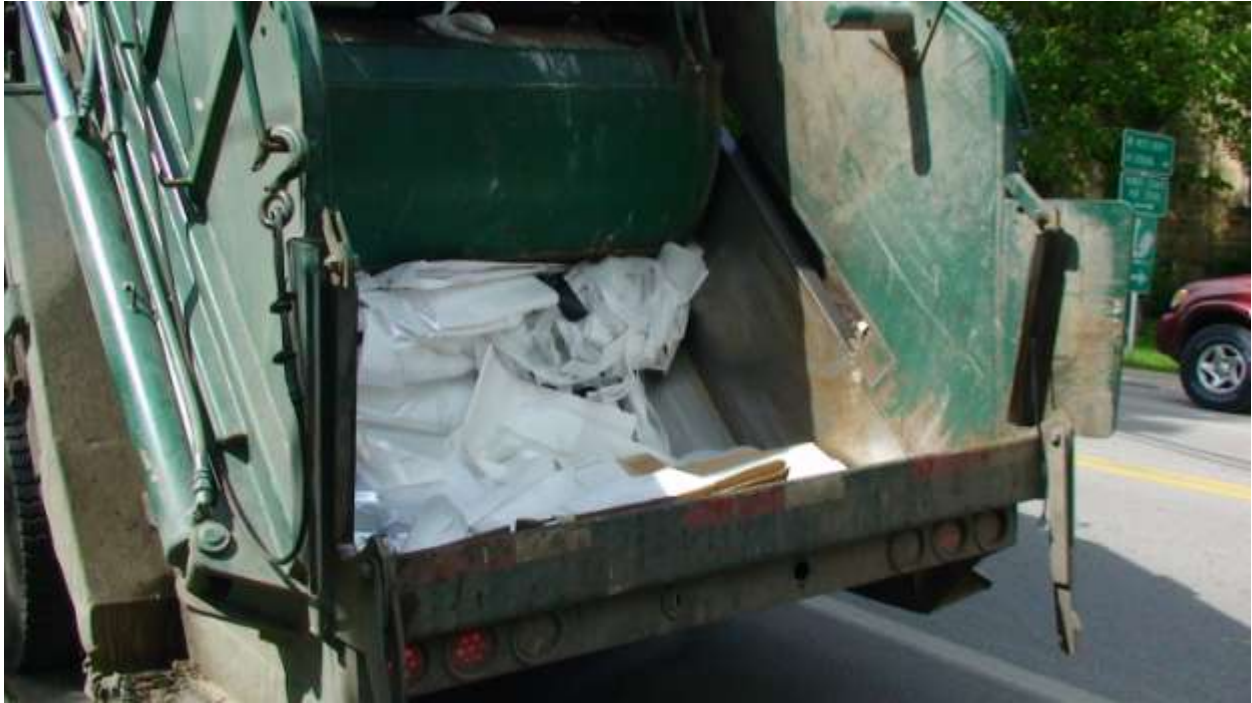
**Photograph of hopper from which Collector fell. Photograph courtesy of KY Labor Cabinet.**

Between stops, Collector 1 rode on the rear step on the passenger side of the solid waste truck. The rear step on the driver side of the truck was broken and it would not support Collector 2's weight. Without a step to ride on, Collector 2 rode on the driver side in the hopper area located in the back of the truck where the solid waste was collected from the trash receptacles. As he sat in the hopper area between stops, Collector 2 separated cans from the trash.

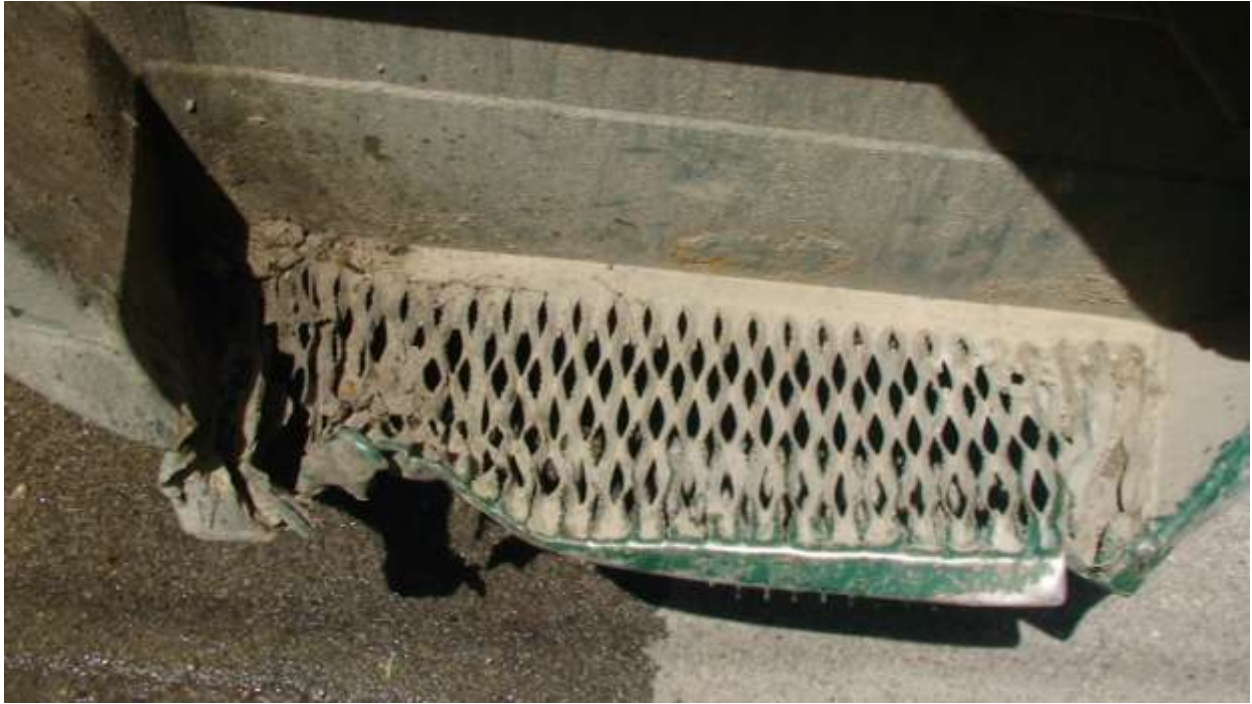
Each time the DVIR is completed, a supervisor should be notified so that needed repairs can be promptly completed. CFR 396.11 also requires that repairs affecting safety be completed prior to the vehicle being operated. According to a municipal official, the broken step had been reported as needing repair for six months prior to the incident. At the time this incident occurred, supervisors were notified verbally that repairs were needed on the solid waste trucks. After this incident, repair requests are now documented in writing.

Photograph of broken step.. Photograph courtesy of KY Labor Cabinet.

**Recommendation No. 1: Municipal solid waste divisions should require drivers to perform daily post-trip safety checks on solid waste collection vehicles and timely repairs should be performed.**

Municipal solid waste divisions should follow the United States Department of Transportation, Federal Motor Carrier Safety Administration, CFR 396.11 Driver vehicle inspection report(s), regulation that requires the driver of a commercial vehicle to perform a post-trip vehicle inspection at the end of the workday. A written report on the condition of the vehicle is also required. A Department of Transportation Driver's Vehicle Inspection Report, DVIR, (Attachment) should be used to note any defects that need to be corrected before the vehicle is operated. The report lists important aspects of the vehicle such as the air compressor, air lines, battery, body, brakes, clutches, wheels and rims, windshield wipers, etc., which the driver should be required to inspect each time the solid waste truck is operated. There is a section on the form for the driver to make notes of items not listed on the DVIR that may need to be addressed immediately or in the future. The DVIR does not contain an item on operation of the hopper. Municipal solid waste divisions should customize the DVIR to include specific items such as proper hopper functioning, and steps' and grab bars' condition.

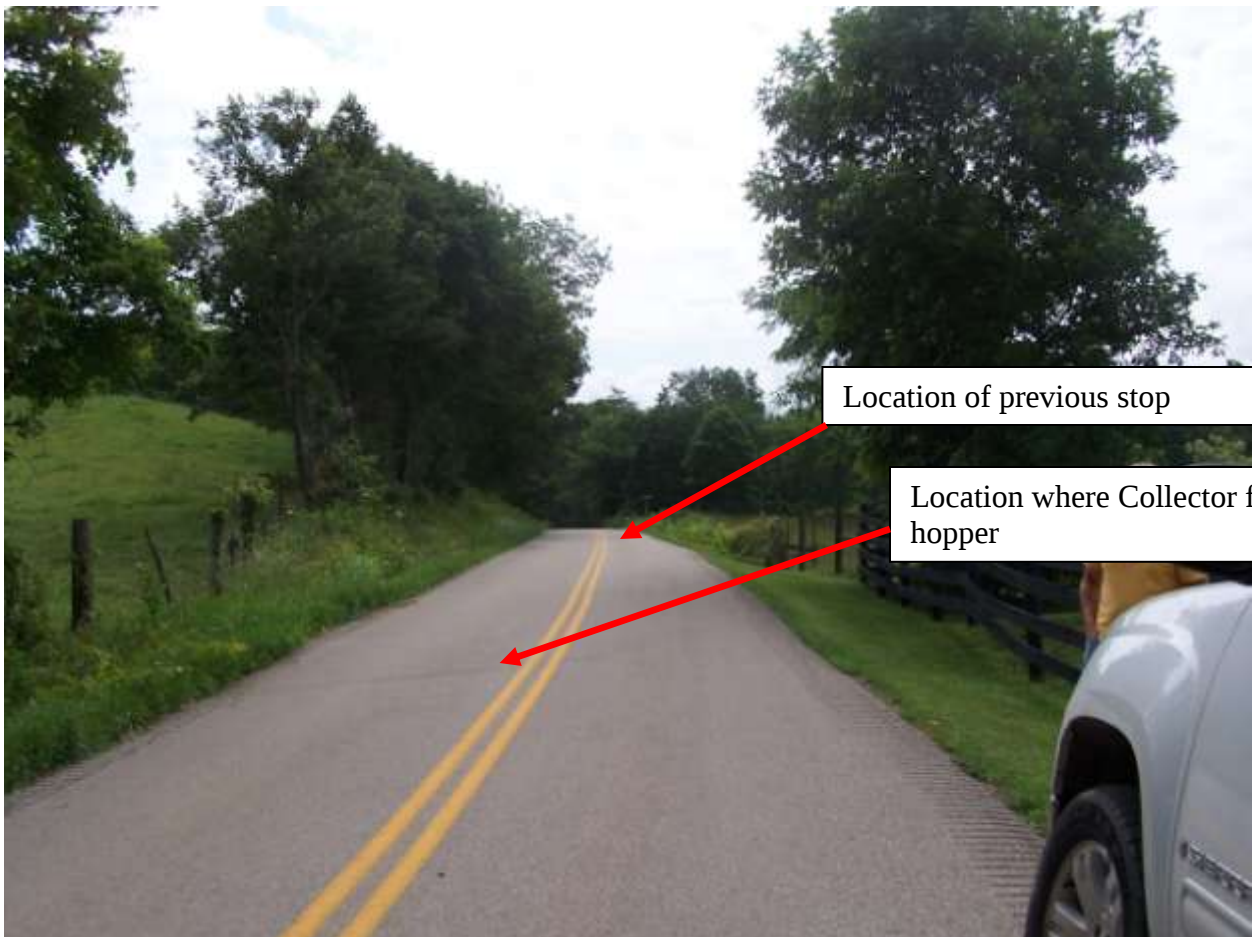
The crew took a lunch break then restarted the route. At approximately 11:40 AM, the crew collected trash from the end of a driveway then proceeded up the road 280 feet toward the next stop. The pavement surface was asphalt, and was smooth, flat and dry; the weather was clear. The posted speed limit was 55 miles per hour. According to the police report, the truck was going between 5 – 10 mph when Collector 2 attempted to jump out of the hopper area, falling onto the pavement striking his head. The vehicle was 50 feet from the next stop. The driver looked out the rearview mirror, saw Collector 2 on the pavement and stopped the truck. The driver and Collector 1 ran to Collector 2; Collector 1 administered first aid. There was no cell phone service at the scene, so the driver drove the solid waste truck several miles to a nearby store, and at 11:50 AM called emergency medical services and his supervisor. Emergency

Location of previous stop

Location where Collector fell from  
hopper

Roadway where Collector fell out of hopper of solid waste truck. Photograph by KY FACE
