NJ FACE INVESTIGATION REPORT

FACE 06-NJ-076

Hispanic Day Laborer Electrocuted When an Aluminum Extension Ladder Contacted an Overhead Power Line

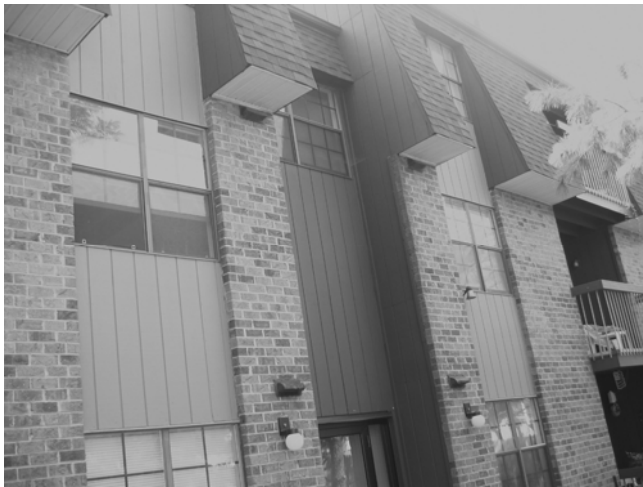
touches to complete the job, which they estimated would take one-half hour. The co-worker left to obtain additional materials. When he returned, the victim informed him that they needed to move the extension ladder that they had been using. The aluminum extension ladder could extend to 32 feet and had a maximum working length of 29 feet. It had been retrieved from a pile of damaged ladders at the general

contractor's offsite storage yard. These ladders had been discarded, but the subcontractor's employees were apparently unaware of this. The foreman had previously told the workers to use the ladder in question only to reach scaffolding, which was no longer in place. Although the rung locks on the ladder worked, there was a rope, but no pulley, to adjust its length. The co-worker reported that he told the victim that they should shorten the ladder before moving it, but the victim replied that instead of shortening it he would carry it extended. The victim told his co-worker to support the ladder so it wouldn't fall. Although the co-worker said that he usually carried a ladder with it held parallel to the ground, this time they carried it while it was upright. Both were apparently unaware of the overhead power lines in the area. They walked approximately 24 feet when a slight wind caused the ladder to sway. The victim was walking backward, holding the ladder by the rungs while his co-worker walked forward holding onto the

Discussion: The employer was responsible for ensuring that all equipment, including the ladder, was free of defects and in good working order. The ladder used in this incident had been discarded by the general contractor because it was defective, but retrieved and used by the workers on this job. They had previously used the same ladder to access scaffolding. Had the ladder not been defective and difficult to adjust, the workers may not have carried it upright. For allowing use of defective equipment, Federal OSHA cited the employer under 29 CFR

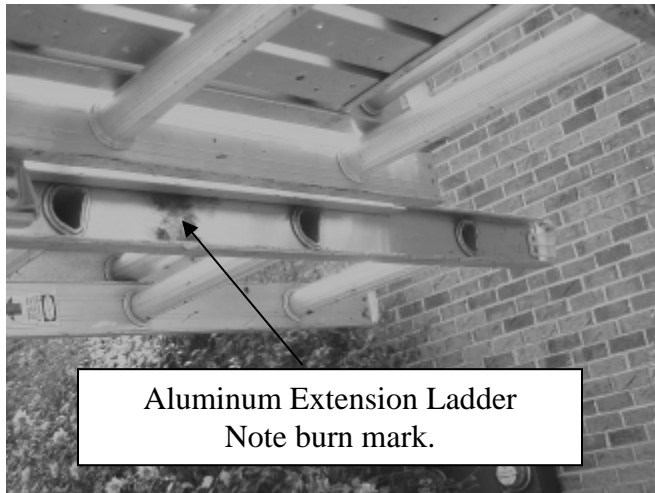
The extended aluminum ladder contacted the 13-KV overhead power line, which was 25 feet above the ground. When it made contact, the co-worker reported that he heard a sound like thunder and saw fire come out of the power line. Both workers released the ladder and it fell to the ground. According to his co-worker, the victim was initially able to crawl, but not able to rise to his feet. Sparks ignited the dry grass at three small spots and the co-worker stomped out the fire. At the time of contact, the co-worker reported that he felt a shock that seemed to travel from his head down through his feet. Although his shoes were not damaged, he developed a

Although the overhead power line was more than 20 feet away from the work area, it became a hazard when the workers carried the ladder in an upright position. The fact that the victim and his co-worker did not recognize this to be a hazard suggests that they lacked understanding and training.
