INVESTIGATION REPORT

FACE 07-NJ-044

23-Year-Old Hispanic Road Maintenance Worker Struck by Wheel that Separated from the Trailer Axle of a Tractor-Trailer Truck

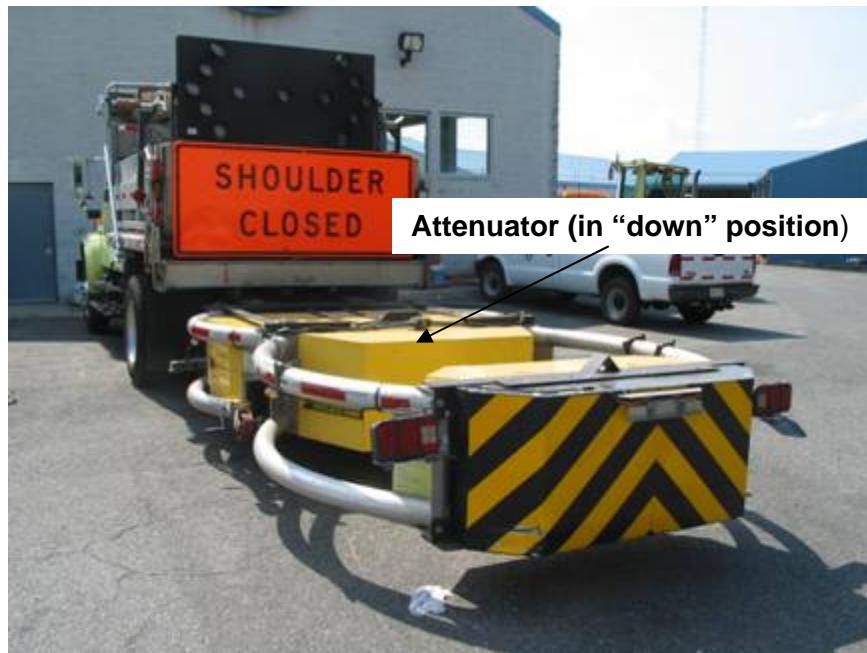
Figure 1: Truck-mounted attenuator-equipped protection vehicle (bump truck)

The incident occurred near a grassy area along the shoulder of the southbound side of a major highway in New Jersey. Two workers were assigned to trim the grass around poles and delineators. A truck with a rear-mounted attenuator (bump truck) was stationed approximately 25 feet north of the incident site (see Figure 1), a lead truck (cover truck) between the attenuator and the site (see Figure 2), as well as two advanced warning signs. While the workers were trimming grass, two rear tandem wheels separated from the axle of a flatbed trailer being pulled by a tractor-trailer truck traveling southbound on the highway adjacent to the incident site. One wheel rolled onto the center median. The other wheel rolled past the attenuator-equipped truck and struck the victim. The coworker witnessed the wheel rolling along the roadway and immediately radioed the victim, but received no response. The coworker walked back toward the incident scene and saw that the victim was lying on the ground. The worker called 911, and police and rescue workers arrived at the scene within minutes. The responders did not find any vital signs, and the victim was pronounced dead at the scene via telemetry.

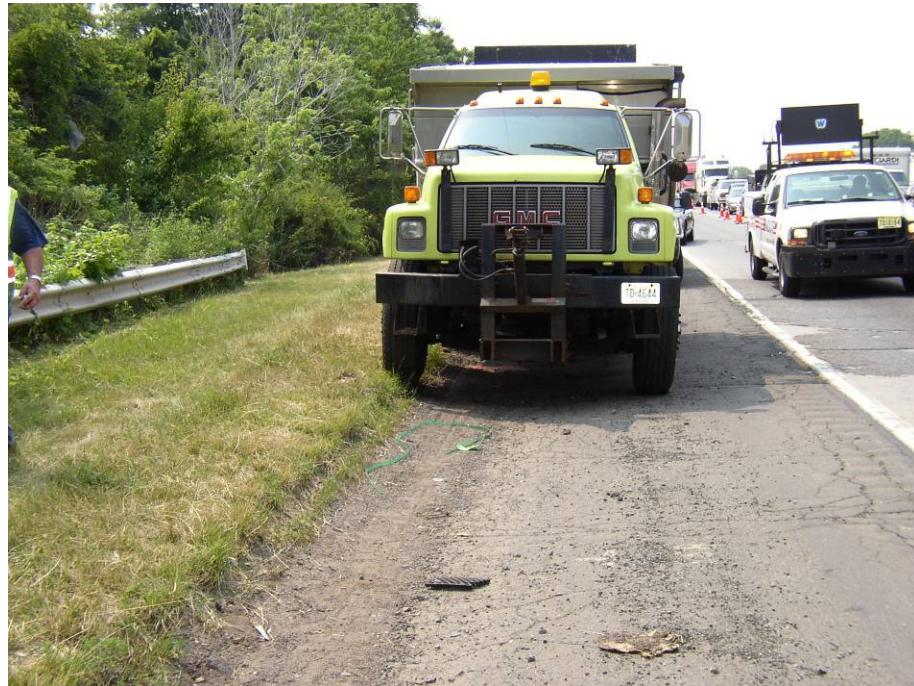
Figure 2: Lead truck (cover truck)

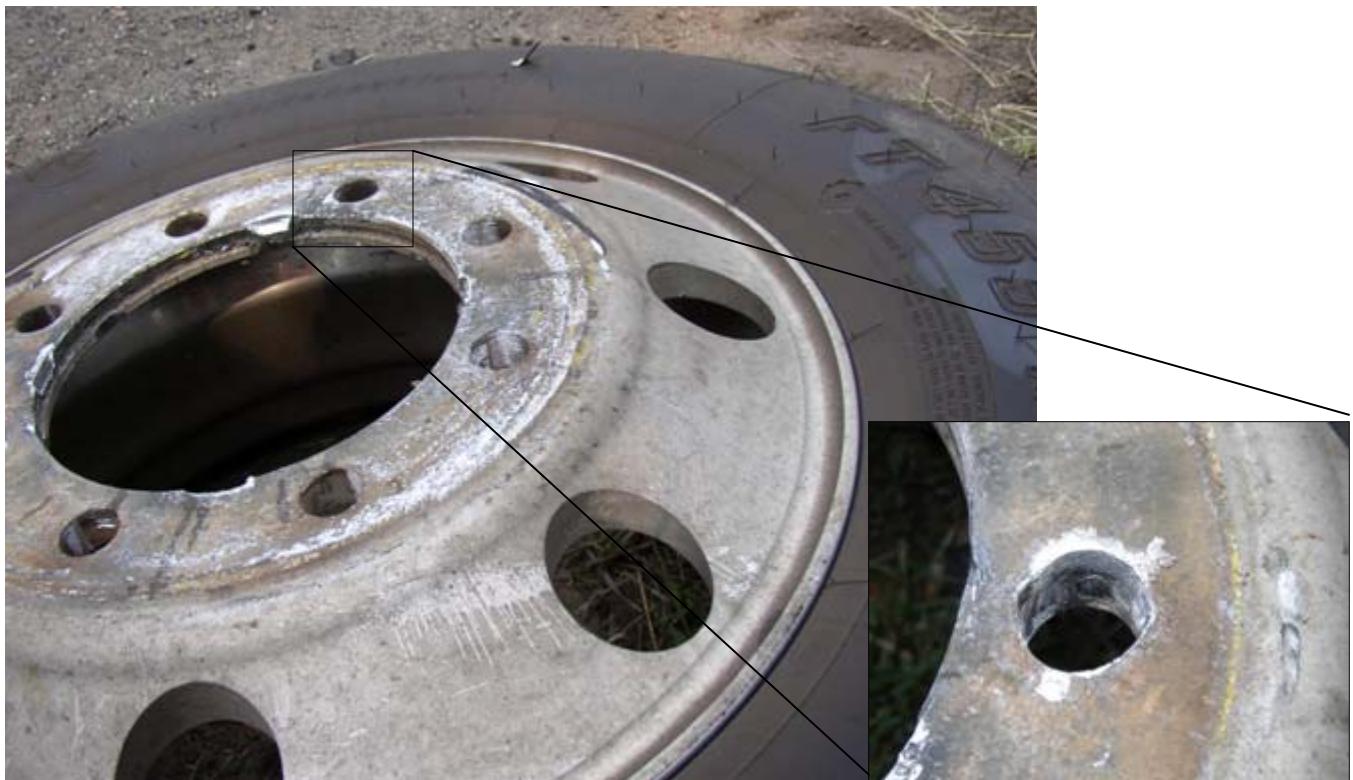
According to the employer, the wheel and tire assemblies completely separated from the axle of the moving truck trailer because the lug nut studs sheared off from the wheel hub. Figures 3 and 4 show the wheel involved in the incident and the axle from which it separated, respectively. When the tire struck the victim, the victim was apparently thrown against an adjacent bridge abutment, landing approximately 30 feet from the initial point of impact with the wheel. Figure 5 shows an overview of the incident site.

Figure 3: Wheel that was involved in the incident

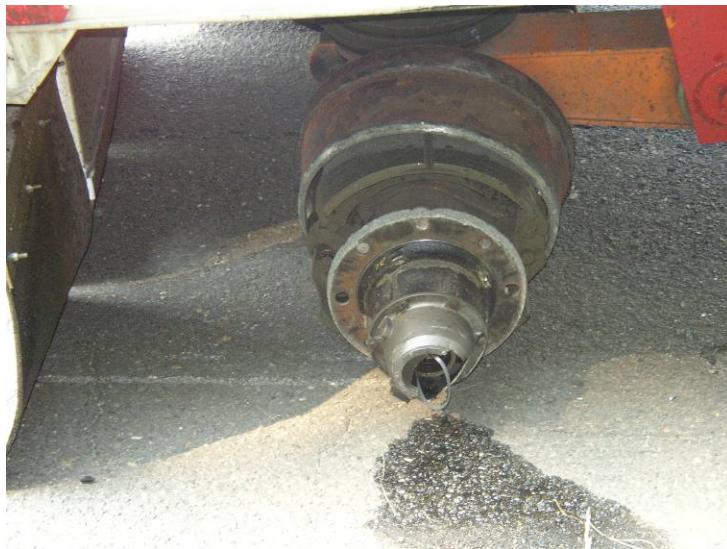
Figure 4: Axle of trailer from which the wheel separated

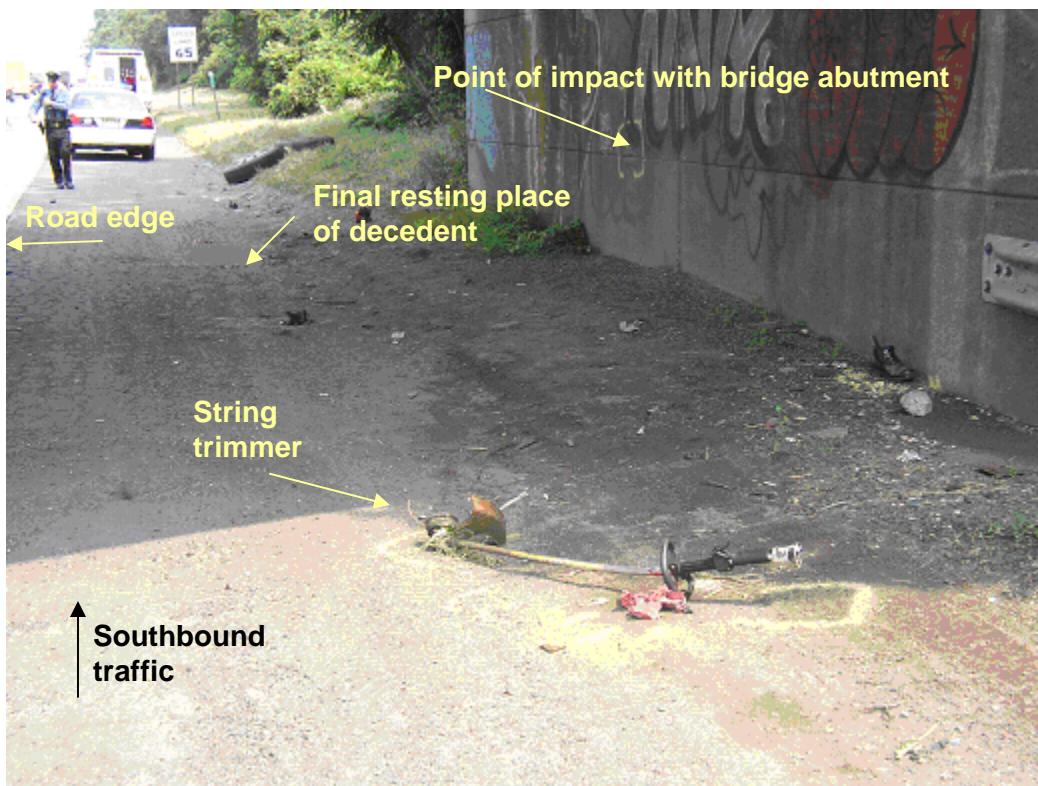
Figure 5: Overview of incident site
