NJ FACE INVESTIGATION REPORT

FACE 08-NJ-079

69-Year-Old Sanitation Worker Run Over by Refuse Truck

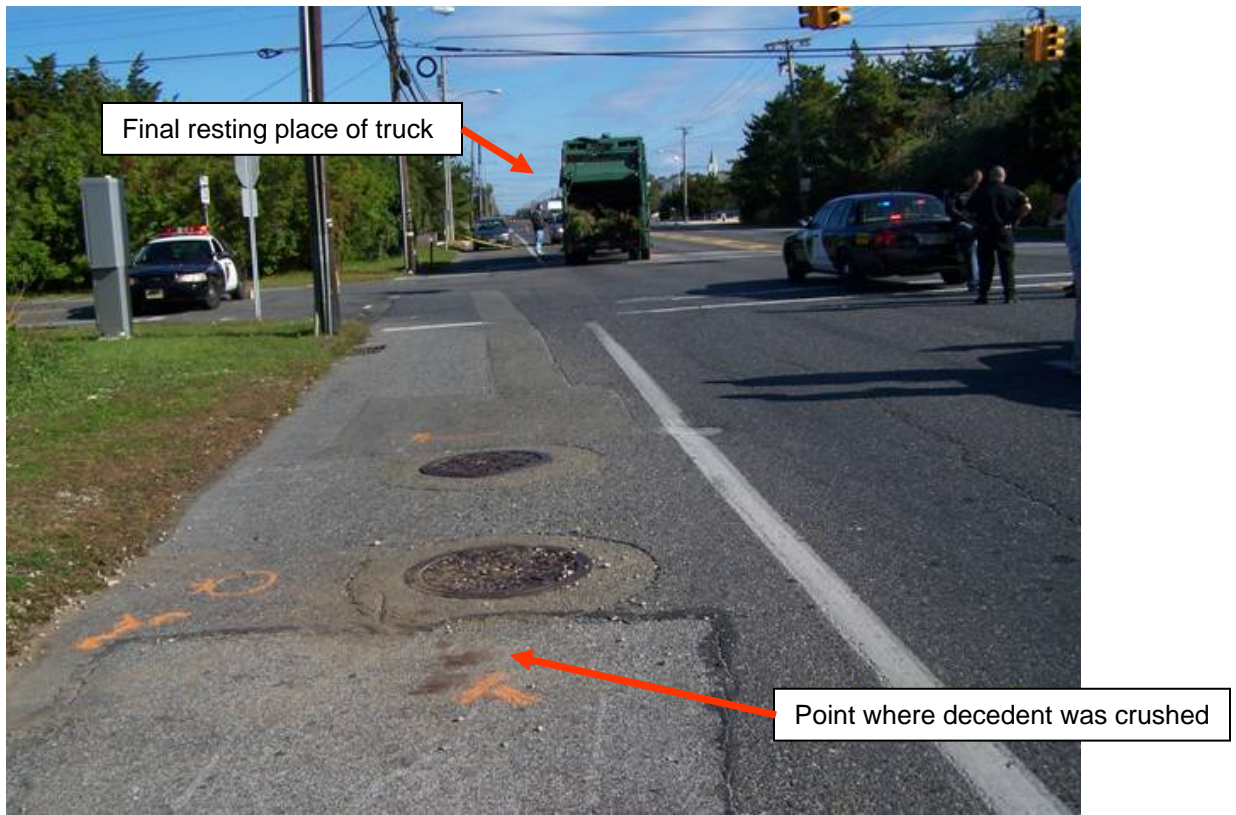
FIGURE 1. Photo of incident site.

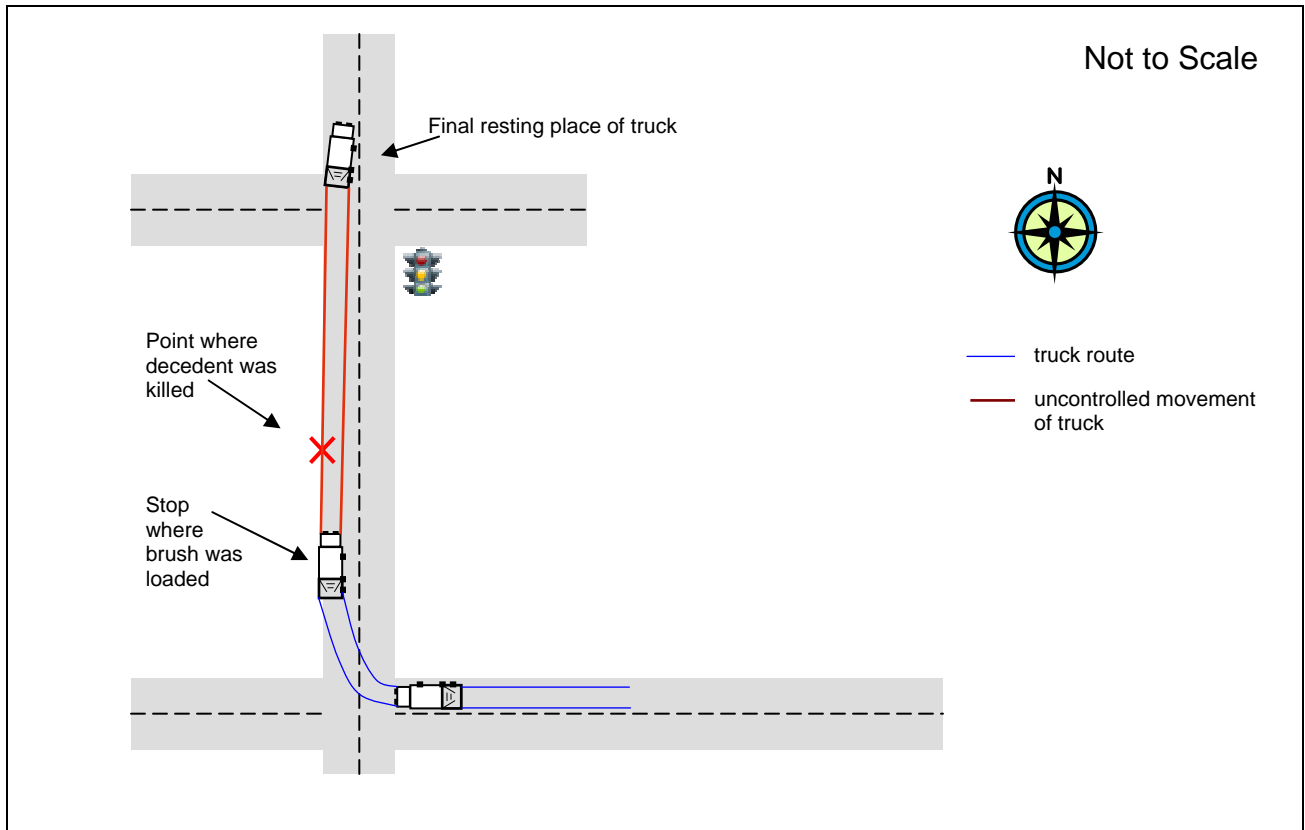
FIGURE 2. Representation of incident; not to scale.

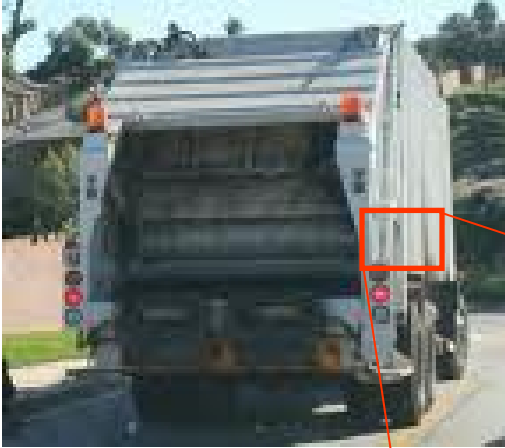
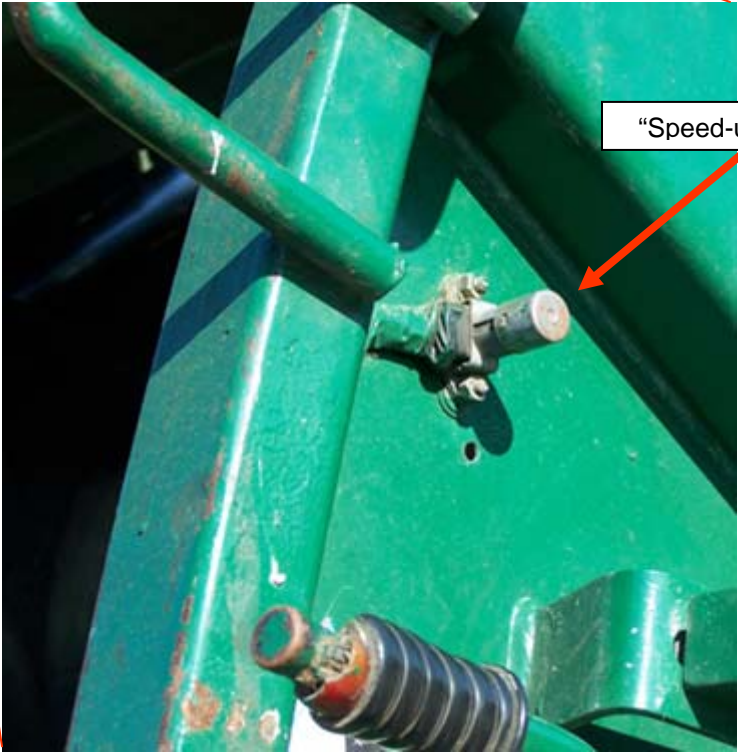
The particular model of truck involved in this incident had the neutral relay removed and the “speed-up” button was converted to a toggle switch. A properly working neutral relay prevents the compactor cycle to be activated while the vehicle is in “drive.” The compactor cycle was therefore able to be engaged while the truck was moving from stop-to-stop. The speed-up button, which activates the compactor, was designed by the manufacturer to activate one full compaction cycle. In this incident, the modifications to the compactor enabled it to be started and stopped at any time.

These two alterations compromised the safety of the equipment. As per ANSI Z245.1, Section 6.2.1 (j), “No one should disable or bypass safety equipment or other protective devices,” and “Mobile equipment must not be operated unless these devices are fully functional.”

FIGURE 3. “Speed-up” button located on side of rear-loading unit.

Recommendation # 3: Equipment should be in good working order, and safety interlocks or other control mechanisms should never be modified, disconnected, or disengaged.
