FATALITY ASSESSMENT AND CONTROL EVALUATION**Mechanic Dies after being Pulled into a Snow Thrower****Case Report: 07NY013****SUMMARY**

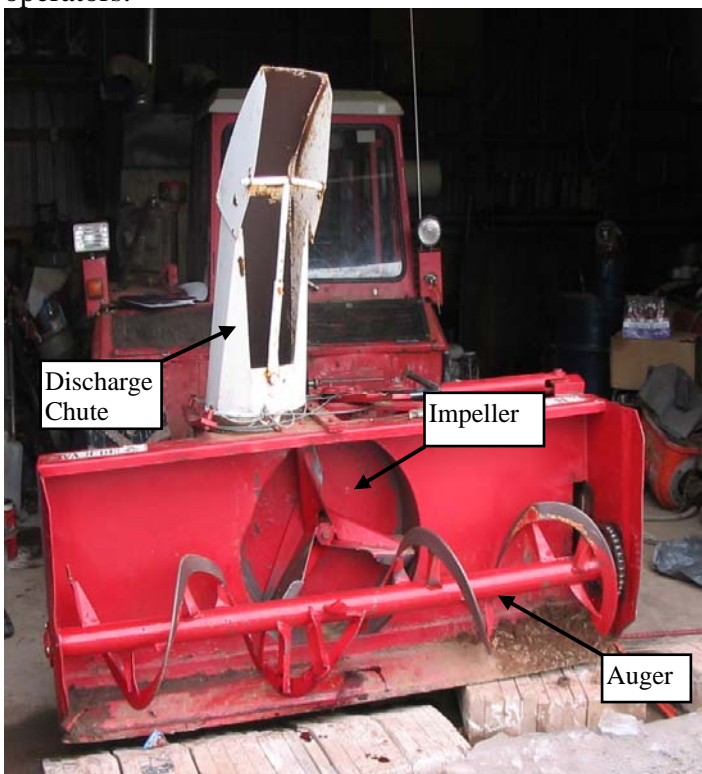
The snow thrower involved in the incident was an attachment snow thrower: a 4-wheel drive 57-horsepower tractor with a snow thrower attachment (Photo 1). The snow thrower attachment was powered by a power-take-off (PTO) shaft from the tractor's engine. It was a two-stage snow thrower collecting snow with an auger and ejecting snow with an impeller through the discharge chute. It was manufactured in 1993 and purchased new by the ski resort in the same year. The snow thrower was used to remove snow on sidewalks in the winter. During summer, the snow thrower attachment was replaced with a lawnmower attachment. The only workers who were authorized to operate the snow thrower were two trained operators. The victim was not one of the trained operators.

Photo 1. The ride-on attachment snow thrower that was involved in the incident (Photo courtesy of OSHA).

According to the American National Standard (ANSI B71.3-2005), all snow throwers should be equipped with an operator presence control (a.k.a. an interlock or dead man switch) that automatically stops the impeller or shuts down the engine when the operator leaves the operator position. The ski resort had five walk-behind type snow-throwers that were all equipped with operator presence controls. When an operator releases the lever at the handle without disengaging the auger/impeller control, the engine automatically shuts off and stops the snow collecting mechanisms. However, the ride-on attachment snow thrower that was involved in the incident did not have the operator-presence control. The employer was aware of the situation, but did not contact the manufacturer for retrofitting the control. According to the manufacturer, this particular model was specifically designed for operating on sloped terrains. When operating on slopes, an operator may lose contact with the seat momentarily due to uneven and bumpy slope surfaces. An operator-presence interlock, which is often located in the operator's seat, may cause the engine to stall even when the operator remains on the seat. There was no warning sign on the machine to alert the users that the tractor did not have the dead man switch. The newer models are all equipped with the operator-presence controls.

Discussion: The attachment snow thrower in this case did not have the ANSI required operator-presence control because the tractor was designed to operate on sloped terrains. For specialized tractors, manufacturers may consider installing the operator presence safety control that can be disabled when the safety interlock poses hazards in special operating conditions. In that case, the operators can use the safety interlock under normal operating conditions. Manufacturers should warn the users through the warning labels on the machine and in the operator/maintenance manuals of the danger of operating a snow thrower without a safety interlock.

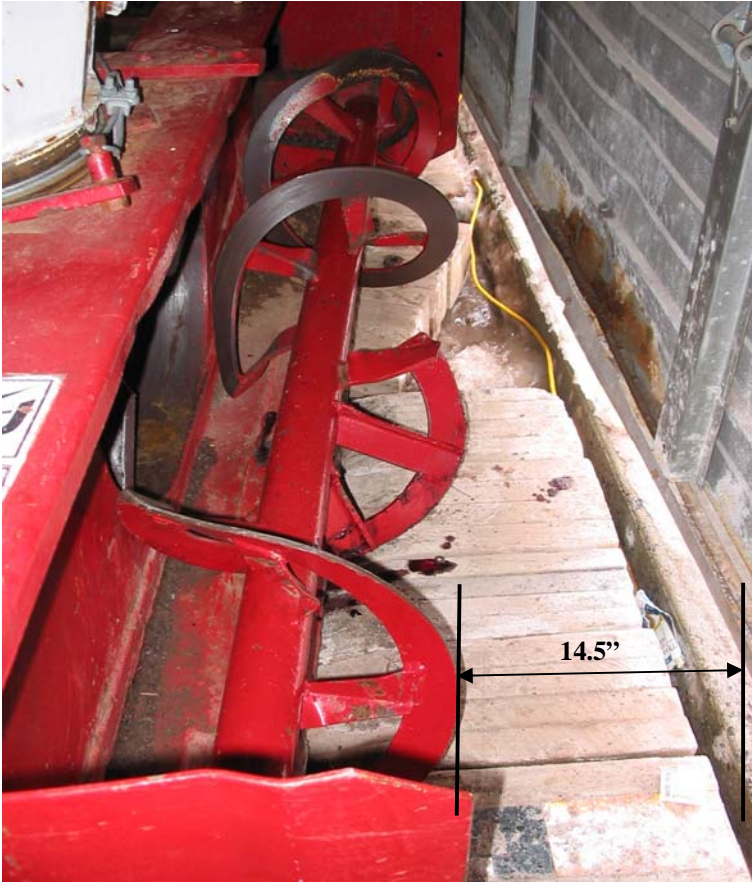
The operator reported that she had disengaged the auger prior to parking the snow thrower in the garage with the auger next to the garage door in an angled position. The width of the garage door was 124 inches; it was a manual door with a latch on the right side. The auger was 72 inches wide. The clearance between the left front end of the auger and the door was measured 3.75 inches; the clearance between the right end of the auger and the door was 14.5 inches (Photo 2).

Photo 2. The victim was caught on the side where the clearance between the door and the rotating auger was 14.5 inches (Photo courtesy of OSHA).

tried to move the snow thrower out of the garage. He started the engine, engaged the PTO, got off the tractor, and positioned himself between the garage door and the auger to open the door. The clearance between the door and the auger was 14.5 inches. His flannel shirt was caught by the rotating auger and he was pulled into it. The co-workers immediately called 911 and notified the resort management. The local emergency rescue squad and ambulance services responded and arrived on site within ten minutes. The victim was pronounced dead at the scene. It was estimated that the victim had been dead for several hours. The Medical Examiner reported in the toxicology report that the victim's blood alcohol concentration (BAC) was 0.12%. The legal limit of BAC for operating motor vehicles in New York State is 0.08%.

Recommendation #1: *Employers should ensure that all their snow removal equipment are equipped with operator-presence controls that are functioning properly.*

Although a safety interlock is required by American National Standard Institute (ANSI), not all tractors are equipped with the interlock. Employers should consult the manufacturers to ensure that their snow throwers have the operator-presence controls. If a snow thrower does not have the control, the employer should consult with the manufacturer for retrofitting. Employers should ensure that the safety features on the snow removal equipment are working properly. Equipment with a malfunctioning safety interlock should be immediately removed from service. It should not be allowed back into service until it is repaired.

Discussion: Any equipment taken out of service for repair or service should be stored in a designated area and should be locked out and tagged out by the trained operator or the maintenance person who is assigned to the repair or service. A warning sign should be attached to the equipment to warn workers not to operate the machine without authorization. No worker should attempt to operate the equipment without authorization.
