MIFACE Investigation Report: #08MI121

Subject: 59-Year-Old Male Worker at a Fruit Storage Facility Died After Entering a Controlled Atmosphere Storage Room

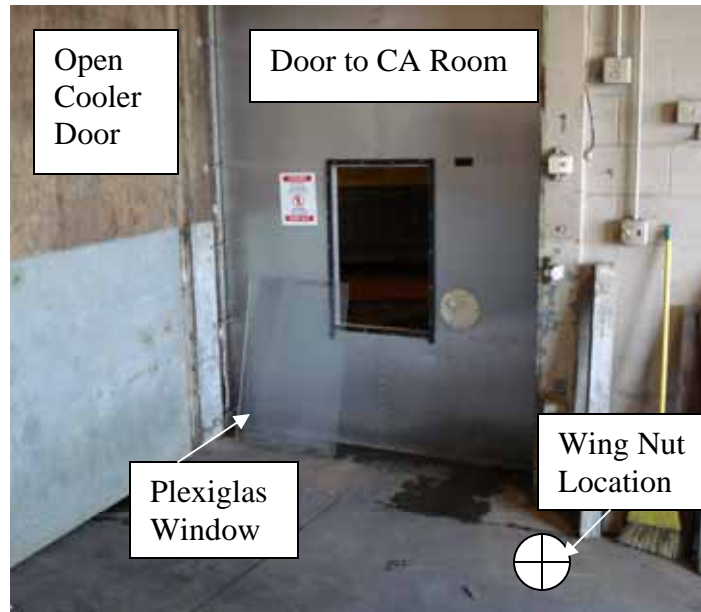
Figure 1. Outer door, inner aluminum door, Plexiglas window, opening to CA room, warning sign, wing nuts location

and the Plexiglas window and climbed through the door opening, and entered the CA room (Figure 1). The owner found him collapsed on the floor on his knees with his head leaning against an apple bin. A bag of apples was found next to his body. The owner leaned through the window opening into the CA room, grabbed the decedent by his coat, pulled him toward the door through the window opening, and checked for a pulse. He did not find a pulse. The owner left the area to call the farm office to have them call for emergency response. Upon returning to the decedent, he took a deep breath, leaned through the window opening, grabbed the decedent under his arms and pulled him through the window opening and out of the CA room. The owner attempted CPR after he pulled the decedent out of the CA room but was unsuccessful in resuscitating him. Emergency response arrived and he was declared dead at the scene. A bag of a different type of apple obtained from another CA room was found on the propane-powered forklift that was parked in the aisleway nearby. The Plexiglas window was found leaning against a wall with the wing nuts nearby.

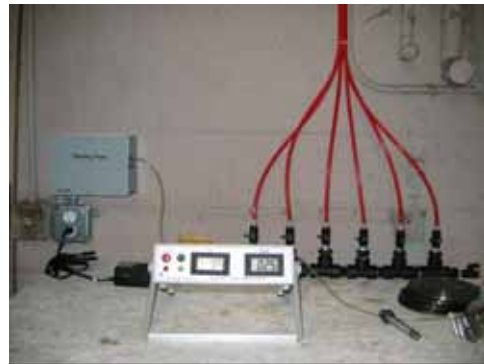
Figure 2. GCS150 and remote sampling configuration

One of the decedent’s duties was conducting and documenting the results of a daily atmospheric check on each sealed CA room. The firm used a direct-reading Gas Control System Inc Model GCS150 Dual Gas Analyzer (O₂/CO₂) with an attached probe to check the level of O₂ and CO₂. After opening the cooler door, a plug in the sample port of the Plexiglas window was removed and the sample probe was inserted into the hole (Figure 5). The O₂ and CO₂ levels and the room’s temperature were recorded on a log sheet.

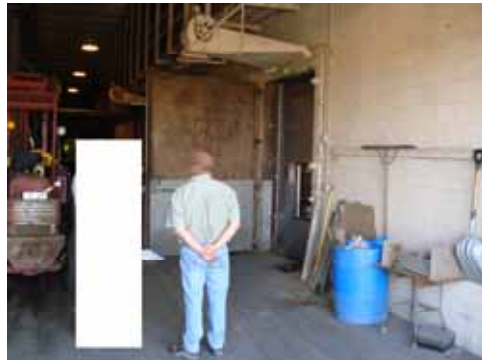
The east entrance to the building was via a large overhead door that opened to an aisleway (Figure 3). The building contained a total of 12 storage rooms, all of which could be converted to use as a controlled atmosphere (CA) room. Controlled atmosphere storage refers to a container, vessel, or in this case, a storage room, designed for the storage of goods, such as food, in an atmosphere where the parameters such as gas type, temperature and humidity are controlled.

Figure 3. View of incident scene from east entrance

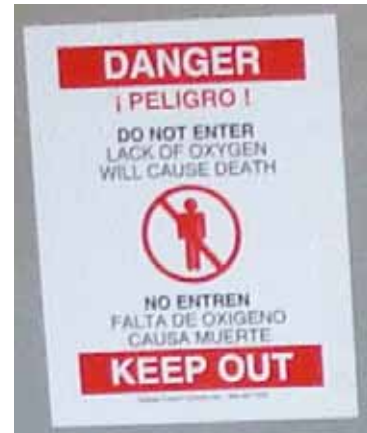
The Plexiglas had a small air sample port (hole) into which an air sampling probe could be placed. At the time of the incident, affixed to the door and near eye level next to the Plexiglas window was an 8.5-inch by 11-inch sign, in both English and Spanish (Figures 1 and 4) stating:

“DANGER	!PELIGRO!
DO NOT ENTER	NO ENTREN
Lack of Oxygen	Falta De Oxigeno
Will Cause Death	Causa Muerte
KEEP OUT”

Figure 4. Close up of Danger sign on door shown in Figure 1

The facility owner indicated that the aluminum door used to seal the room was delivered with the sign shown in Figure 4. This sign did not meet the MIOSHA warning requirements. Controlled atmosphere environments for the long-term storage of fruits and vegetables require a low oxygen level in the room, thus meeting the definition of a permit-required confined space. Although equipment manufacturers routinely affix appropriate warning signs/labels indicating safety hazards on equipment prior to shipment to the end user, this door manufacturer did not. Controlled atmosphere generating equipment and door manufacturers should include appropriate confined space warning signs affixed to the products they manufacture and ship.

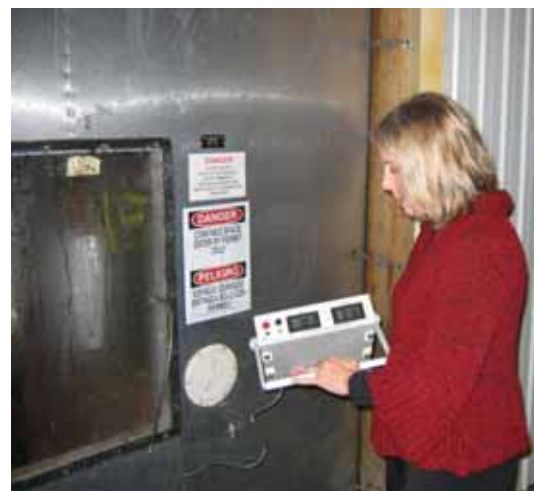
Figure 5. MIFACE researcher simulating previous CA room sampling procedure using GCS150 and sampling probe (different room)

- 1) Developed a written confined space entry procedure and conducted confined space training for employees;
- 2) Conducted forklift training;
- 3) Placed Confined Space Danger signs on the aluminum door of each CA storage room;
- 4) Identified and marked all overhead pipes;
- 5) Conducted emergency response training; and,
- 6) Placed oxygen and carbon dioxide air portal lines at the back of each CA room and ran those lines to a central location in the building. This central area was established to record results for all 12 CA rooms (Figure 2). This arrangement replaced the practice of inserting an air sampling probe through the Plexiglas window (Figure 5).

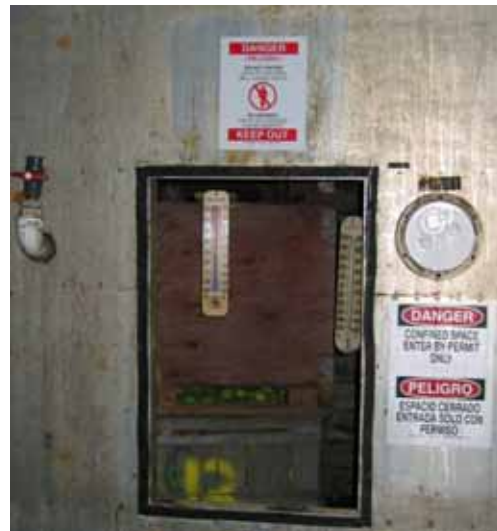
Figure 6. All doors to the CA rooms in the facility have the required Confined Space signs (in Spanish and English) affixed

At commercial and farm CA storage rooms, a sign reading: “DANGER – PERMIT REQUIRED CONFINED SPACE. DO NOT ENTER” or other similar language should be located at the entrance of the room (Figure 7). These signs should be understandable to all workers. In some workplaces, signs in more than one language may be necessary. The facility owner posted the required signs following the incident (Figures 5 and 6).

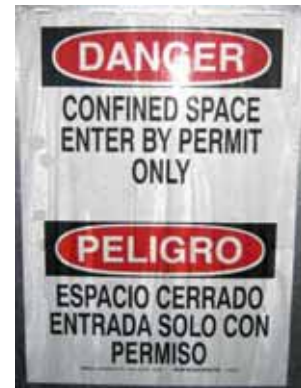
Figure 7. Close-up of Confined Space sign shown in Figures 5 & 6
