MIFACE INVESTIGATION REPORT: #08MI062

SUBJECT: Machinist Dies When He Came Into Contact With a Rotating Vertical Cutting Head of a Gantry Mill.

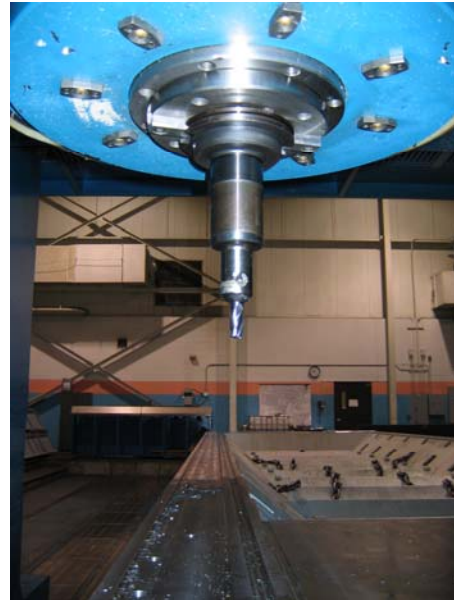
In the summer of 2008, a 48-year-old male machinist died when he came into contact with a rotating vertical cutting head of a gantry mill (Figure 1). The decedent programmed the gantry mill to begin a milling operation. Leaving the remote pendant attached to the gantry mill frame, he walked approximately seven feet to the home position of the cutting head near the south end of the part being machined. The head descended to perform the cut and then moved at cut height west to east to align with the starting point of the cut. The head began traveling north into the material (Drawing 1).

Figure 1. Cutting head of vertical gantry mill and part being machined

The vertical gantry boring, drilling and milling machining center accepted material 50 feet long and 15 feet wide to be worked. The mill was eight to ten years old. The mill operated in three directions: X (length of part), Y (across part) and Z (up and down). The operator controls for the gantry mill were located in a cab that was mounted on the southwest corner of the frame. A closed circuit TV camera was mounted on the north side of the cab’s exterior wall with a monitor in the cab. The door of the cab was seven feet away from the “home” position of the cutting head. The 5/8-inch diameter, 1 1/2-inch long cutting head tracked East/West/East across the gantry frame and the gantry moved North/South across the material being worked. When the cutting head was in operation, it rotated at 2,500 rpm. As the cutting head was being positioned, it operated at 600 rpm. A portable cable-connected remote, with its back magnetically attached to the frame of the machine, could be used by the operator to position the cutting head. The mill was equipped with an emergency stop, but the remote did not have emergency stop capability.

- Employers should require that cutting head movement be stopped prior to the operator performing work near the point of operation.

To address the hazard presented by the rotating cutting head, the employer has mandated that the operator stay on the operator's platform when the machine operates in Auto Cycle. The cutting head was engaged as the decedent neared the work area to blow chips, conduct measurements, or lubricate the cutting area. To ensure operator safety, MIFACE recommends that when work is to be performed by the operator in the vicinity of the rotating cutting head, that the machine be stopped before performing the work. When the operator is clear of the point of operation, the head can be re-engaged.

- Machine manufacturers should include an emergency stop on pendant remotes. If the remote does not have an emergency stop, machine owners should contact the manufacturer to inquire if the remote could be retrofitted with an emergency stop.

After the incident, the firm contacted the manufacturer to inquire as to whether an emergency stop could be installed on the pendant control. Although the manufacturer indicated there would be limitations of use of the pendant, an emergency stop could be added. Machine manufacturers should include an emergency stop on any pendant control. If a pendant control does not have an emergency stop, the company using the machine should inquire whether retrofitting the pendant is possible.

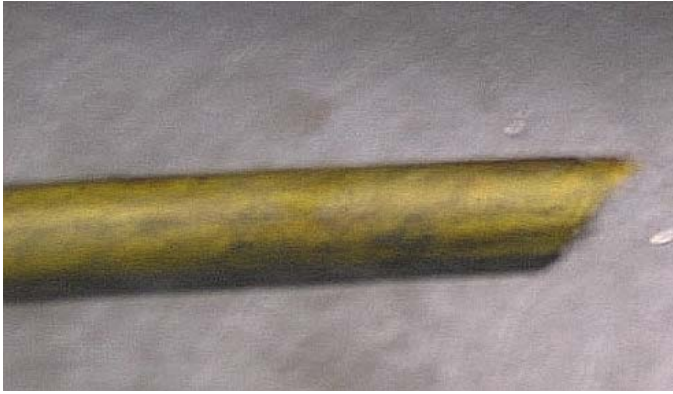
Figure 2. Picture of severed air hose

A severed air hose used to blow chips from the part was found west of the part on the track floor (Figure 2). The night shift operator postulated that the hose may have been positioned around the decedent and the hose was caught by the rotating cutting head chuck. A rubber mark was found on the chuck approximately 2-1/2 inches from its base. The wound area contained yellow and black debris (the color of the air hose). The owner indicated that the air gun and approximately one foot of hose was removed by the biohazard clean-up crew.

- The employer should consider a vacuum system instead of compressed air to remove chips from the machining area.

MIFACE encourages the employer to investigate options to replace the use of compressed air for chip removal. One option to minimize the risks posed by flying chips is a vacuum system. Additionally, tools such as a chip scraper or stout brush with a sufficiently long handle to keep workers away from moving parts could be considered.
