Massachusetts FACE • Occupational Fatality Report

School Traffic Supervisor was Fatally Injured when Stuck by a Motor Vehicle - Massachusetts

Investigation: # 08-MA-046-01

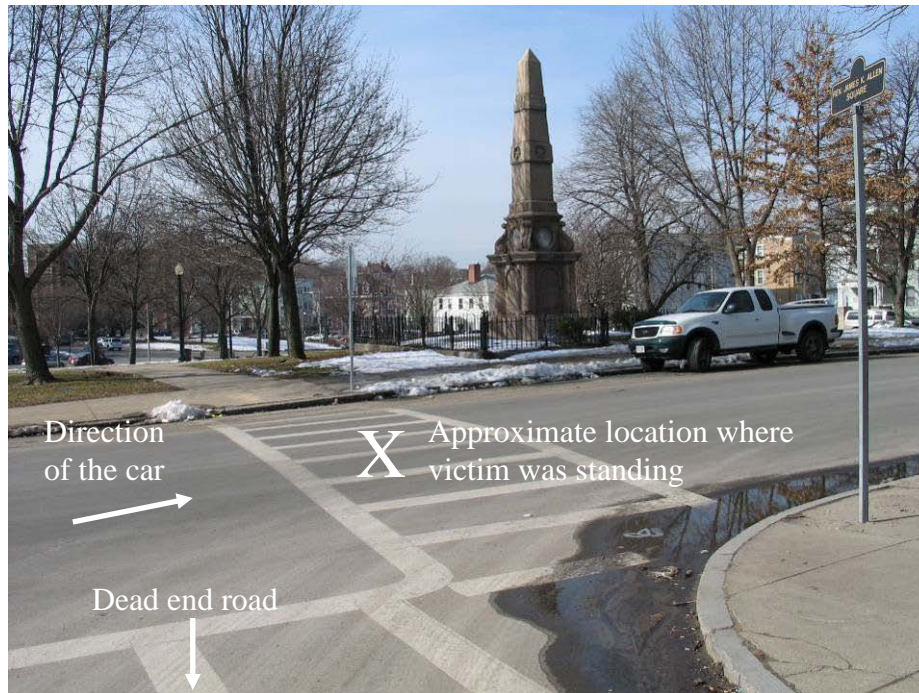
Figure 1 – T-shaped intersection where the victim was assigned.

The school closest to the crossing location where the victim was assigned is an elementary school for students in kindergarten through fifth grade. The school has approximately 500 students in attendance and is located on a relatively short dead-end roadway that runs east and west. The east end of the dead-end roadway is where the school is located and the roadway begins at the west end at a T-shaped intersection (Figure 1). There is a stop sign facing the motorists that are traveling west on the dead-end roadway towards the T-shaped intersection. A park is located on the opposite side (west side) of the intersection from the dead-end road. This T-shaped intersection is the crossing location where the victim was assigned. The other roadway that makes up this T-shaped intersection runs north and south and is a more heavily traveled main roadway.

Both roadways handle two-way traffic and are approximately 56 feet wide, but do not have center yellow divided lines. The roadway's painted markings consist of white fog lines at the edges of

the roads and crosswalks. There are two white painted crosswalks at the T-shaped intersection. The two painted crosswalks have two white parallel lines that run the width of the roadway and white longitudinal lines that are parallel to traffic flow. One of the crosswalks is located at the west end of the dead-end roadway at the T-shaped intersection. The other crosswalk is located on the main roadway at the northern side of the T-shaped intersection. The latter is the crosswalk the victim was located in at the time of the incident (Figure 1). A few hundred feet south of the T-shaped intersection is a skewed four-way intersection where there are no stop signs and traffic travels quickly up to and through the intersection (Figure 2).

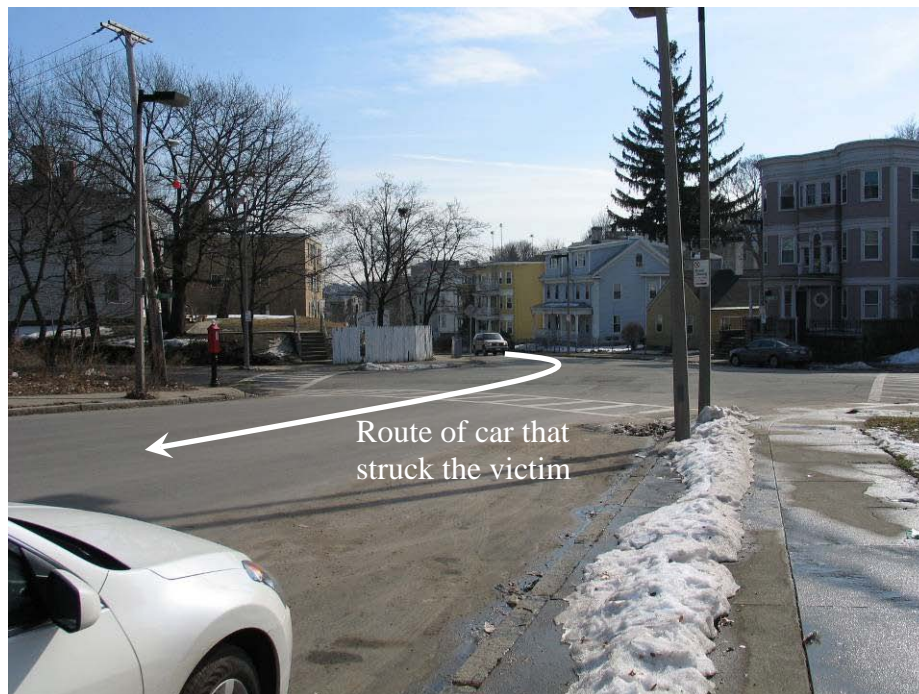
Figure 2 – Skewed four-way intersection south of the incident location.

Prior to the incident the victim had finished crossing a group of students from the park location, eastward across the main road. Once the students were on the sidewalk, the School Traffic Supervisor stayed on the sidewalk with the students to attend to a student. When finished attending to the student the School Traffic Supervisor noticed that another student had crossed through the park and was at the edge of the roadway waiting to be crossed. The victim stepped into the crosswalk while signaling for all traffic to stop. The victim walked to the middle of the roadway within the crosswalk and the student started crossing. The victim then noticed a motor vehicle, a passenger car, traveling on the main roadway heading north towards the T-shaped intersection (Figure 3). This motor vehicle had previously turned right at the skewed four-way intersection onto the main roadway where the victim was positioned.

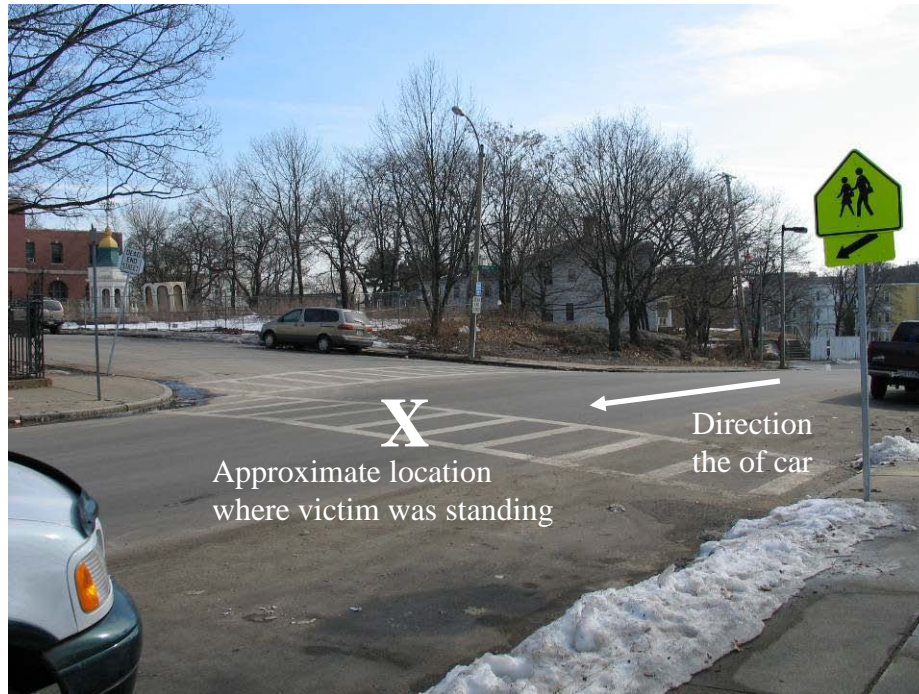
Figure 3 – Incident location with a school crossing assembly sign added after the incident.

Since the incident, the city has installed three fluorescent yellow-green school crosswalk signs. One of the signs is located on the south side, facing traffic traveling west on the dead-end roadway toward the T-shaped intersection. The other two fluorescent yellow-green school crosswalk signs are located on the main roadway. One crosswalk sign faces traffic traveling north on the main roadway just beyond the intersection near the crosswalk where the incident occurred. The other faces traffic traveling south. Two of the three fluorescent yellow-green school crosswalk signs have the supplemental diagonal downward pointing arrow showing the actual location of the crosswalk. This combination of the two signs is called a school crossing

sign assembly. The school crosswalk sign that does not have the diagonal downward pointing arrow was the sign located on the main roadway facing traffic traveling north, the same direction the motor vehicle that struck the victim was traveling.

As recommended by the Manual on Uniform Traffic Control Devices (MUTCD) the signs posted at school crosswalks should include the school crosswalk sign supplemented with a diagonal downward pointing arrow showing the location of the crosswalk (school crossing sign assembly).¹ In this case, a diagonal downward pointing arrow sign should be added to the fluorescent yellow-green school crosswalk sign on the main roadway facing motorists traveling north to make a complete school crossing sign assembly.
