## **Massachusetts FACE • Occupational Fatality Report**

### **Dockworker Dies Due to Carbon Monoxide Poisoning While Using a Gasoline Powered Pressure Washer to Clean Inside a Freshwater Tank - Massachusetts**

**Investigation: # 06-MA-045-01**

**Release Date: March 11, 2010**

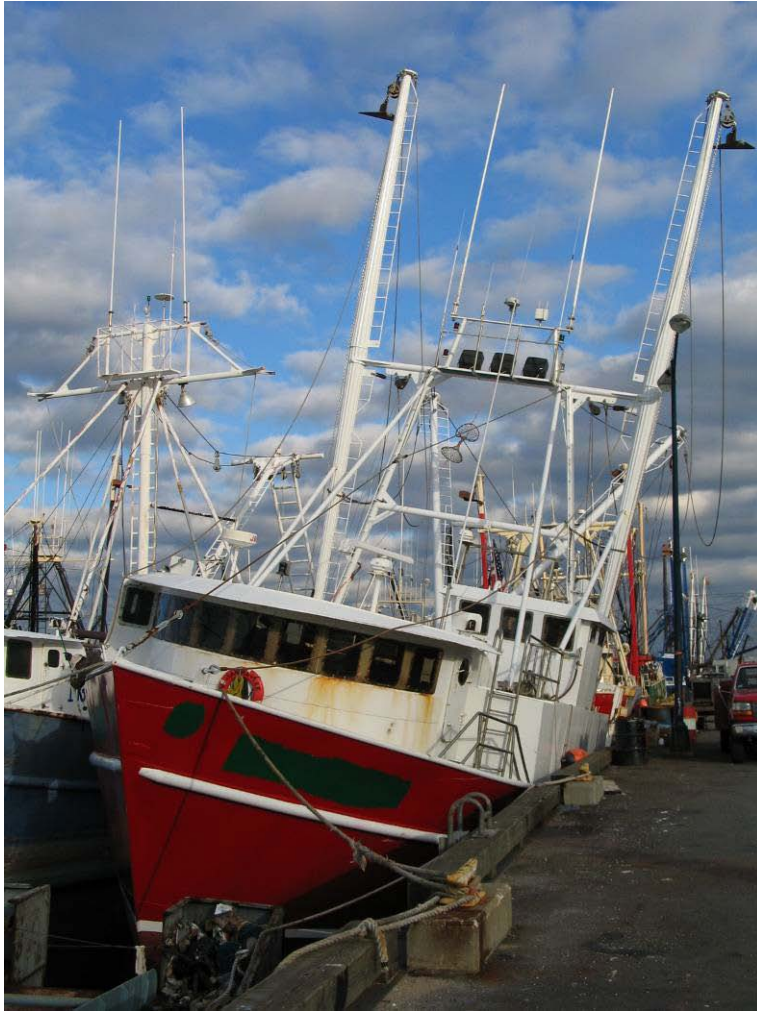
On the day of the incident, the victim had been assigned to clean the fresh water holding tank for a 90-foot steel hulled fishing vessel that was purchased two weeks prior to the incident (Figure 1). The vessel was being rigged as an offshore scalloper, which includes installation of steel towing dredges that are dragged along the sea bottom to collect scallops. The vessel was docked at a wharf at the time of the incident.

**Figure 1 – Vessel involved in the incident.**

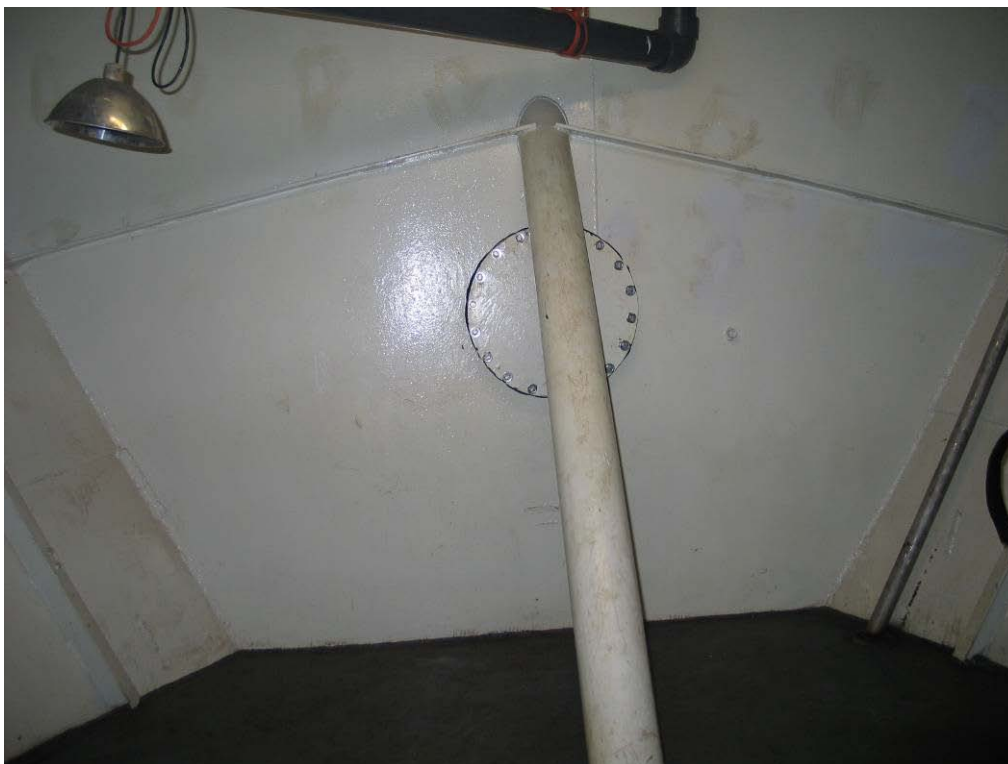
The freshwater tank was located below the foredeck, the forward part of the vessel below the main deck. It was accessed from the main deck by descending a narrow, steep ten-foot steel vertical fixed ladder down to the lower deck auxiliary engine room. This room provided access to the Captain's sleeping quarters, main engine room and fish holds toward the stern of the vessel and the water tank toward the bow, or front of the vessel. The portal to the water tank was a small round opening, approximately 22.5 inches in diameter, located approximately four feet above the floor level of the lower deck (Figure 2).

**Figure 2 – Circular entrance to freshwater tank.**

Tanks are one of the most common locations where confined space fatalities occur.<sup>10</sup> In this case, the employer did not recognize the water tank as a confined space, although it met all of the criteria described. The employer should have tested the atmosphere for CO prior to the victim's entry and during the task. The employer should also have provided employees with training about confined space hazards and rescue procedures (See Recommendation #3.)

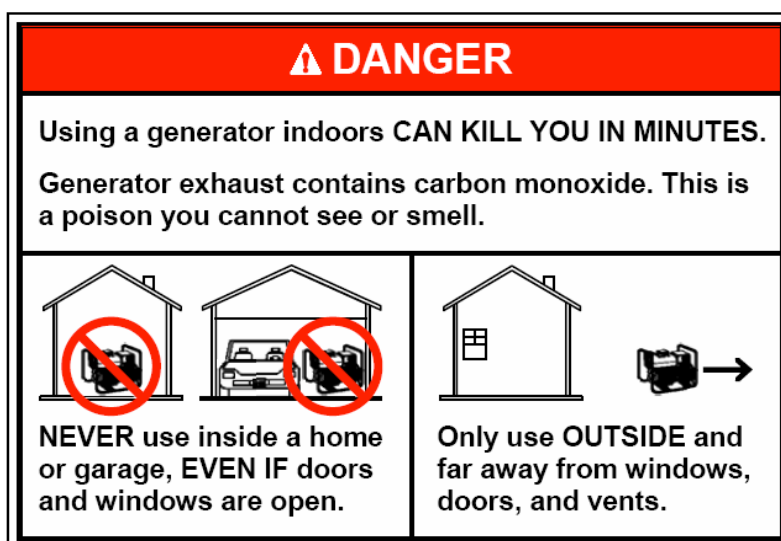
**Discussion:** Retailers, distributors and rental agents for fuel burning equipment should ensure that all customers who are purchasing or renting fuel-burning equipment understand the hazards of CO by providing them with a CO fact sheet, such as the *CO Poisoning* FACE Facts developed by Massachusetts FACE or the *CO Questions and Answers* sheet developed by the Consumer Product Safety Commission (CPSC).<sup>13, 14</sup> In addition, they should also add CO warning label, such as the one developed by the CPSC to all generators, pressure washers and other fuel-burning equipment manufactured (Figure 3).<sup>15, 16</sup>

**Figure 3 – Consumer Product Safety Commission  
fuel-burning generator CO warning label.**

**Discussion:** Despite the history of deaths and injuries from fuel-burning equipment, the hazards of CO are still not well recognized. The CPSC issued a final rule in 2007 with a requirement that CO warning labels be displayed on all portable generators and packaging that is manufactured or imported into the United States (16 CFR 1407).<sup>16</sup> Manufacturers should take added steps to help educate people about CO by also including CO warnings on other fuel-burning equipment, such as pressure washers. In addition manufacturers should also post instruction manuals that include CO warnings on their web sites.
