**SUBJECT:** A Solar Panel Installer Dies When He Falls Off a Roof

**SUMMARY**  
**California FACE Report #10CA003**

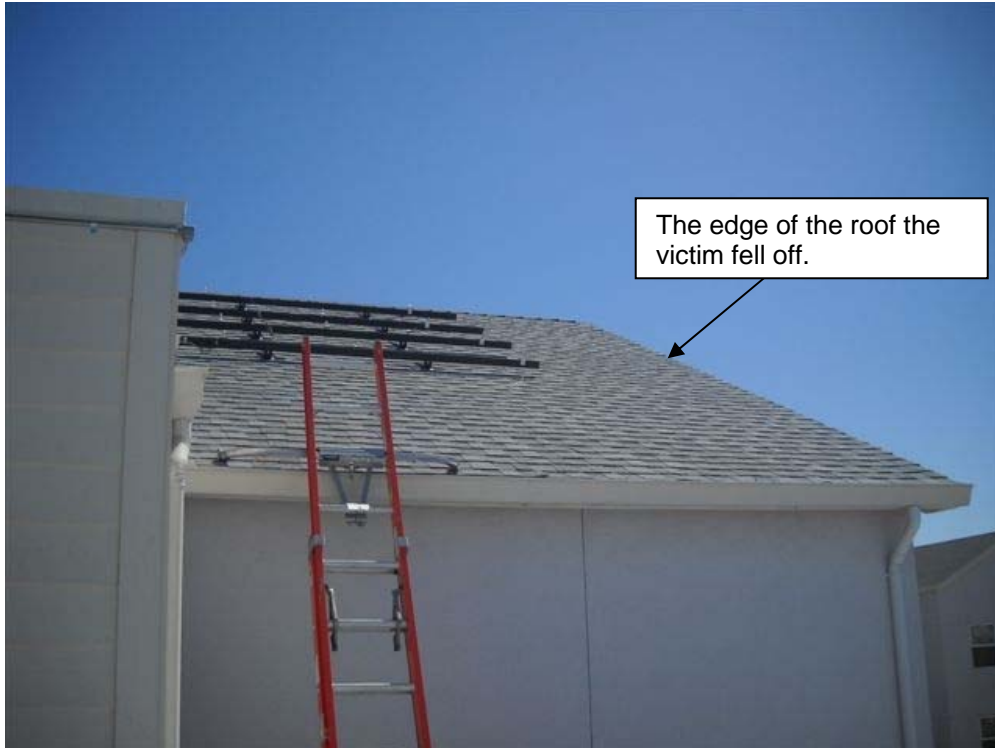
The location of the incident was a housing unit with multiple three-story apartment buildings. Solar panels were being installed on the sloped roofs of the apartment buildings. On the unit where the incident occurred, access to the roof was gained by a stairwell up to a third floor landing and then a straight ladder from the landing to the bottom of the sloped roof. The distance from the bottom of the sloped roof to the landing was approximately eight feet. The distance from the sides of the sloped roof to the ground below was approximately 45 feet. The slope of the roof was approximately 9:12 or 37 degrees.

**Exhibit 1. The roof edge the victim fell from.**

**Recommendation #1: Employees wear fall protection when working on sloped roofs with identified fall hazards.**

Fall protection should be worn by employees on sloped roofs greater than 30 degrees, or whose work exposes them to a risk of a fall in excess of 7 ½ feet. The two types of fall protection systems commonly used on roofs are a personal fall restraint (PFR) system and a personal fall arrest (PFA) system. A PFR system is used to prevent an employee from falling. It consists of anchorages, connectors, lanyards, and body harness. A PFA system is used to stop an employee during a fall from a working level. This system consists of an anchorage, connectors, a deceleration device, and a body harness. Had the victim been wearing the required fall protection, his death would have been prevented.

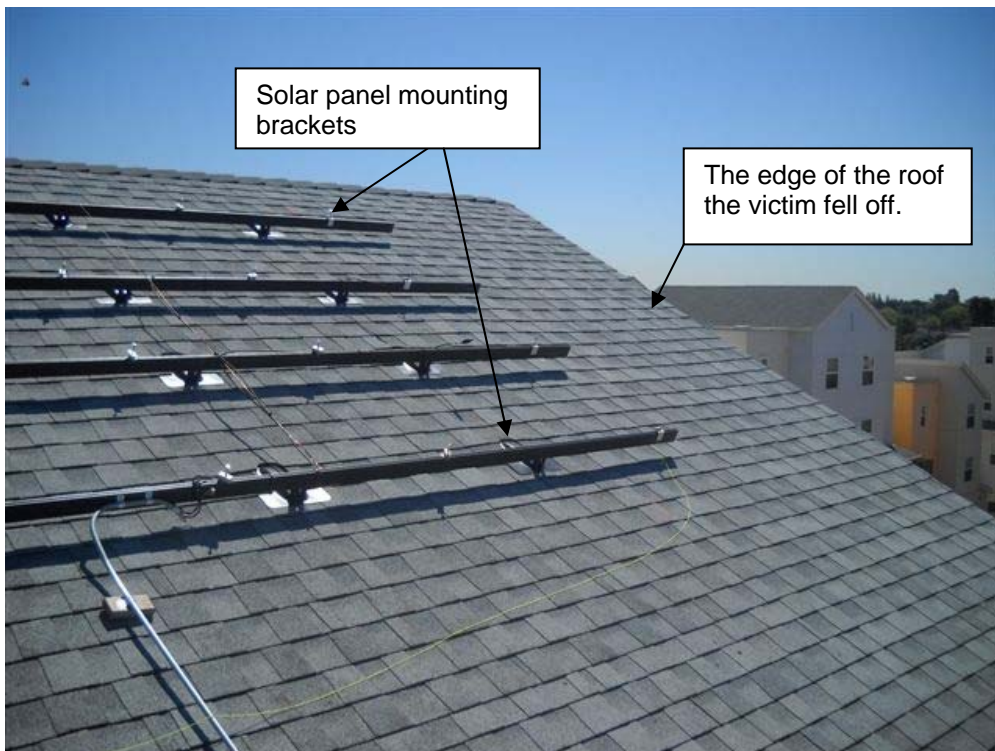
On the day of the incident, the victim along with his supervisor and co-worker were on the sloped roof checking the alignment of the brackets for the support structure of the solar panels. This was their second day on the job. The victim was working within four to five feet of the roof edge and was probably walking backwards as he performed this task. Neither the work crew nor the victim were wearing fall protective equipment and was tied off, and there were no guard rails or safety nets in place. The co-worker and supervisor heard the victim say something, and then looked over at the spot where they last saw the victim. By that point, the victim had fallen over the edge of the roof onto to the concrete sidewalk below. The co-worker immediately called 911. The fire department and paramedics arrived at the location within minutes of the call. The victim was air lifted to the hospital where he was pronounced dead.

**Exhibit 2. The mounting brackets for the solar panels and the roof's edge where the victim fell.**

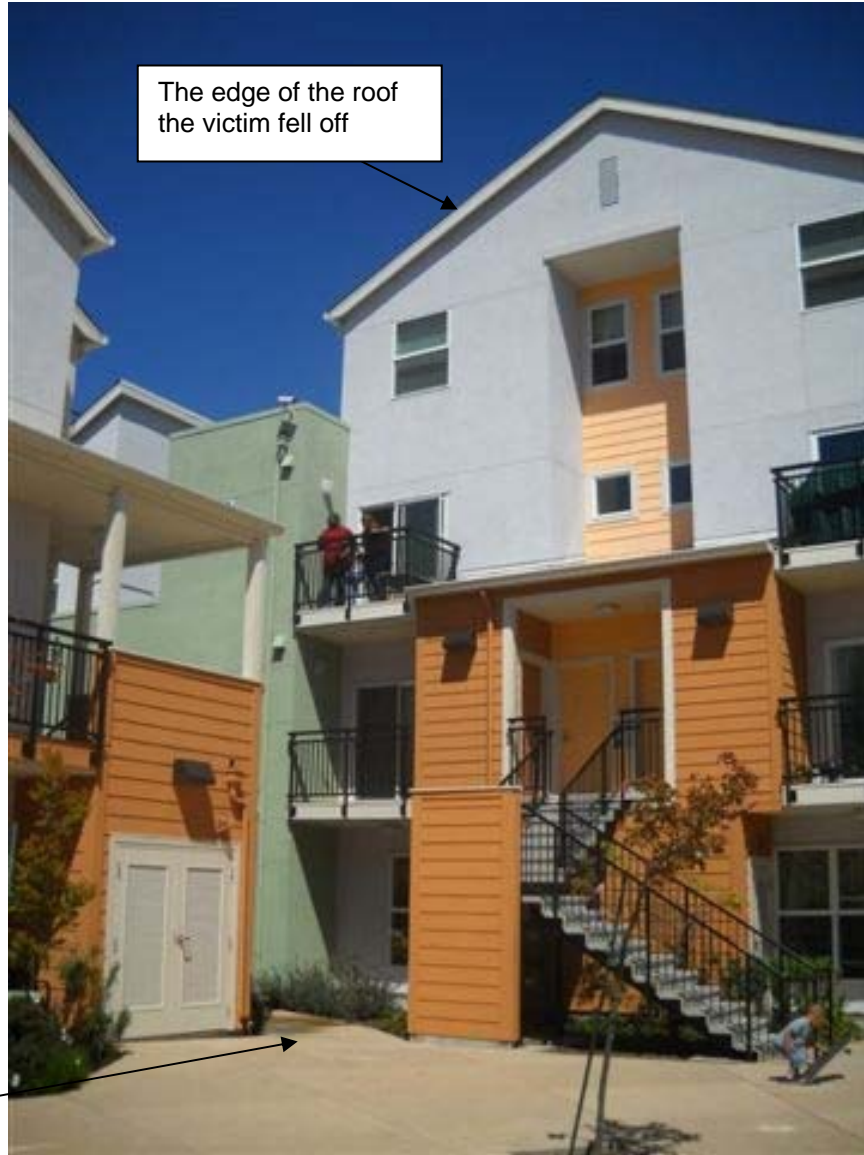
The edge of the roof  
the victim fell off

The concrete  
sidewalk where the  
victim landed after  
falling off the roof

**Exhibit 3. The three-story apartment building involved in the incident.**
