Massachusetts FACE • Occupational Fatality Report

Laborer Dies after Falling From an Aluminum Extension Ladder at a Residential Construction Site - Massachusetts

Investigation: # 08-MA-042-01

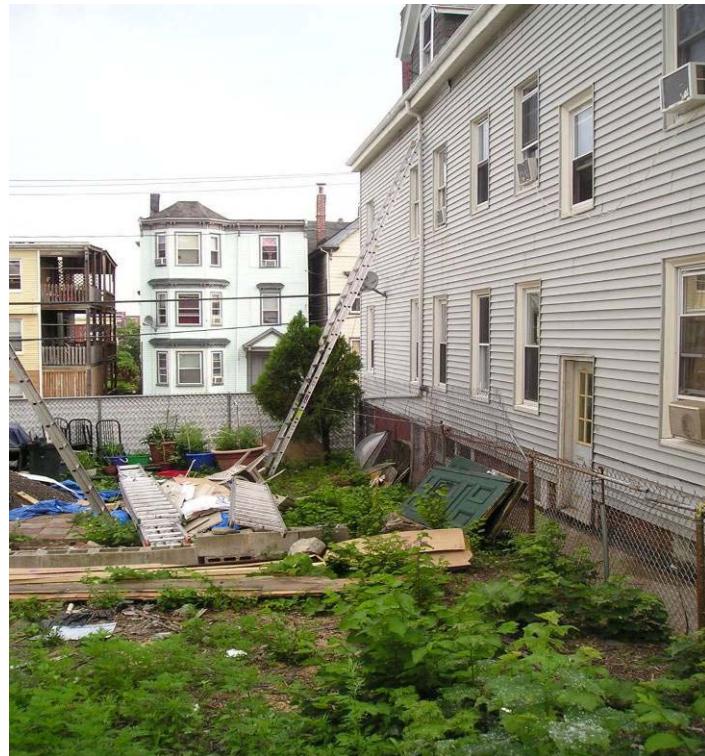
At approximately 5:00 p.m. the victim and the co-worker went to the neighboring house to start the repair (Figure 1). The right side yard property line of the three-family house they had been working on all day was the same property line for the backyard of the neighboring house where the piece of siding was going to be reattached. A chain link fence ran along this property line. The distance between the neighboring house and the chain link fence was approximately three feet. This entire three foot distance was a poured concrete pathway that ran along the rear of the house. The pathway led to the street and approximately five feet in from the street there were concrete stairs within the pathway.

The section of vinyl siding that was loose was approximately six feet long and six inches wide. The piece was located in the middle of the back side of the house up at the roof's edge approximately 20 feet high (Figure 2). The victim and the co-worker brought a 32 foot aluminum extension ladder to the back of the house. The company owned this ladder and although at the time of the investigation, the company owner did not know the ladder's rating, it was reported that the ladder was one year old and in good shape. When setting up the ladder, the victim and co-worker positioned the base in the right side yard of the three-family to help angle the ladder. The ladder extended up and over the chain link fence, with the top of the ladder placed against the house just under the loose section of vinyl siding. The ground where the base of the ladder was positioned was a flat and grassy; the ladder was extended approximately 20 feet (Figures 1 and 2).

Figure 1 – Incident location with an extension ladder set up in a similar location as it was at the time of the incident.

Recommendation #2: Employers should ensure that ladders are equipped with stabilizers and are set up properly.

Discussion: In this case, it appears that a combination of ladder set up, including lack of stability accessories, and overreaching / overexertion from the ladder on which the victim was working, contributed to this incident. To minimize the hazard of falling from an unstable extension ladder, ladder stabilizers (also known as standoffs) should be used at all times. Ladder outriggers are also available and can help stabilize a ladder during use. In addition, following the procedures outlined below will help prevent falls from extension ladders.

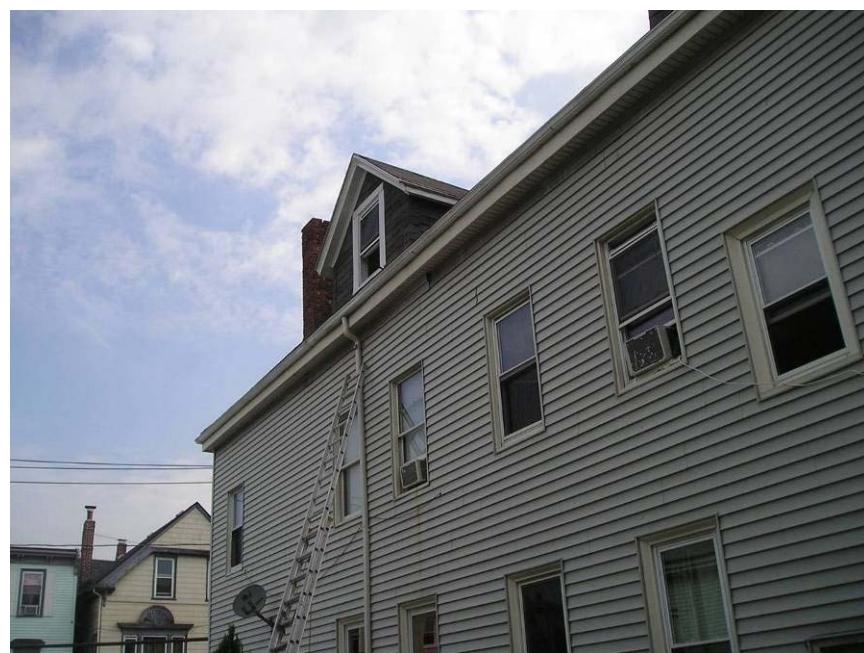
Figure 2 – Neighboring house where the incident took place. Note the loose piece of vinyl siding to the right and above the top of the ladder.

Recommendation #1: Employers should ensure that ladders are not used as work platforms, when feasible.

Discussion: Scaffolding and aerial work platforms provide a better work surface for employees, even with the increased set up and dismantling time compared to ladders. Working from ladders can pose a fall hazard; therefore ladders should only be used for accessing higher and lower levels.¹ If the task to be performed requires the worker to push, pull, or pry, as in this case, then the use of scaffolding or aerial work platforms rather than a ladder is strongly recommended. Prior to employees using scaffolding and aerial work platforms, employers must provide employees training on their proper use (Recommendation #3). In this case, the task of reattaching the piece of vinyl siding required the victim to do some pushing and pulling. In addition, the location where the task was to be performed would not allow for an aerial work platform to be used, therefore scaffolding might have been a better work surface than a ladder.
