# MIFACE INVESTIGATION REPORT: #08MI128

## SUBJECT: Farmer Died When Portable Elevator Fell Onto Him

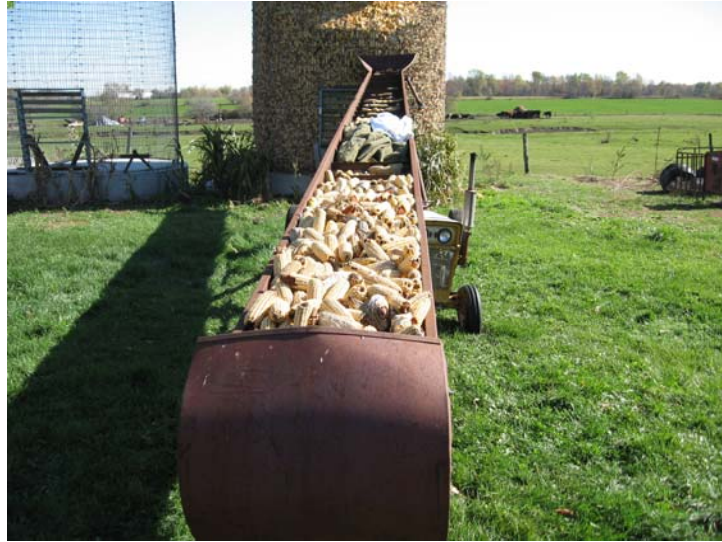
Figure 1. Elevator position at time of incident

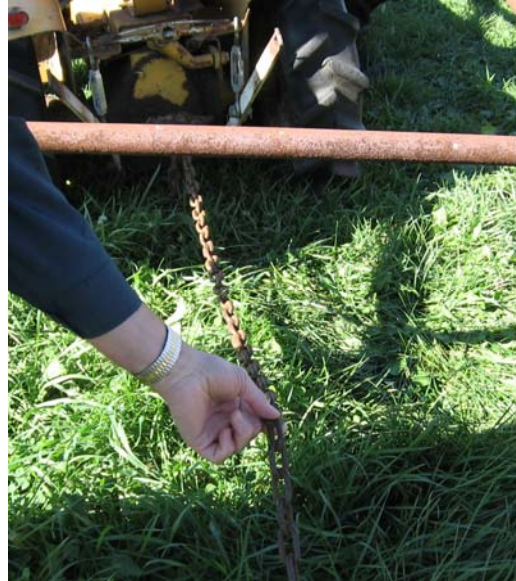
Figure 2. Chain attached to rear axle of tractor

**should never attach a chain to the axle of the pulling unit or to the axle of the unit being pulled.** In this incident, the boot (or ground end) should have been used as the hitching point after the elevator was lowered and locked into position. If an attachment point for an older piece of equipment is not present, a solid metal tow bar specific to the equipment could be farm made and used to assist with towing using the agricultural tractor’s draw bar.

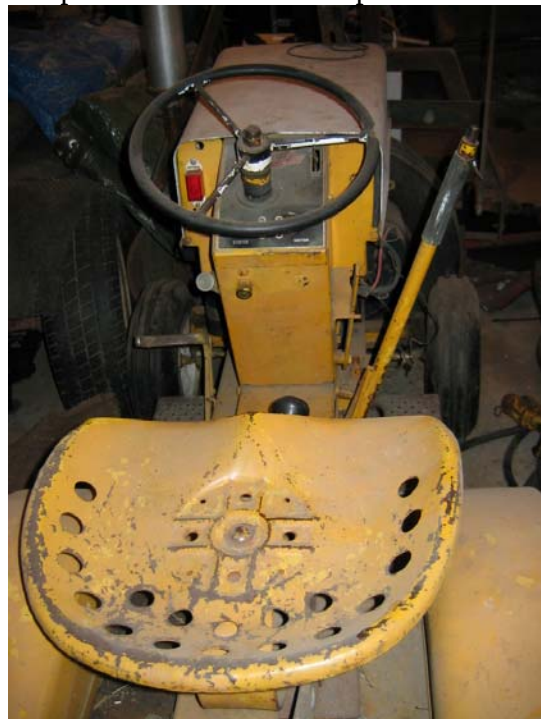
Figure 5. Lawn tractor involved in incident

- Use appropriate equipment to move the elevator.* The decedent had available to him a tractor equipped with a four-post ROPS frame and canopy, which if used, would have prevented the elevator from striking him, even if he had improperly positioned himself under the raised elevator. The lawn tractor was *not equipped* with a ROPS frame and was not designed to perform this task (Figure 5).
- Ensure elevator is empty prior to transport.* The top heavy elevator had the extra weight of about two bushels of ear corn at the high top end, which may have contributed to a possible upend event and resulting elevator collapse. Although cable or winch failure was not a factor in this incident, operators should be made
