## **Massachusetts FACE • Occupational Fatality Report**

### **A Cooperative Placement 11<sup>th</sup> Grade Student was Injured while Operating a Jointer in a Millwork Shop - Massachusetts**

Investigation: # 08-MA-1NF-01  
Release Date: December 21, 2009

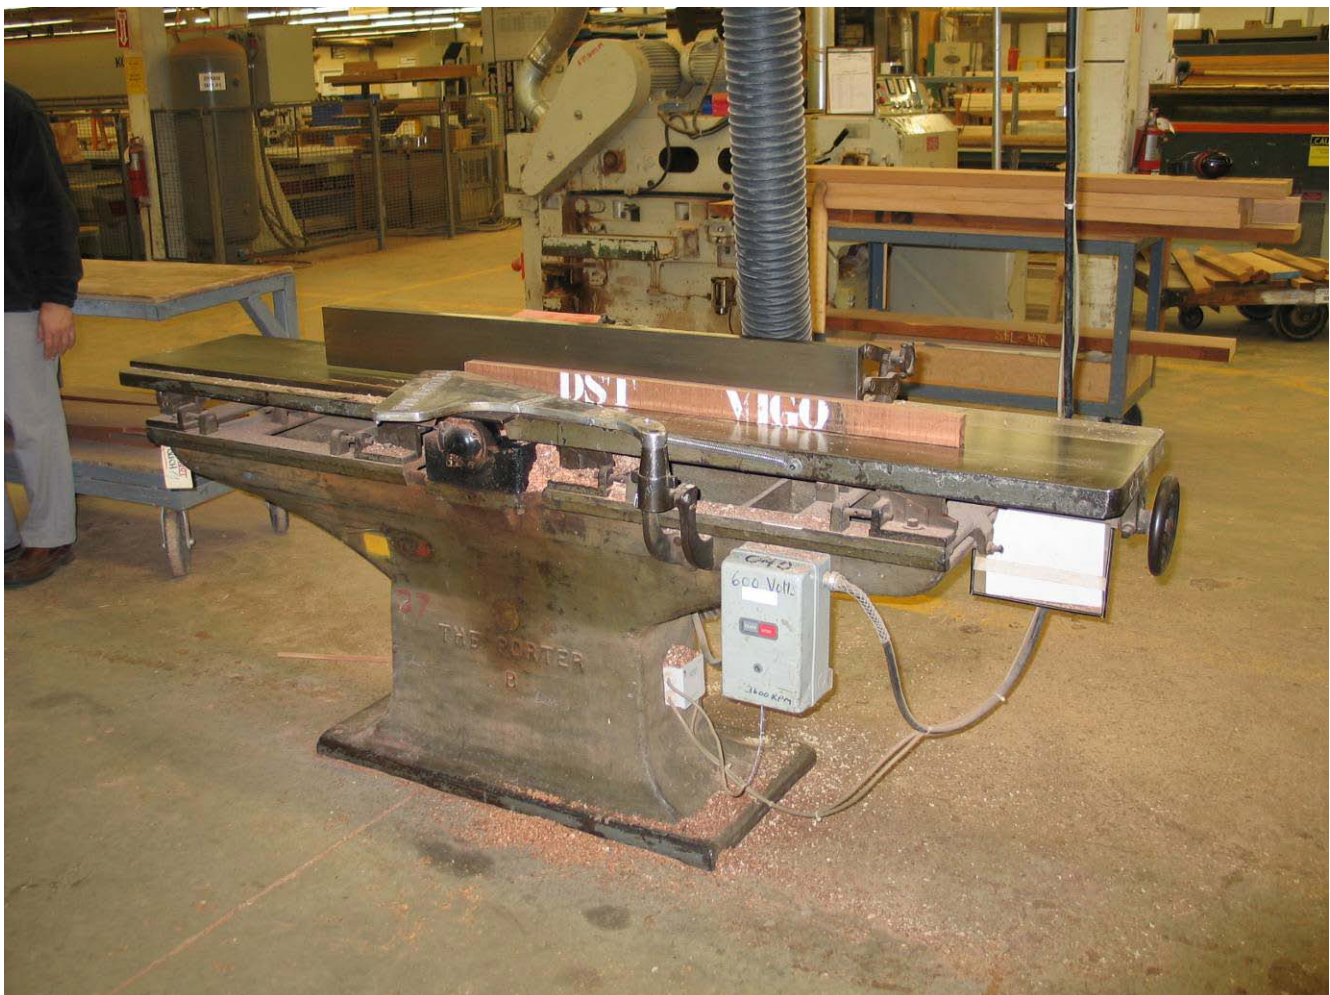
**Figure 1 – Jointer involved in the incident**

The woodworking machine that the student was operating at the time of the incident was a 12-inch jointer that had been acquired by the millwork company during the purchase of another company. The exact date the jointer had been manufactured is unknown. The company owns two other jointers and any repairs and preventive maintenance to the jointers and other woodworking machines are performed in-house, except for specialized and complicated repairs for which the manufacturers are contacted to do the repairs. Although the company did not have the manufacturer's operator manual for the jointer involved in the incident, they did have the manuals for their other jointers.

The manufacturer equipped the jointer with a guard that covers the front side of the cutterhead, from the fence towards the operating area. The guard is equipped with a hinge and an integrated spring. The hinge and spring allow the guard to move with the wood work piece during cutting, keeping the cutterhead covered. The guard had been repaired twice and both repairs had been performed prior to the jointer being acquired. An additional guard had been made for the jointer that covers the back side of the cutterhead, from the fence back, and had already been installed on the jointer when it was acquired.
