SUBJECT: Janitor Dies When He Falls into a Baling Machine that Bales Cardboard for Recycling

SUMMARY
California FACE Report #09CA009

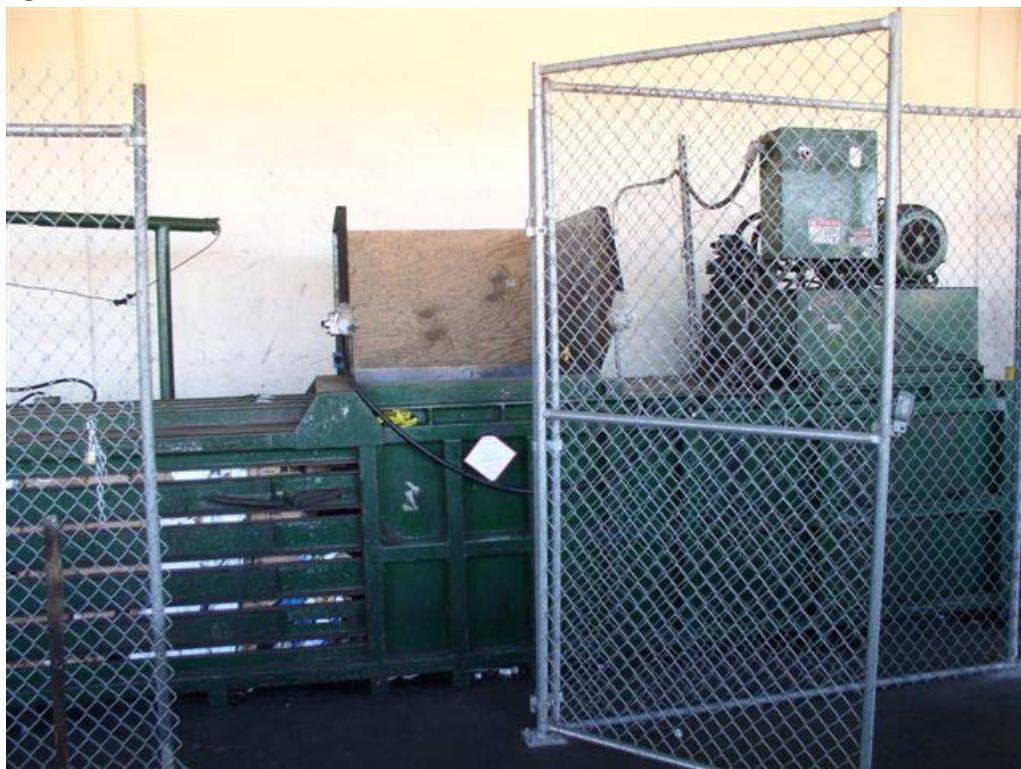
Exhibit 1. The front view of the cardboard baling machine involved in the incident.

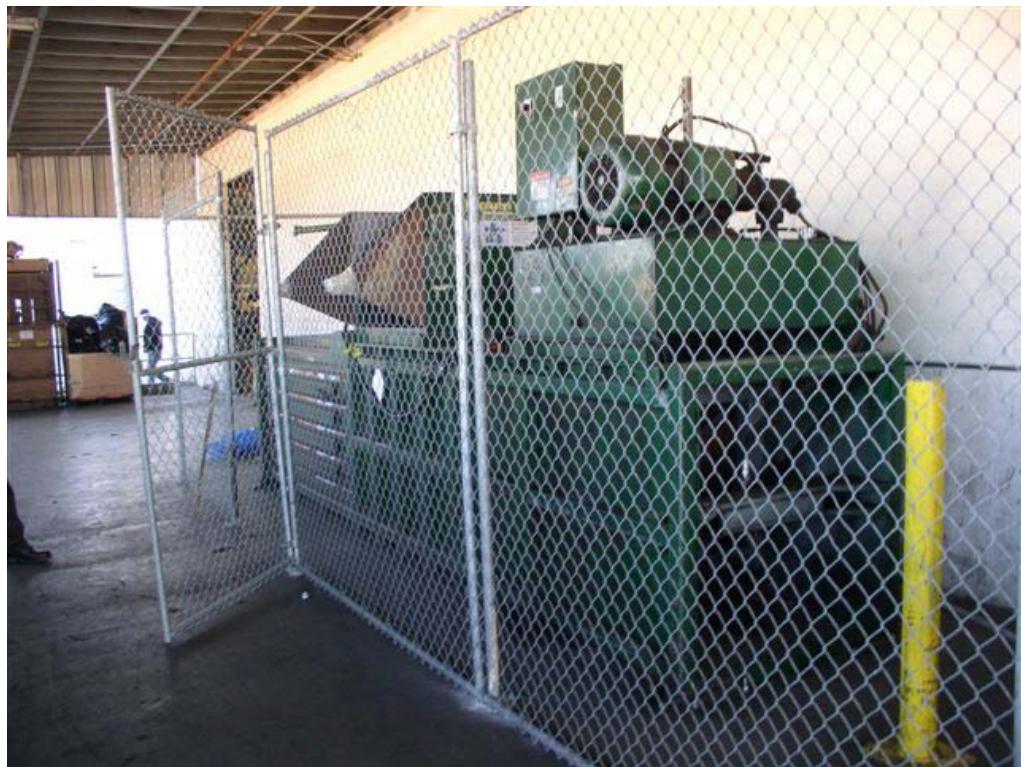
Exhibit 2. Side view of the cardboard baling machine.

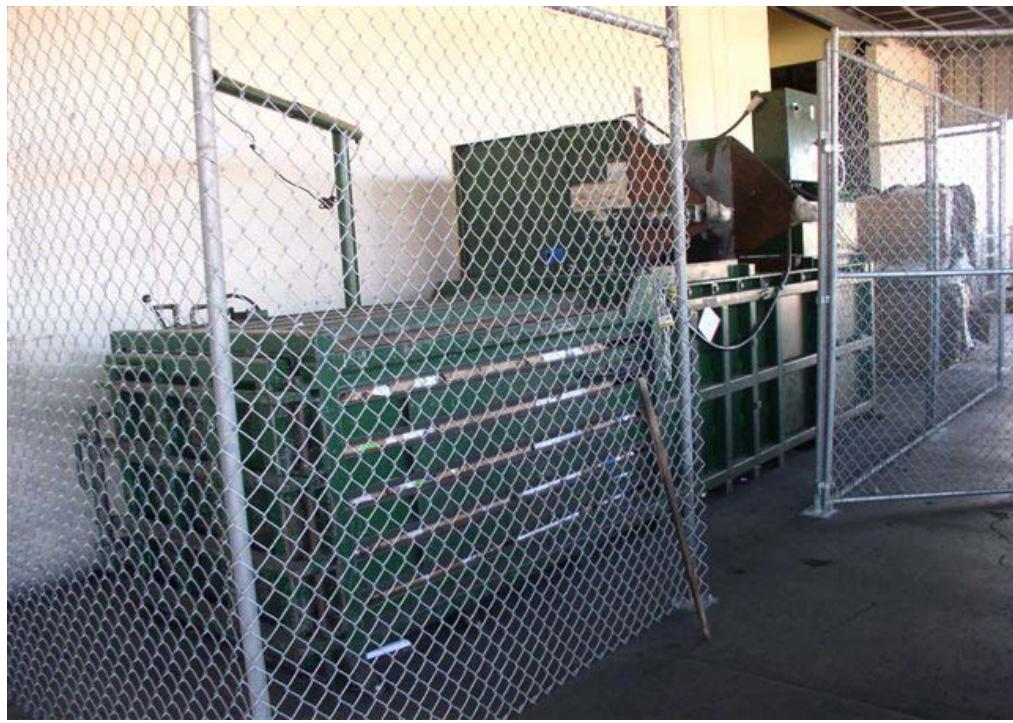
Exhibit 3. Alternate side view showing the baling chamber.

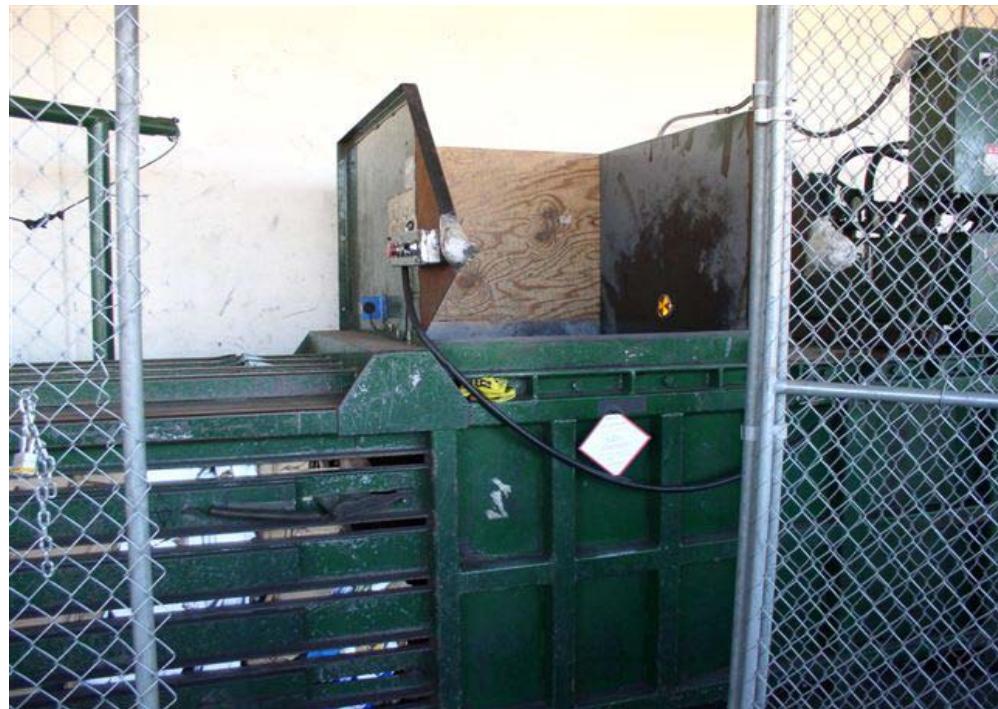
Discussion: In this incident, the victim was able to gain access to the point of operation of the machine through the opening on the open side of the hopper. It is not known exactly why the victim was standing in the compaction chamber. When he entered the compaction chamber, his body broke the sensor beam and activated the ram that crushed him. Guards around the machine's point of operation are necessary to prevent entry of hands, fingers, or any part of the body into the point of operation. Had this guard been in place, the victim would not have been able to climb into the machine and this incident might have been prevented.

Exhibit 4. The feed hopper and compaction chamber.

Recommendation #1: The area around the machine's point of operation is guarded by barriers or interlocked safety gates.

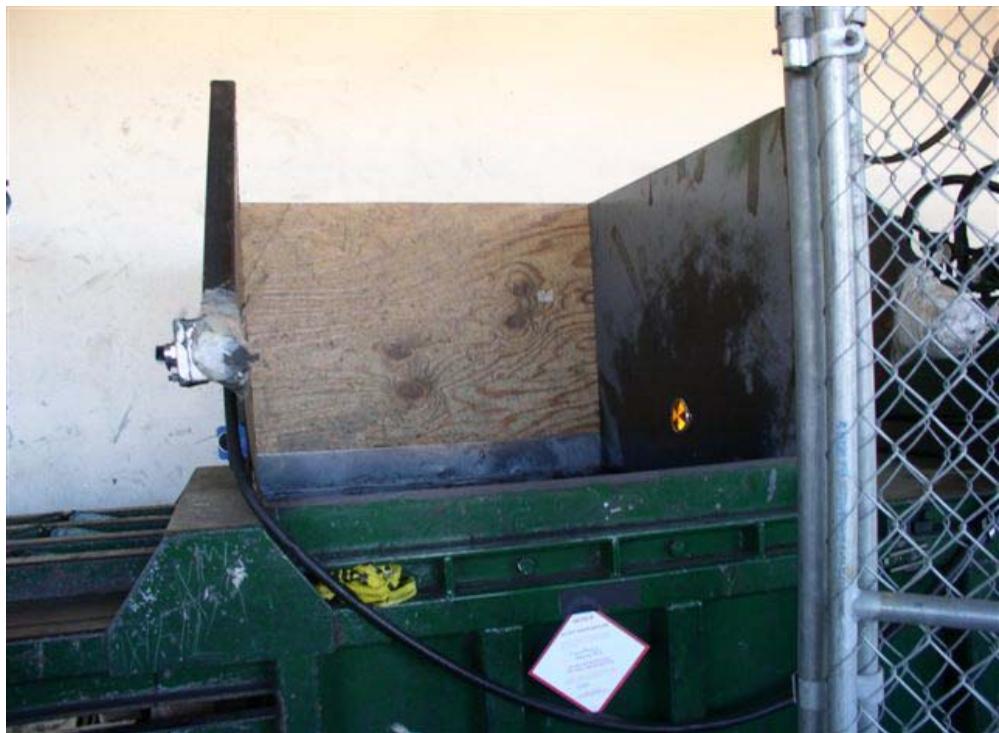
Exhibit 5. Closer view of the feed hopper.

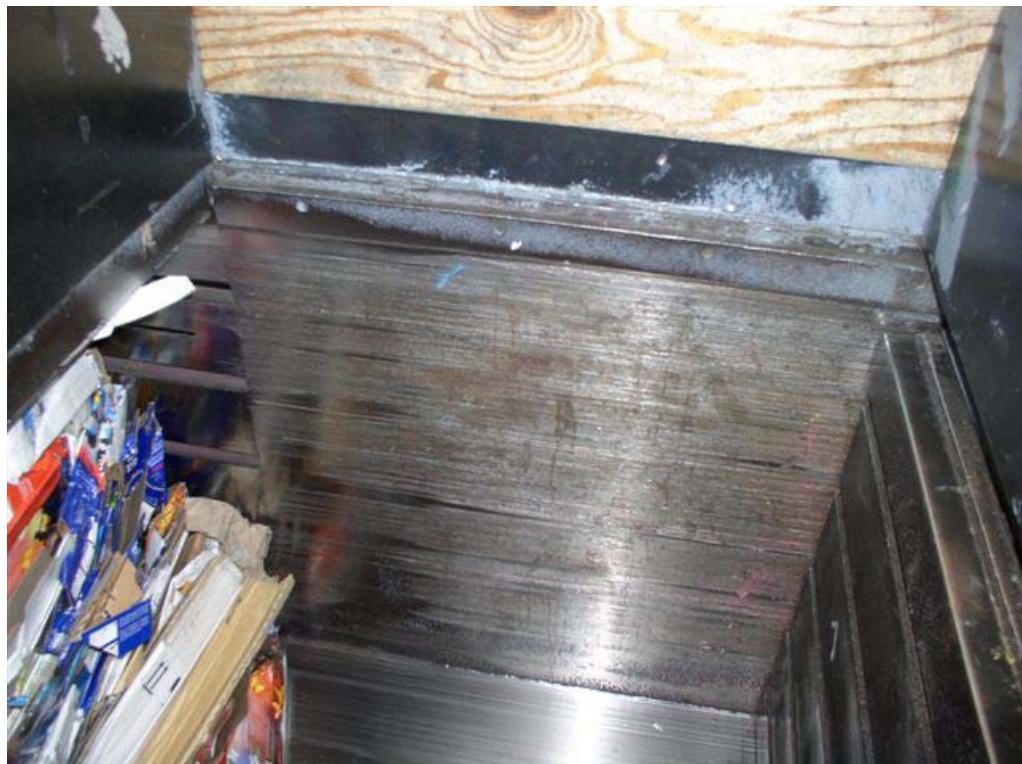
Exhibit 6. Inside view of the compaction chamber.

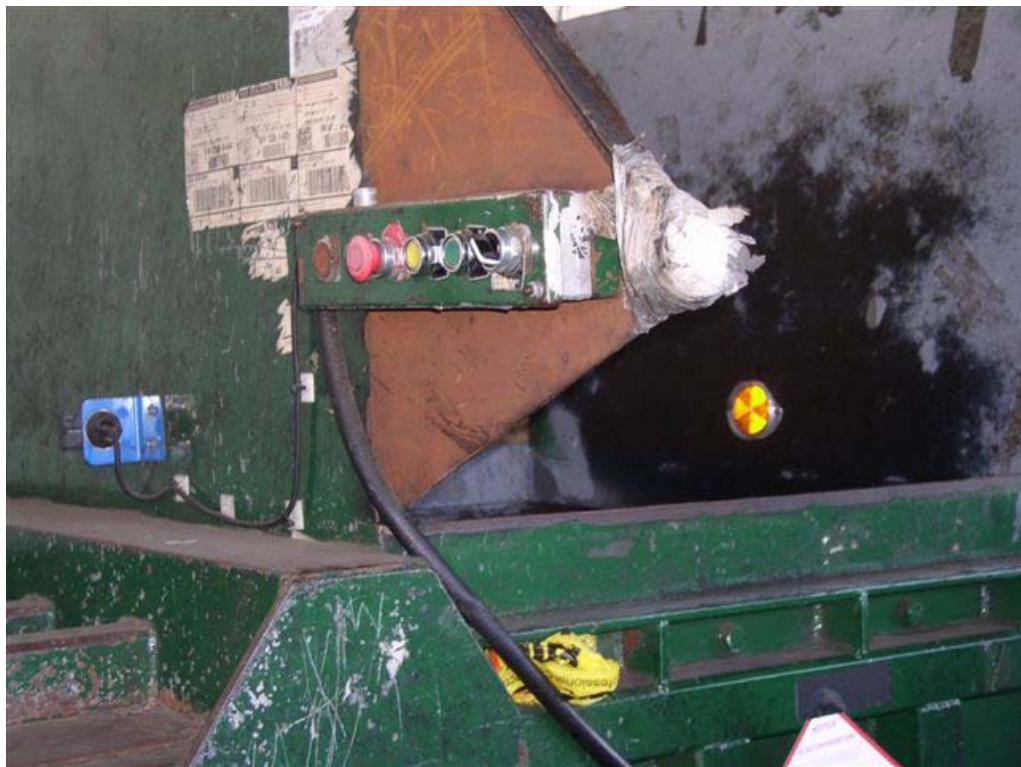
Exhibit 7. The controls and electronic sensor.

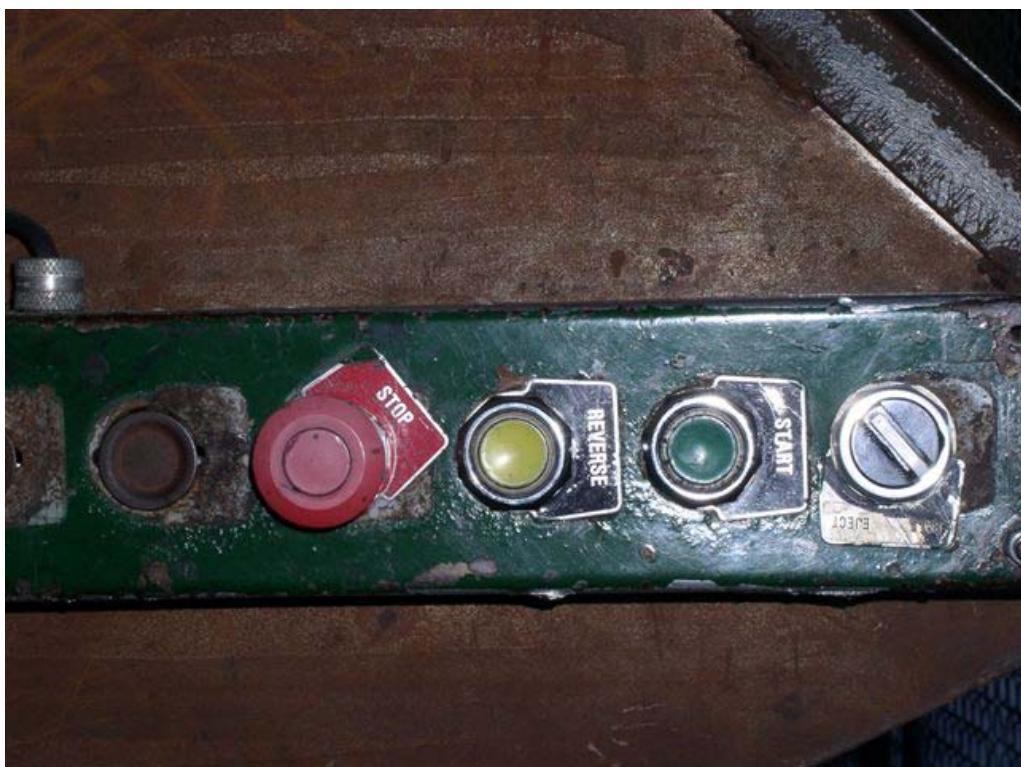
Exhibit 8. Close-up of the controls.
