Coal Truck Driver Dies in Rollover After Tire on Trailer Fails

Incident Number: 06KY100

Kentucky Fatality Assessment and Control Evaluation (FACE) Program

Incident Number: 06KY100 Release Date: May 12, 2009

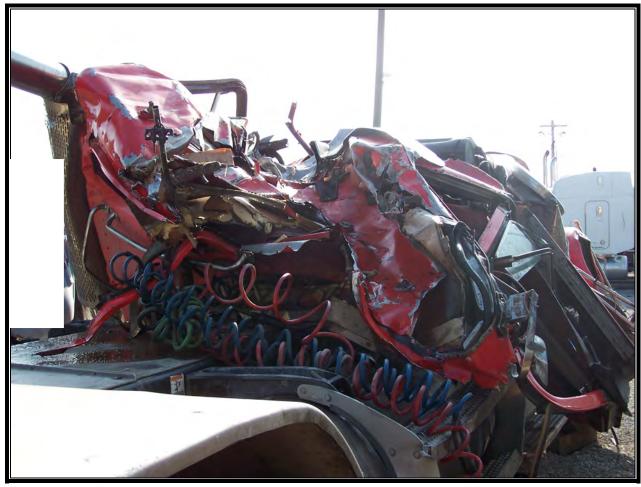
Photograph of semi involved in crash. Photograph taken by KY FACE personnel.

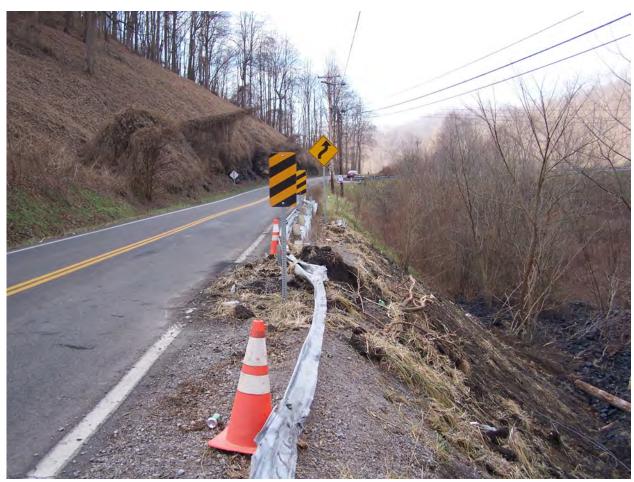
Accident reconstruction conducted by the Kentucky State Police revealed that there were 284 feet of skid marks prior to the point where the tractor overturned. The tractor then skidded approximately 82 feet on its side and top before coming to rest upside down and on top of the guard rail. There was approximately 120 feet of damaged guard rail.

Location where tractor and trailer came to rest. Photograph taken by KY FACE personnel.

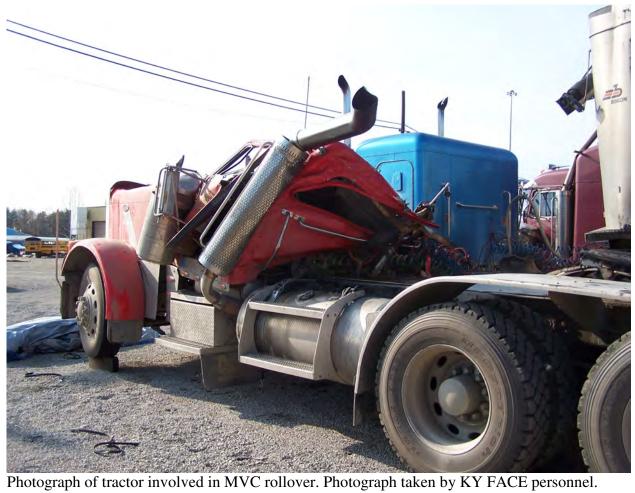
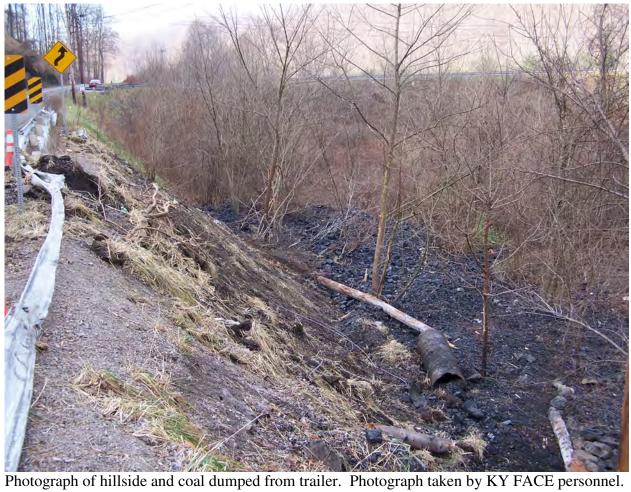
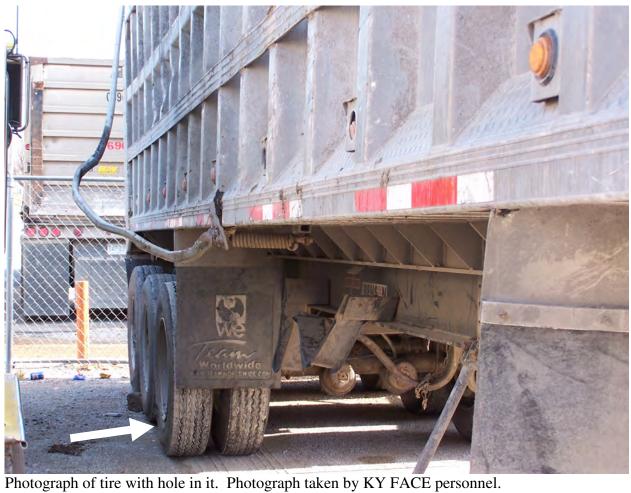
At approximately 2:40 PM, a witness in the front yard of his house next to the crash scene reported that he heard a loud sound like a tire blowing, saw the truck and tractor overturn, and called 911. The witness reported that the first emergency responders, the local volunteer fire department, began arriving 'within minutes" and were followed by the state police and ambulance personnel. Ambulance personnel called the county coroner at 2:50 P.M. The coroner arrived and pronounced the driver dead at the scene at 3:20 P.M. The local fire department controlled traffic and worked for two hours using a 'Jaws of Life" hydraulic device to remove the driver from the tractor. Kentucky State Police and the county coroner stated that there was nothing found in the area that would have caused a tire to blow. A gash was found in the middle

rear outer tire. Toxicology tests detected tramadol, oxycodone, and hydrocodone in the driver's system at the time of the crash.

Recommendation No. 1: Employers should require drivers to perform pre-trip and post-trip inspections on the tractor and trailer prior to operation.

Federal Motor Carrier Safety Administration regulations CFR 396.13 and CFR 396.11 require commercial motor vehicles to be inspected before driving the vehicle and at the completion of the day's work. CFR 396.3 requires companies to not only inspect every commercial vehicle, but to keep the vehicle properly repaired and maintained. Reports are to be completed and available for the next driver to review as part of their inspection of the vehicle. Companies should require drivers to complete the Department of Transportation Driver's Vehicle Inspection Report, DVIR, (Attachment 1) and to turn them into the office each day. If the driver finds a defect detrimental to safety, it is recommended that the equipment be taken to the proper mechanic for repairs. The report lists important aspects of the vehicle such as tires, battery, body, brakes, clutches, wheels and rims, windshield wipers, etc., which the driver is required to inspect each time the semi is operated. There is a space on the form for the driver to make notes for items not listed on the report that may need to be addressed immediately or in the future. After completing the report, the driver either signs that the vehicle is in satisfactory condition or that defects need correction or repair before the vehicle is returned to service.
