FROM: Iowa FACE Case No. 2004IA011 Report Date: 01 June 2005

SUBJECT: Mechanic Dies When Tractor Overturns While Removing Tree Stump in Cemetery

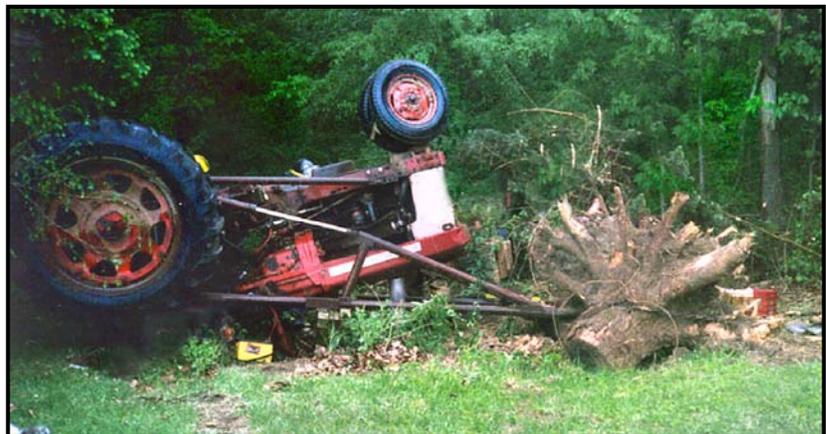
During the spring of 2004, a 36-year-old mechanic died in a tractor overturn. He was working alone in a cemetery picking up tree trimmings and removing a tree stump. He was using a narrow-front-axle (tricycle-type) farm tractor with a front-end loader. The loader was an older model with hydraulically-extendable lower links/lift arms to raise the loader bucket and its load (Photo 1).

Photo 1 – Side view of the overturned tractor showing the raised front-end loader with the stump secured by a log chain.

The tractor was aimed at an angle forward and downward across the slope, tilting to the left as he attempted to lift the heavy tree stump by raising the front-end loader. The stump was secured to the loader by a log chain around it and the loader bucket. As the loader bucket raised well above the height of the hood of the tractor, the tractor tipped onto its left side and continued to roll onto its top, stopping upside down on top of the operator. The victim was found by another worker who came to the cemetery to mow grass later in the day.

Discussion: All tractors with front-end loaders should be equipped with a roll-over protective structure (ROPS) and seatbelt to minimize the potential for injury in the event of an overturn. Front-end loaders should be installed only on tractors that have a wide front axle, not on those with narrow (tricycle-type) front axle, with both front- and rear-wheels of the tractor spaced as widely as possible. The tractor-loader-load combination should be properly ballasted with weight on the rear axle or carried on rear hitch area of the tractor.

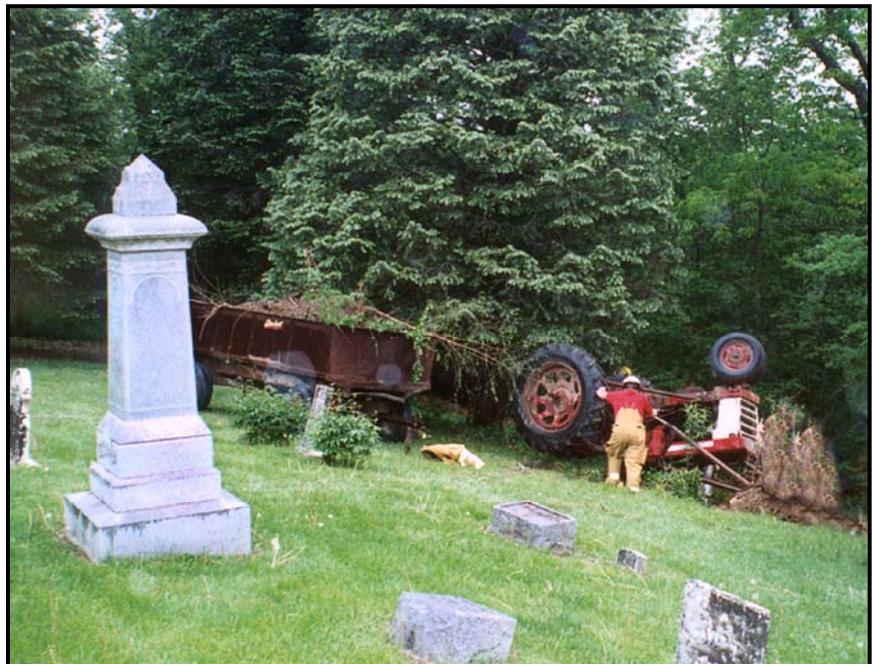
During the spring of 2004, a 36-year-old male part-time mechanic was killed in a tractor overturn. Iowa FACE personnel were alerted to this incident by a local newspaper article and began an investigation. Information was gathered from the County Sheriff, the State Medical Examiner, and the Clerk of the local township responsible for maintaining the cemetery (Photo 2).

Photo 2 – Overview of the cemetery showing the wagon load of branches and the degree of slope in the area.

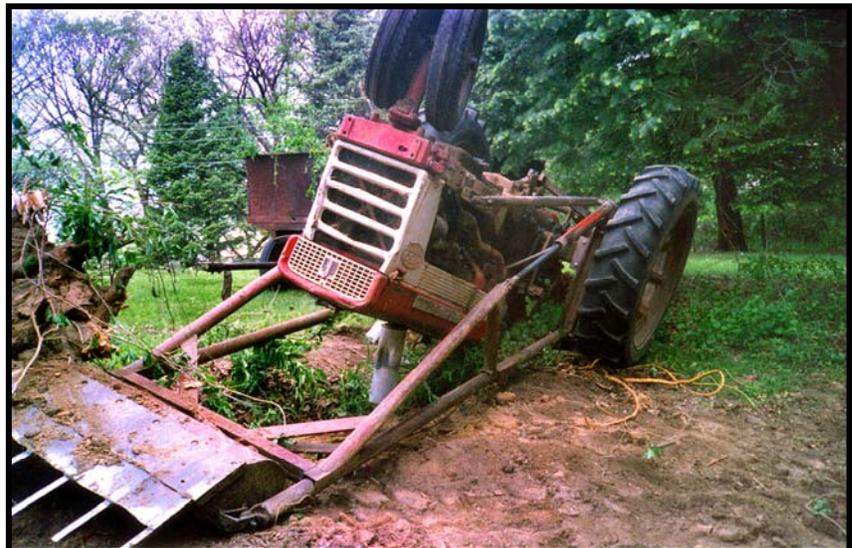
Photographs confirm the tractor had its front-end loader raised high (Photo 3) with the large stump reportedly tethered by a length of log chain secured around its bucket. The victim was apparently attempting to carry the stump and proceed to load it into the wagon nearby when the overturn occurred. The tractor-loader combination was aimed forward downhill in an area sloping downhill and to the left ahead of the tractor. Rescue workers found a bag containing several cans of beer, and postmortem tests results documented the victim's blood alcohol content (BAC) at 0.11%. This likely influenced his assessment of the overturn risk, including the equipment, operating, loading, and terrain factors contributing to it.

Photo 3 – Front view of the tractor, with the wagon uphill in the background, showing the front loader was raised prior to the overturn.
