TO: Director, National Institute for Occupational Safety and Health
FROM: California Fatality Assessment and Control Evaluation (FACE) Program
SUBJECT: A Maintenance Worker Dies When He Falls Through a Skylight

SUMMARY
California FACE Report #07CA007

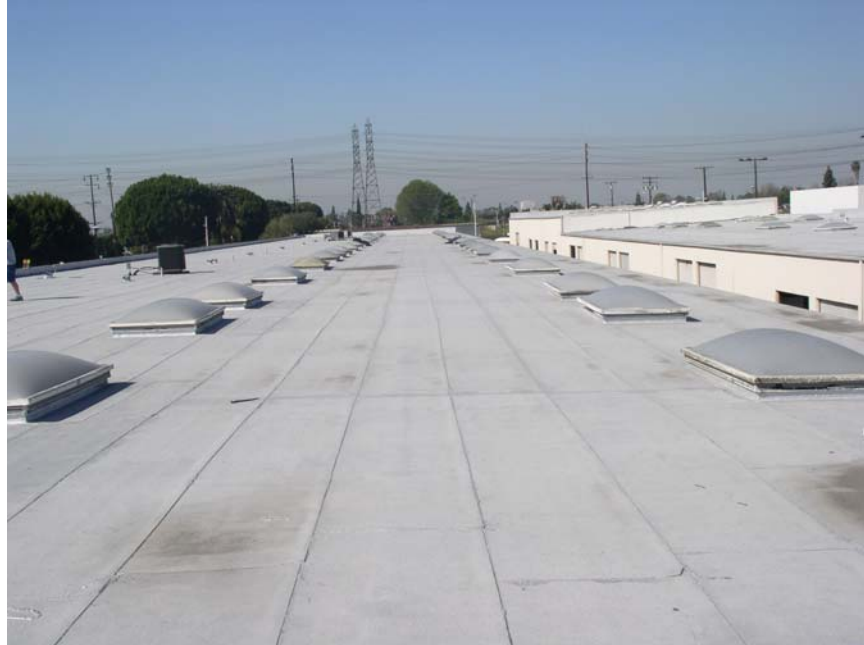
EXHIBIT 1. The roof of the building where the incident occurred.

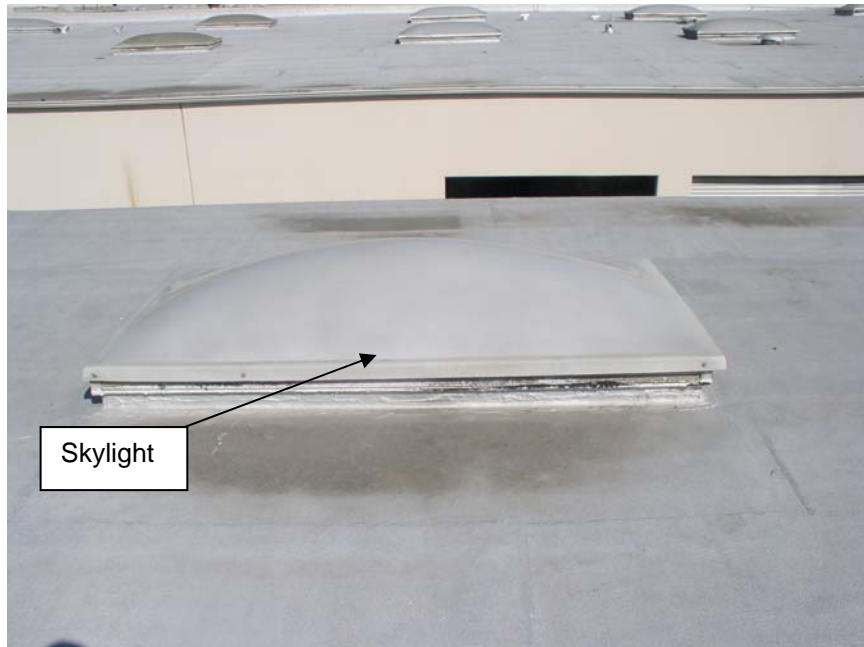
The two maintenance workers secured an extension ladder to the outside of the building to gain access to the roof. The co-worker held the ladder while the victim climbed to the roof and located the skylight that was to be cleaned. The skylight was four feet wide and eight feet long, and had a fiberglass cover. Using a push broom, the victim started sweeping the debris off the skylight. As he applied pressure to the broom handle to sweep off dried bird droppings, the broom handle broke. The victim lost his balance and fell through the skylight cover and opening. He hit a sprinkler pipe and then fell 17 feet to the floor below. The co-worker notified the maintenance supervisor, and then went to the aid of the victim. The co-worker transported the victim by private vehicle to the hospital, where he died from his injuries eight days later.

EXHIBIT 2. The skylight involved in the incident.

Discussion: In this incident, the employer did not recognize the fall hazard for employees cleaning a skylight. Skylight cleaning safety procedures should include a site-specific safety plan (hazard analysis) that would identify employer expectations, safe work practices, and engineering safety devices and/or personal protective equipment required for the job. If a skylight or its cover is not designed to withstand at least 400 pounds/square foot, or twice the weight of the employee and his work gear, the employee must be protected from falling through the skylight. In this case, there should have been a screen, guardrails, or personal fall protection system in place. Job

sites should be evaluated by a competent person to identify safety equipment and work practices that will be utilized to accomplish the work. Any safety issues or concerns, or potential hazards, should be identified before beginning work and become part of the site work plan. In this particular case, the use of any one of the devices or methods listed above would have prevented this incident.
