**SUBJECT:** A Maintenance Supervisor Dies When He Falls off a Ladder into a Hot Water Tank.

**SUMMARY**  
**California FACE Report #07CA005**

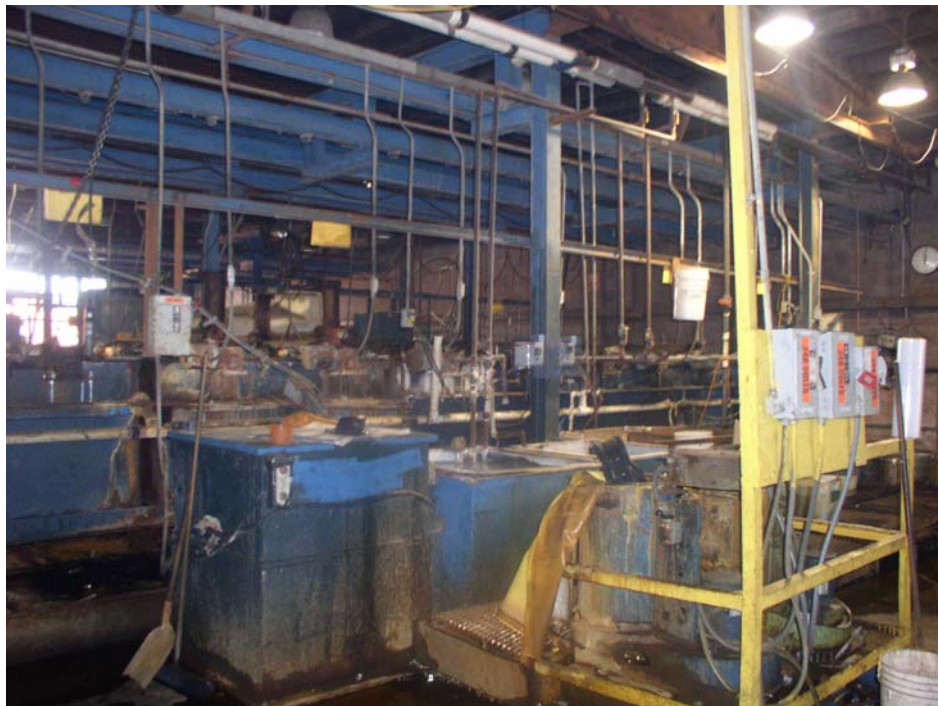
**Exhibit 1. The shop where the incident took place.**

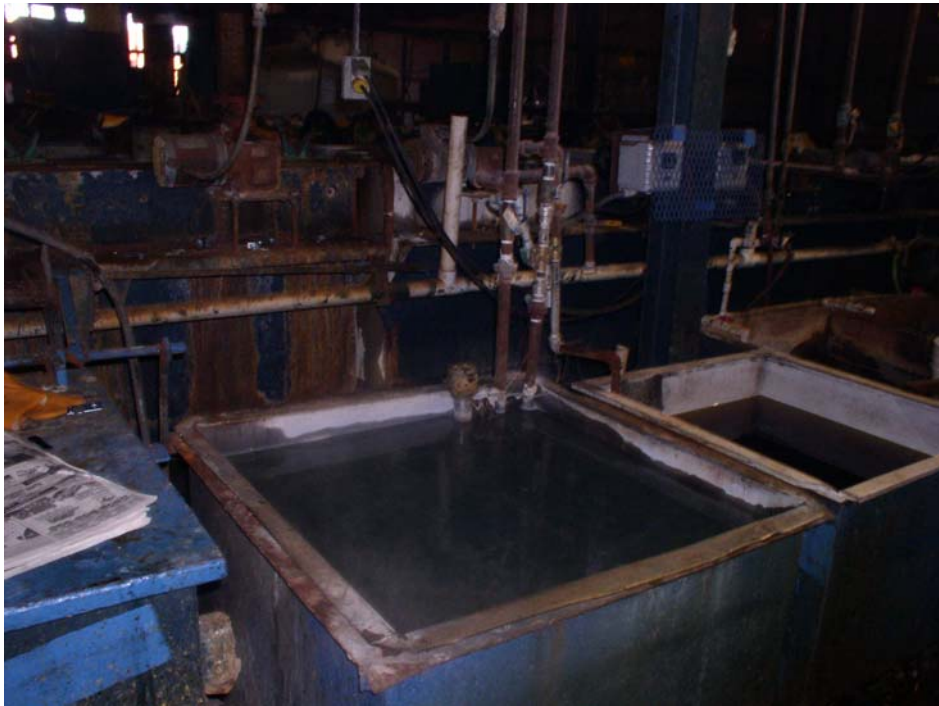
The site of the incident was the tank area of a metal finishing company. The hot water tank the victim fell into was three feet deep with a water temperature of approximately 160 degrees Fahrenheit. The tank was used for rinsing off parts that had been dipped in other chemical or acid tanks, and was not covered. On the day of the incident, the victim was responding to a service call involving a possible electrical short circuit in a dryer. With the help of an apprentice worker, the victim secured an extension ladder adjacent to the hot water tank in order to gain access to the conduit located above him. The victim used a 20-foot extension ladder with a 250-pound capacity that was manufactured in 2006. The victim ascended the ladder to the eighth or ninth rung and reached beyond the rails of the ladder to remove the cover plate on the conduit. He was about to check the wires with an electrical tester when he told the apprentice to go to the supply room for a part. It is not known if the victim slipped or received an electrical shock that may have precipitated his fall into the hot water tank. Other employees witnessed the victim exiting the tank by himself after approximately 10 seconds.

**Exhibit 2. The tank filled with hot water.**

Discussion: The tank involved in this incident was not covered to prevent objects or individuals from falling into it. When employees are required to work directly above open tanks, employers should ensure that the top of the tank is covered with a grating or grille with openings no larger than two inches and of sufficient strength to hold the weight of anything that may fall on it.

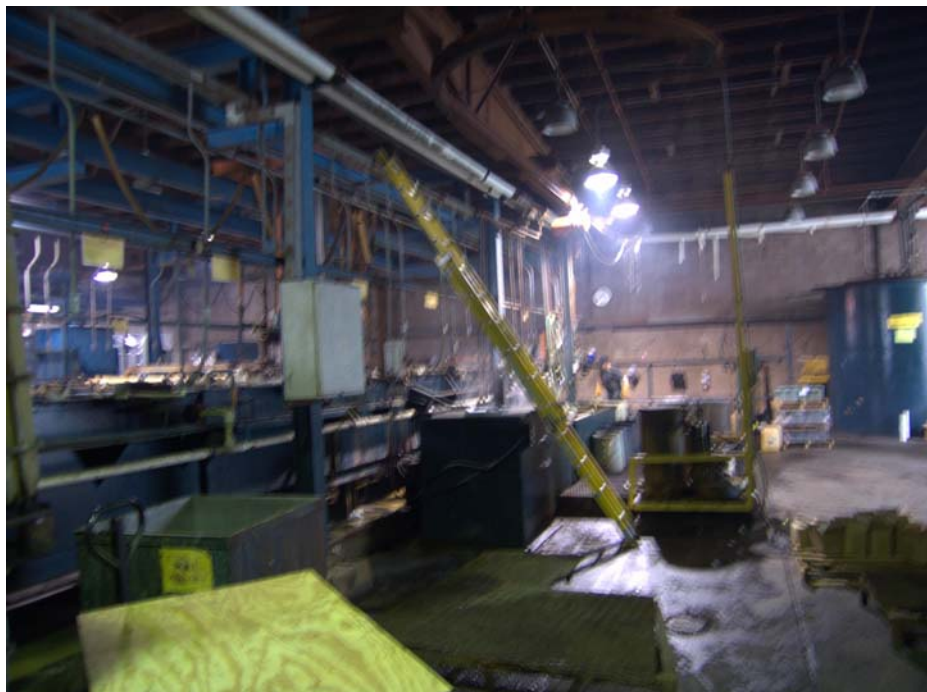
Discussion: The use of a ladder limited the work area of the victim to an arm's length on each side of the ladder. In order to reach the conduit, the victim needed to maintain his balance while holding the ladder with one hand. Although the fall was not witnessed, it is likely the victim lost his balance by attempting to exceed a safe reach. The use of mobile scaffolding or another type of work platform such as a scissor lift would have provided a stable work surface and enabled the repairs to be completed safely.

**Exhibit 3. The incident scene with the ladder in place.**

Discussion: The worksite should be evaluated for potential hazards prior to beginning any job or work task. Such an evaluation would have shown that a ladder was not the appropriate choice for the job. The electrical repair was located above the tank such that the use of a ladder required reaching beyond a safe distance.

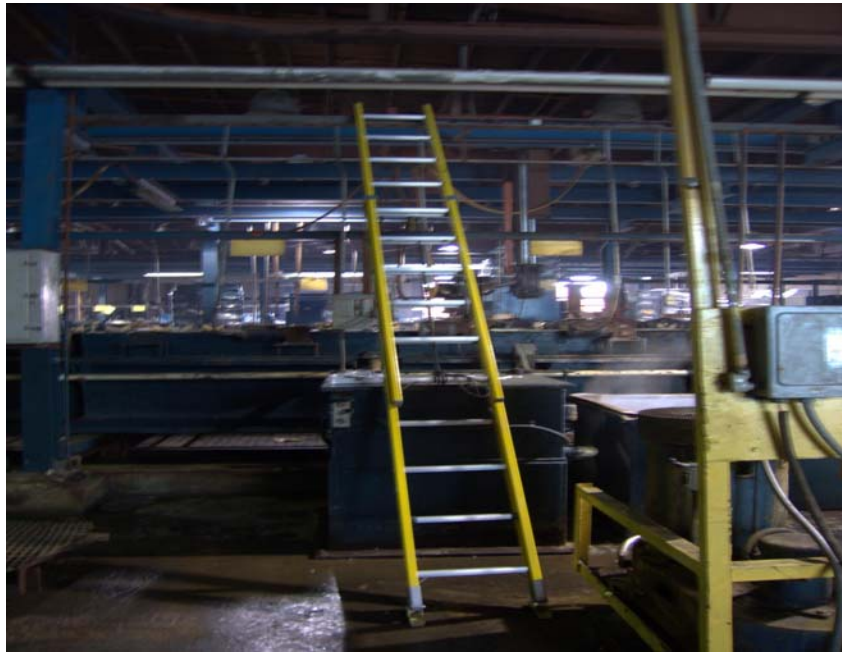
**Exhibit 4. Alternate view of the ladder secured in place.**
