# MIFACE INVESTIGATION REPORT: #06MI135

## SUBJECT: Unrestrained Custom Spray Applicator Died When Ejected From a Self-Propelled Sprayer After Sprayer Struck an Oncoming Semi-Truck Trailer

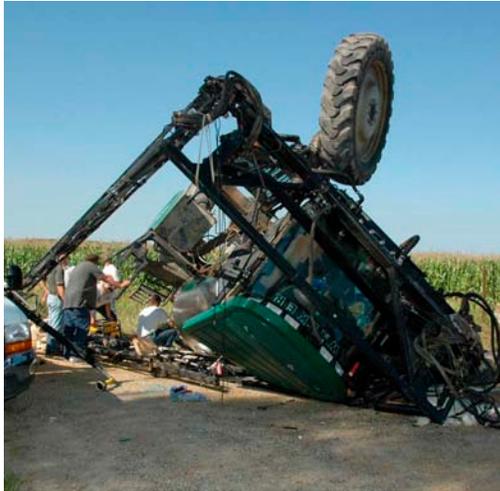
Figure 1. Overturned Sprayer

The decedent did not stop at the intersection corner and proceeded to enter the intersection and struck the driver's side of the semi trailer. The sprayer was dragged southbound for several yards, then rolled, and slid to a stop. The decedent was ejected to the southeast and came to rest in a drainage ditch along the east edge of the roadway. The semi came to a controlled stop to the south of the intersection. The police noted that there was no pre-impact braking from either vehicle. Emergency response was called and the decedent was transported to a local hospital where he died

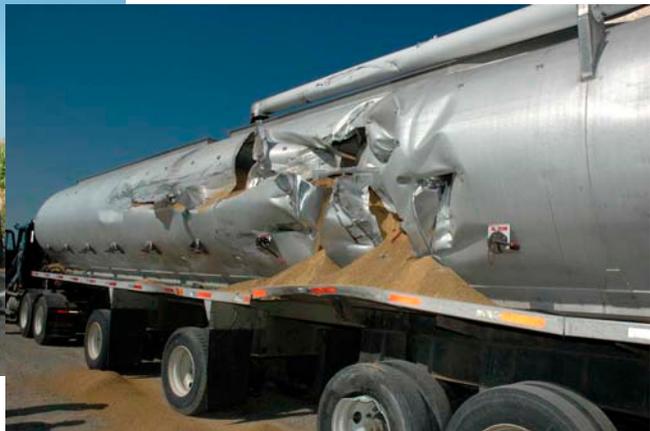
Figure 2. Trailer struck by sprayer

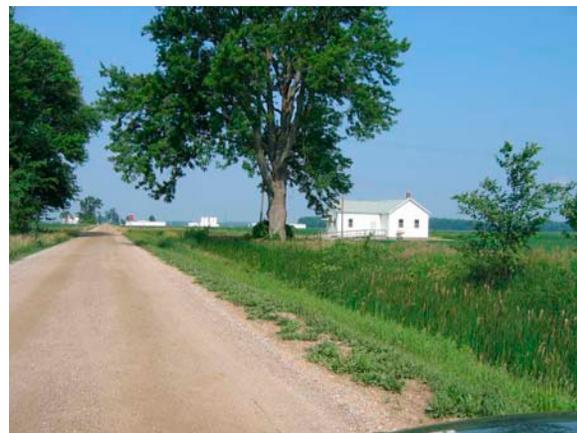
Figure 3. Visibility westbound on road as approaching intersection

The incident occurred at the intersection of two 2-lane gravel roads with un-posted speed limits of 55 mph (Figures 3 and 4). The day was clear and the road conditions were dry. Crop fields and ditches bordered both roads. At the northeast corner of the intersection was a building that the police report indicated did not contribute as an obstruction at the intersection.

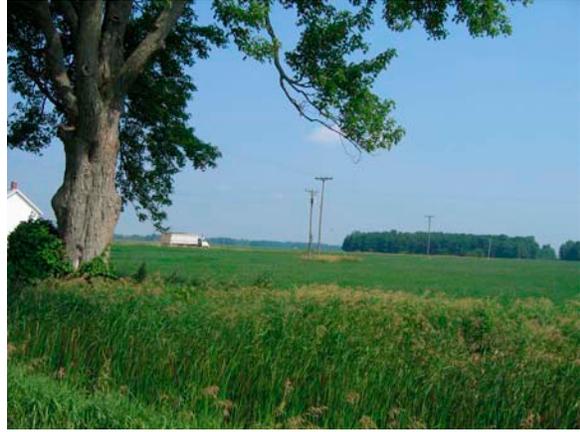
Figure 4. View of north/south road as approaching intersection traveling westbound.

The incident occurred at 9:00 a.m. A semi tractor-trailer, which was hauling grain, was traveling southbound. The semi tractor-trailer had the right of way. The north-south road

did not have a stop sign regulating traffic at the intersection. The decedent was traveling westbound and had a stop sign at the intersection.

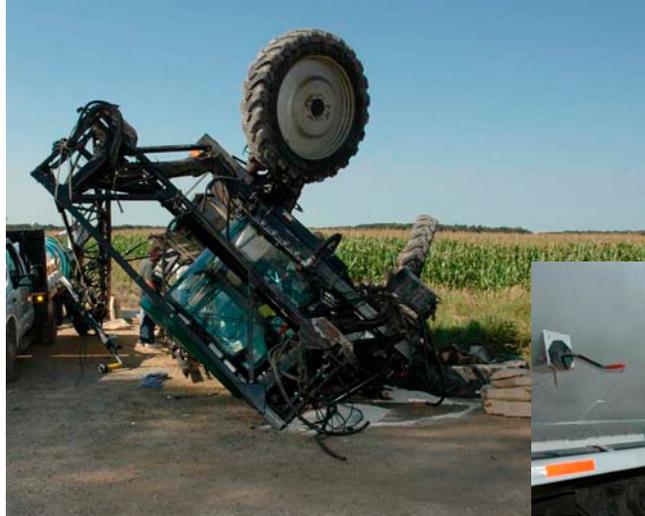
Figure 5. View of overturned sprayer

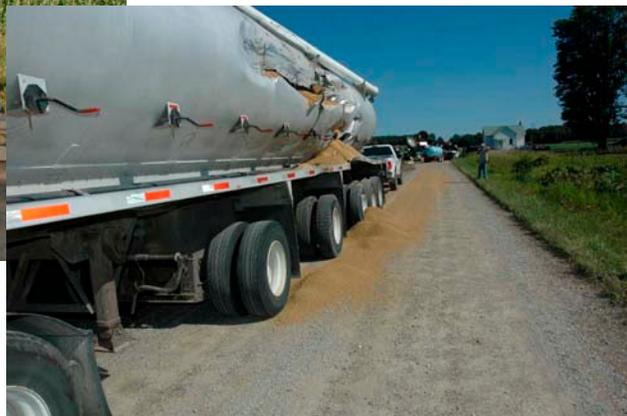
Figure 6. Trailer struck by sprayer and path of spilled grain

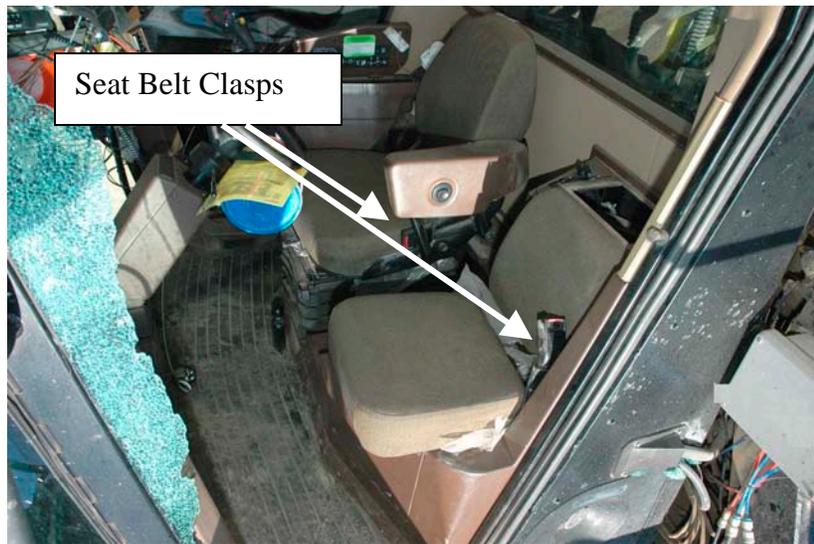
Figure 7. Sprayer interior showing seat belt clasps for each front seat passenger.

- Employers should require employees to wear seat belts or seatbelt/shoulder harness restraints when the equipment is equipped with these personal restraint systems.

When an implement of husbandry such as a sprayer is driven on public roads, the Michigan Motor Vehicle Code Rule 257.717(2) requires that a person operating an implement of husbandry follow all traffic regulations. Rule 257.710e(3) of the Michigan Motor Vehicle Code requires that each driver and front seat passenger of

a motor vehicle operated on a street or highway in this state shall wear a properly adjusted and fastened safety belt when the equipment is so equipped.

Many pieces of equipment used at a cooperative, such as forklifts, front-end loaders, and sprayers are equipped with either a seat belt or a seatbelt/shoulder harness safety restraint system. Employers should require, regardless of on-road or off-road use, that employees use the safety restraint system supplied by the equipment manufacturer at all times while operating the equipment. Employers should ensure such restraints are in place and in good working condition.
