SUBJECT: A boat repairman dies from burns received from a fire caused by an exploding battery.

SUMMARY
California FACE Report #07CA004

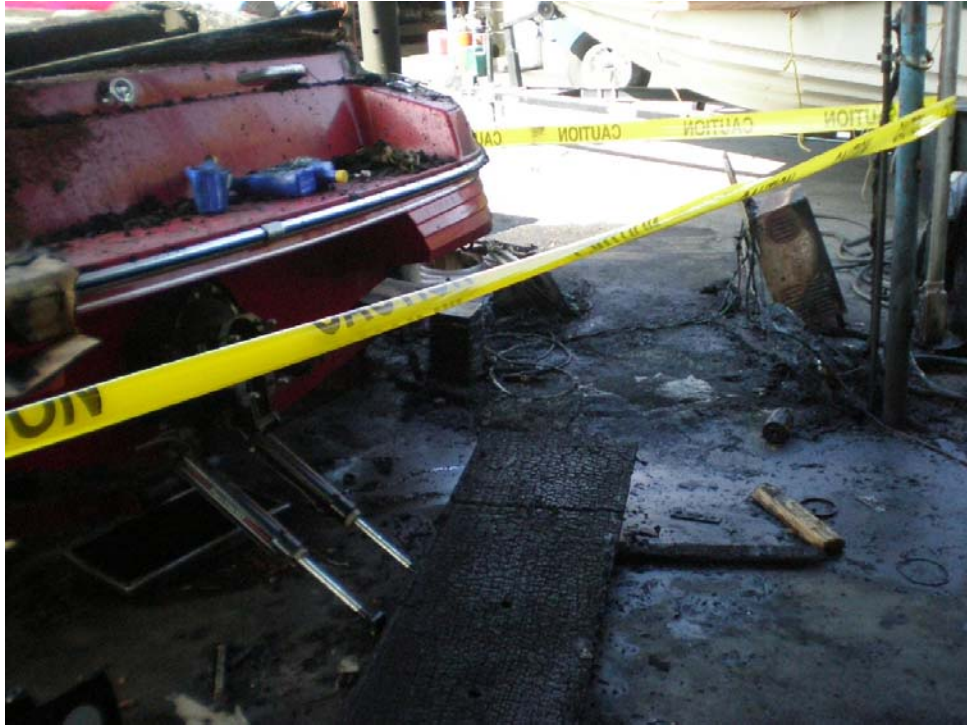
Exhibit 2. A picture of the area in the shop where the incident occurred.

Recommendation #1: Ensure employees follow documented battery charging guidelines.

Discussion: The charging of lead-acid batteries can be hazardous. However, many workers may not see it as hazardous since it is such a common activity in many workplaces. The two primary potential hazards are from hydrogen gas formed when the battery is being charged and the sulfuric acid in the battery fluid. Batteries contain sulfuric acid, which is poisonous, corrosive, and causes burns/irritation on contact with the skin or eyes. Short circuits can cause extensive arcing, burning and melting of metal objects, and explosion of any charging gases. Electric shocks can also be received both from the batteries and from the charging equipment. There is a risk of fire and/or explosion if flammable mixtures of hydrogen with air accumulate. The following safe working practices for charging batteries are designed to prevent similar incidents from occurring:

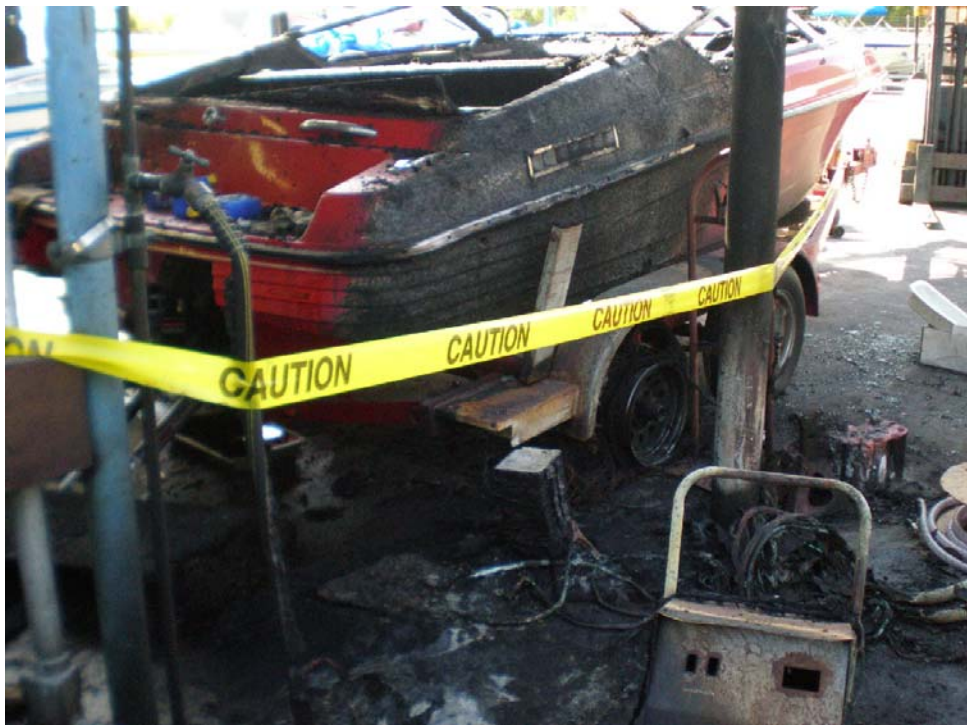
Exhibit 3. A picture of the boat that caught on fire.

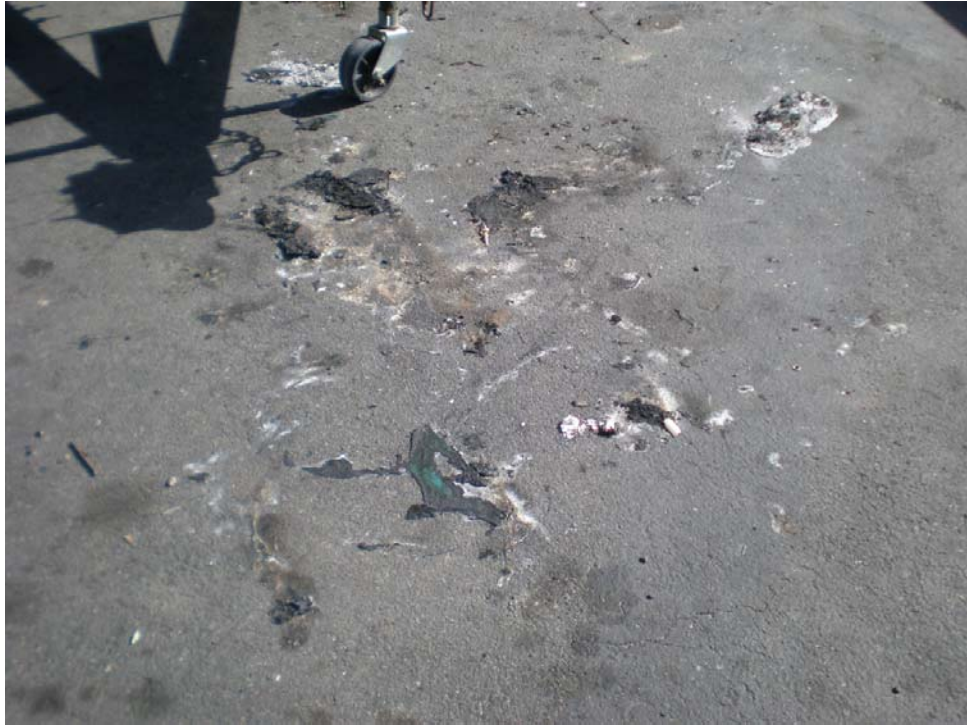
Exhibit 4. A picture of the remains of the clothes the victim was wearing.

Recommendation #2: Ensure employees clothing and safety apparel is appropriate for the work being done.

Discussion: Most man-made fabrics, such as nylon, acrylic, or polyester, will melt when ignited and produce a hot, sticky, melted substance causing extremely severe burns. When exposed to extreme heat and flames, clothing containing some synthetic materials like polyester will melt and can fuse to the skin. This essentially creates a second skin and can lead to horrific, disfiguring burns. The clothing worn by the victim was made of a polyester material and therefore was inappropriate for the work being performed. Clothing should be of such design, fit, and durability as to provide adequate protection against the hazards for which they are designed. They should be reasonably comfortable and not unduly encumber the employee's movements. The protection worn by employees when handling or charging batteries should also include safety apparel, such as a face mask, goggles, apron, and gloves. Had the victim been wearing proper clothing and safety apparel for the work being performed, the incident might not have been prevented, but his injuries may not have been fatal.

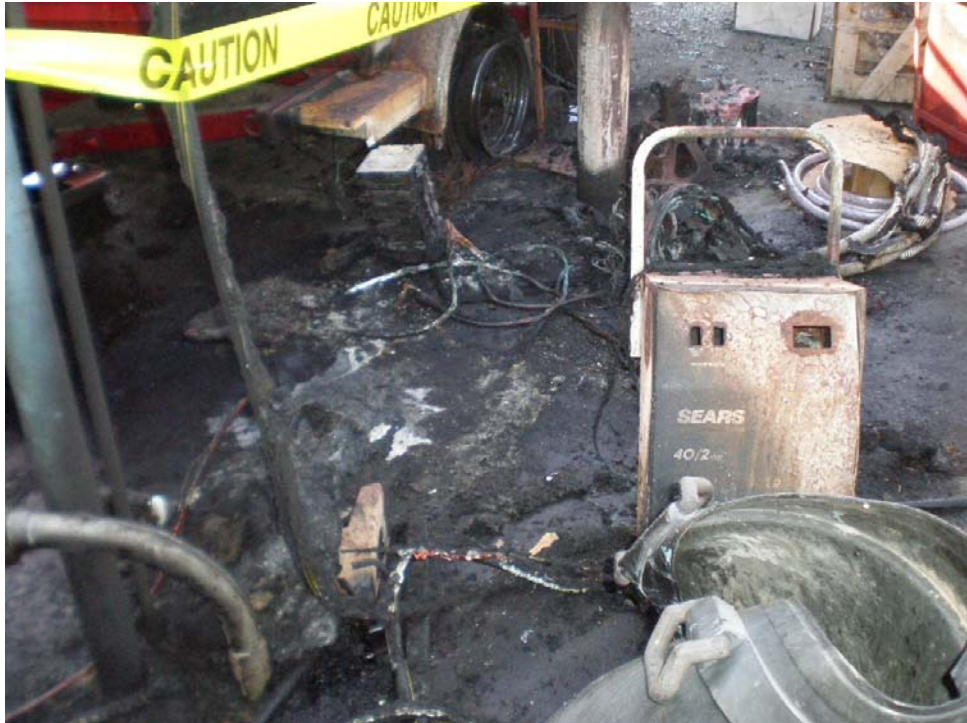
Exhibit 5. A picture of the battery charger involved in the incident.

- Always switch off the battery charger before connecting or disconnecting any battery.

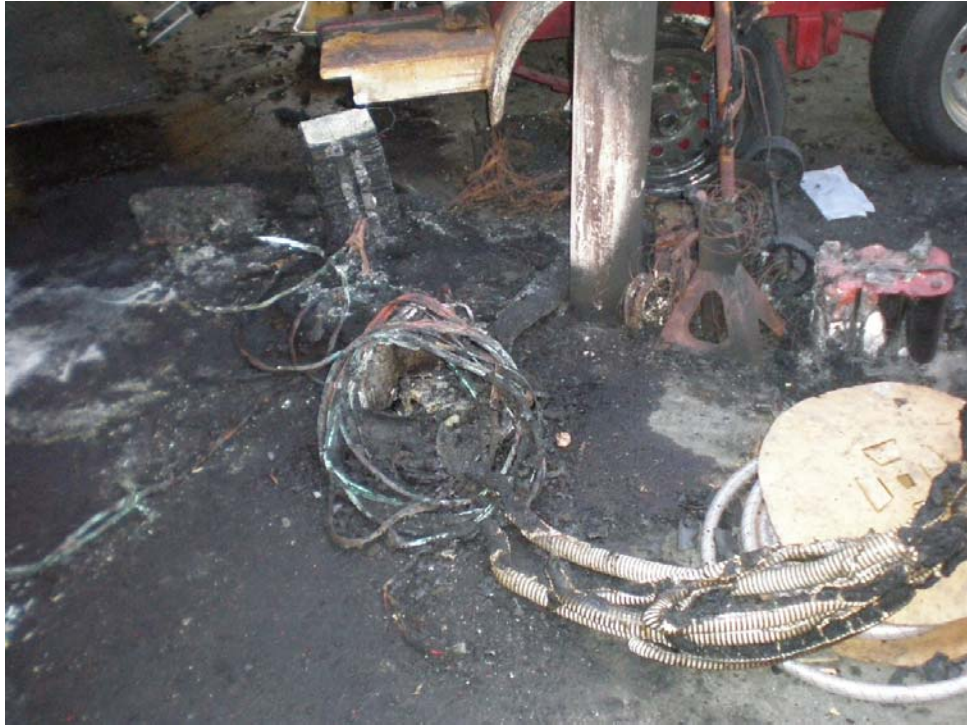
Exhibit 6. A picture of the battery that blew up.

- Designate the charging area 'No Smoking.'
- Before connecting charger, always add water to each cell until battery acid covers plates to help purge extra gas from cells. Do not overfill.

- Charge battery with caps in place. Most U.S. batteries are made with flame arresting caps. Do not pry caps off sealed batteries.
