MIFACE INVESTIGATION #07MI007

Subject: Carpenter Dies After Fall From a Ladder That Slipped From Its Base While Positioned on Frozen Sand

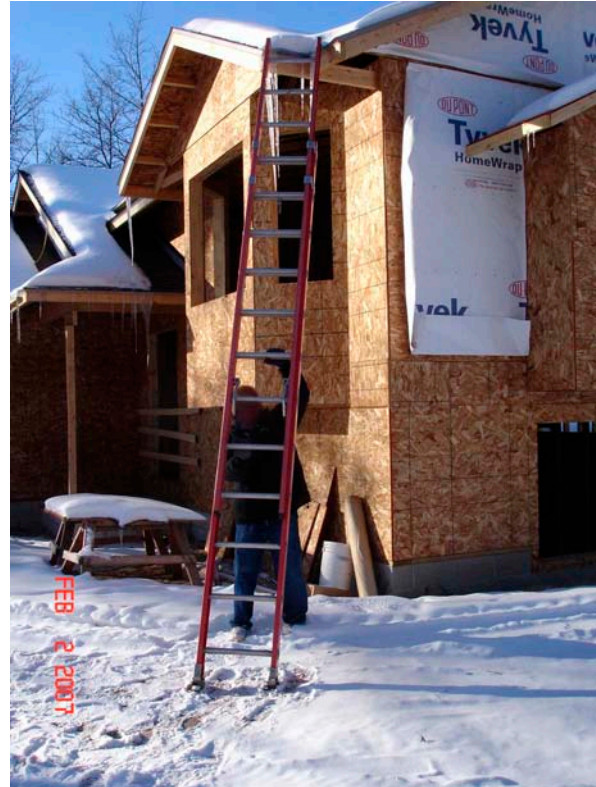
Figure 1. Re-enactment of ladder placement and position of individual holding the ladder

Work Practice	Discussion
Ladder placement against the house may not have been the appropriate pitch.	A portable ladder's safest pitch is when the horizontal projected distance from the top support to the base is not more than 1/4 of the vertical distance between these points. The more the base is moved from this position, the greater the risk that it will slip outwards and fall.
Ladder was diagonally placed against inside corner of the roof.	The ladder's stability was most likely compromised when the side rails were placed on a diagonal against the inside corner of the roof to protect the drip edge.
Ladder placed on potentially unstable base material (frozen sand).	Although the sand was frozen, it may not have provided a substantial and stable base as required. The safety feet may not have been dug deep enough and may have been anchored into loose sand on the frozen sand surface. One method to ensure the ladder's safety feet were embedded deeply enough in the sand would have been to use a claw hammer to dig two to three inches deep into the surface and then place the safety feet into the hole.

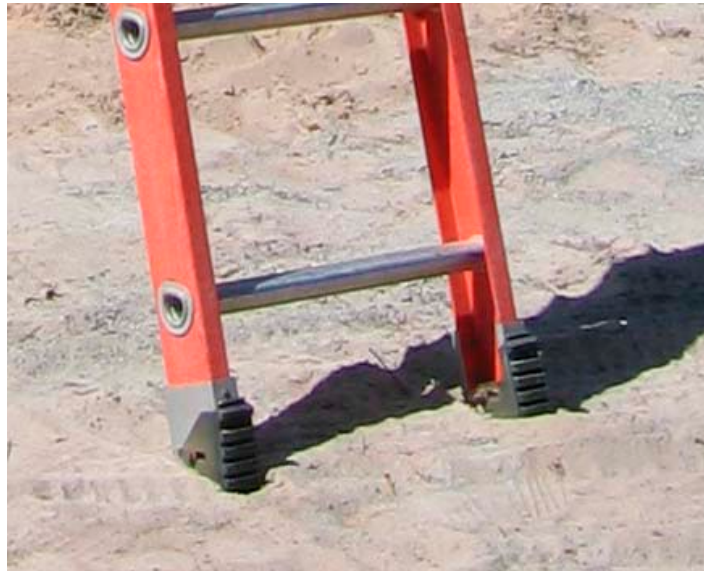
Figure 2. Ladder safety feet in the up position

contribute to the fall. The top of the ladder was almost flush with the roof height. The base material was sand, frozen to a depth of approximately four inches. The pitch of the ladder is unknown. The coworker stated to the MIFACE researcher that the ladder's safety feet were in the up position and "dug into" the frozen sand (Figure 2). Figure 1 and Figure 3 were taken at the time of the MIOSHA compliance officer's site inspection and are re-enactments of the ladder position and the position of the coworker under the ladder. The sand was not snow-covered at the time of the incident. Figure 2 shows the sand base and the safety feet in the up position. The coworker also re-enacted the incident scenario for the MIFACE researcher, placing the ladder safety feet in the up position and at a similar pitch as in Figure 1 and Figure 4.

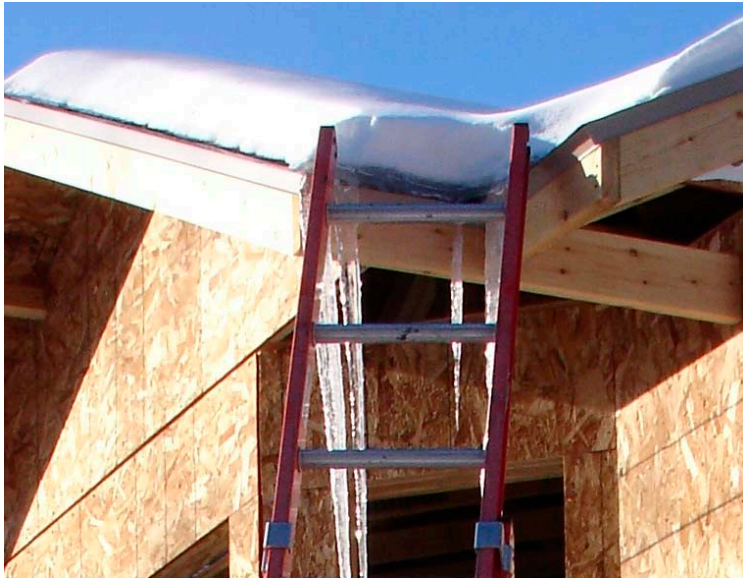
While his coworker was changing the knife blade on his utility knife to a hook blade so he could cut shingles for the ridge cap, the decedent set the Type IA fiberglass extension ladder diagonally across the inside corner of the roof to secure a 2-inch by 4-inch piece of wood to the fascia under the drip edge to protect the drip edge (Figure 3). In this incident, the ladder was clean and free of defects that might

Figure 3. Ladder placed diagonally across inside corner

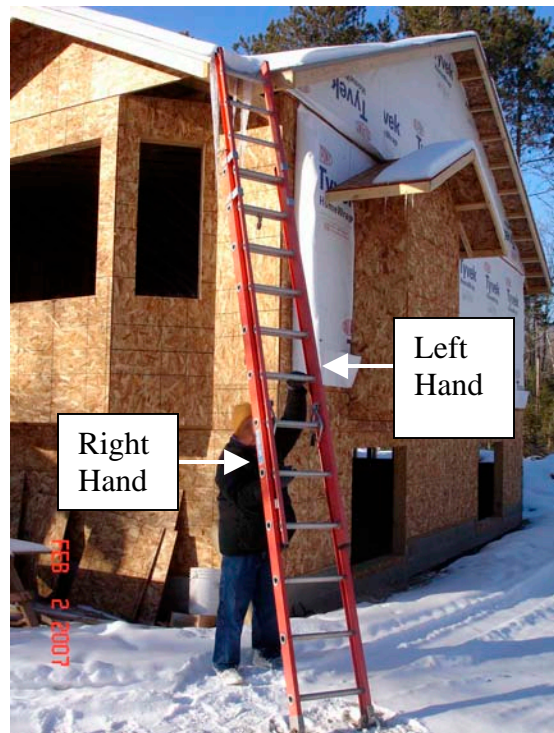
Figure 3. Re-enactment of the position of the coworker under ladder

been done in the past, the coworker stood under the ladder with his back facing the house and placed his left hand on the rung #7 and his right hand on rung #5 (Figure 4). The decedent, who was wearing his tool belt and carrying the 2-inch by 4-inch piece of wood, ascended the ladder. As the decedent climbed passed his coworker, the coworker turned his head so he would not get sand from the decedent's shoes in his face. The decedent was above the coworker when the coworker felt a "pressure on his hands." As the decedent passed him, the coworker sensed the decedent's weight on the ladder and called out to the decedent that it was too heavy for him. As he called out to the decedent, the ladder base kicked out away from the home and the coworker lost his grip. As the ladder fell, it struck the coworker on his left shoulder and arm and knocked him to the ground. The decedent, perhaps to avoid landing on his coworker, jumped/fell in the opposite direction landing on his back approximately seven feet from the ladder. The wood the decedent was carrying landed near the home. The ladder's final resting spot was several feet from the home.

Ladder not lashed or held in position.	Ladders should be lashed/secured by attaching ropes or straps to the ladder side rails, not the rungs, onto a stable, fixed object. The base of the ladder could be secured by securing ropes/straps from the ladder side rails to stakes in the ground, using fixed blocks or sandbags, or using ladder stabilizers.
Ladder not extended three feet past the roofline.	Because the extension ladder length was long enough, the ladder side rails should have been at least three feet or more above the roofline.
Individual supporting the ladder standing under the ladder.	The position of the coworker made it difficult to control ladder movement. A better position for an individual to provide ladder support would be to stand in front of the ladder, hold both side rails, and place one foot on the bottom rung of the ladder.
