Worker Killed When Crushed By Multiple Granite Slabs - Massachusetts

Investigation: # 05-MA-059-01

Release Date: September 27, 2006

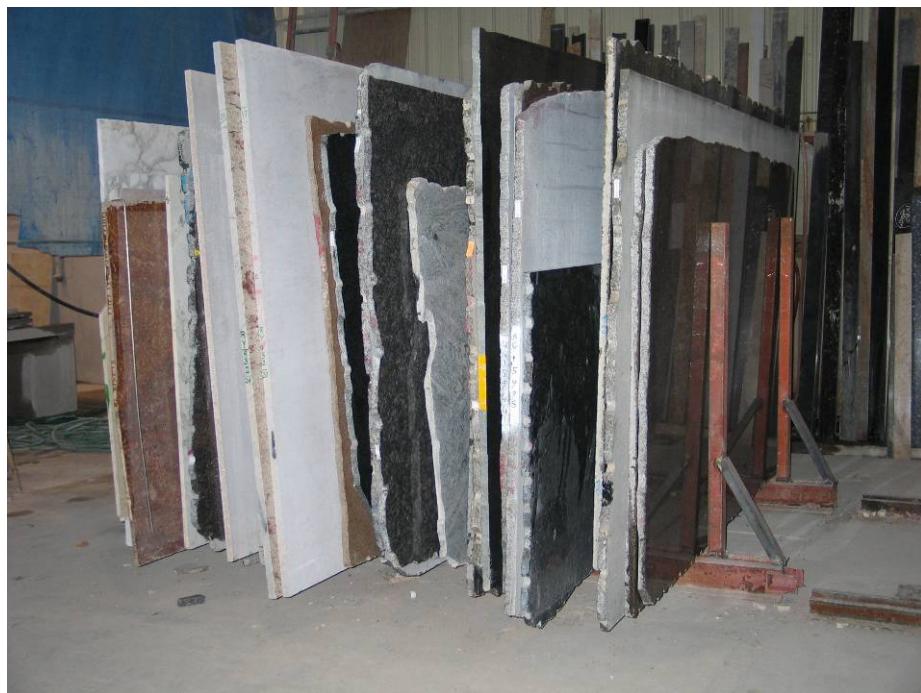
Slab racks are designed to store material in slab form. The slab rack involved in this incident was a metal vertical rack with multiple sections separated by support pins (Figures 1 and 2). The manufacturer of the slab rack could not be determined during the investigation. At the time of the incident, the slab rack was loaded with stone slabs. The first section contained five stone slabs, including the granite slab being retrieved (granite slab 2), which was the second slab in from the end support pins. Measuring approximately six feet high, ten feet long, and one and one quarter inches thick, granite slab 2 was shorter than the stone slabs stored on either side. Granite slab 2 weighed approximately 1,000 pounds.

**Figure 1 – Slab rack involved in the incident
(end support pins had been welded to the rack by the company)**

An office worker placed a call for Emergency Medical Services (EMS) after being told about the injured employees. EMS arrived within minutes of the call and transported the unconscious victim to a local hospital where he was pronounced dead. EMS also transported the injured saw operator to a hospital for non-life threatening injuries. At the time of the site visit, the company had welded the slab rack's support pins so they could not be removed.

Recommendation #1: Employers should use slab racks designed with fixed support pins and individual compartments for each slab.

Discussion: The hazards involved in this fatal incident, which could have been prevented, underscore the need to use slab racks designed with fixed support pins and individual compartments for each stone slab. In this case, the use of slab racks with individual compartments for each stone slab would have allowed sufficient space to attach the gantry crane clamp on to the granite slab without having to move the surrounding stone slabs. Using racks with fixed support pins would have eliminated the crushing hazard associated with this incident by ensuring that support pins are kept in place, preventing the stone slabs from tipping over.

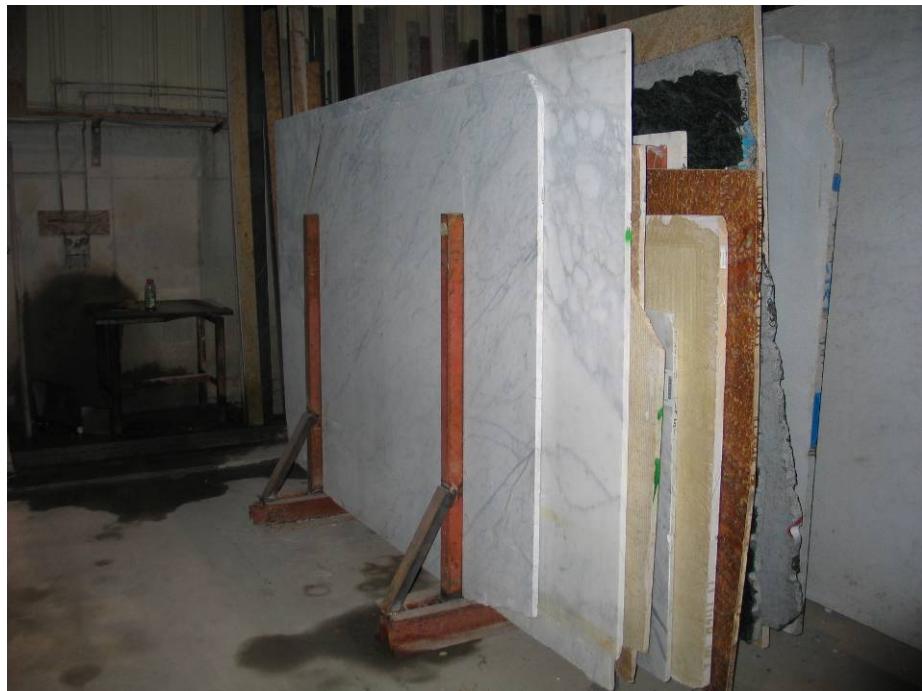
At the time of the incident, granite slab 2 was being retrieved to be fabricated into a countertop. The retrieval of granite slab 2 was problematic because the crane's clamp could not be attached to the slab due to it being shorter than the stone slabs stored on either side of it. To create space for the crane's clamp to attach to granite slab 2, the other stone slabs in the first section of the slab rack had to be tilted away from granite slab 2. Because granite slab 2 was stored with four other stone slabs in the first section of the slab rack there was not enough room inside this section of the slab rack to tilt any of the stone slabs. To enable the first stone slab to tilt away from granite slab 2, the victim positioned himself with his back up against the middle of the first stone slab. The victim then pulled out one of the two end slab rack support pins. The saw operator positioned himself at the edge of the first stone slab and pulled out the remaining support pin. The victim and the saw operator then tilted the first stone slab towards themselves resting the slab against the victim's back as a second coworker went to retrieve the overhead gantry crane to attach the clamp onto granite slab 2.

While the slab rack support pins were removed, the other four stone slabs, including granite slab 2, started tilting towards the victim and saw operator. The saw operator attempted to stop the

four slabs from tilting but was unsuccessful. The victim and the saw operator could not support the weight of the stone slabs, estimated to be 5,700 pounds. All five stone slabs fell, crushing the victim against a stone table and striking the saw operator.

Figure 2 – At time of the incident the end support pins were removed.

Discussion: At the time of this incident, the end support pins of the slab rack were removed allowing the stone slabs to fall over. Manufacturers of slab racks should evaluate and consider supplying only slab racks designed with fixed support pins. A fixed support pin design would eliminate the hazards associated with removable support pins, such as the creation of a space large enough for stone slabs to tip and fall. In addition, manufacturers should ensure that slab racks are designed to withstand the loads and forces imposed on them from the placing, storing, and retrieving slab materials.
