**SUBJECT:** A machine operator died when caught in the threads being wound onto the take-up spool of a warping machine

**SUMMARY**  
**California FACE Report # 06CA006**

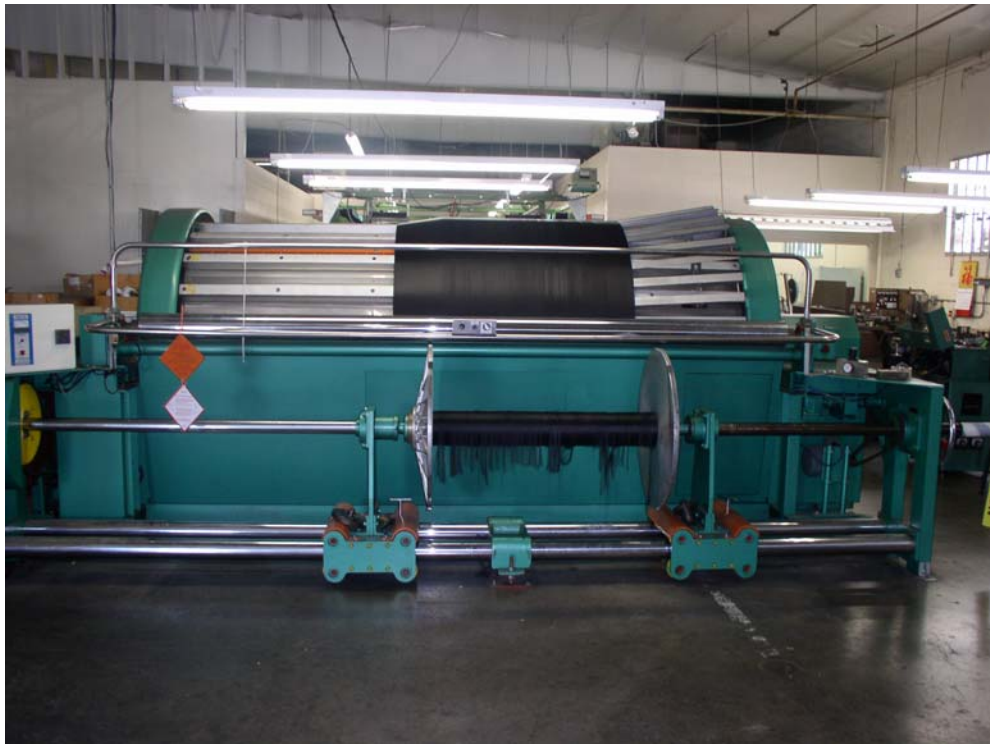
The site of the incident was a manufacturing facility that produced woven cloth labels for clothing. The machine involved in the incident was called a warper. The warper was not used on a continual basis, but was operated approximately six to eight times a month, depending on the need. The warper machine draws nylon thread from 600 spools of thread mounted on a rack called a "creed" behind the machine. The threads are wound around a large drum using various speeds and tension, and then cut into sections. The ends of those threads are then fed onto a smaller removable spool mounted on the front of the machine. When the smaller removable spool was full, it was replaced with an empty spool. The operator's job was to control the speed and tension on the threads being wrapped around the spool and to replace the spool when full.

**Exhibit 1. A picture of the machine involved in the incident.**

**Recommendation #1: Ensure employee safety by installing guards around the moving parts and pinch points of the machine to protect employees from accidental contact.**

Discussion: In this particular case, the victim was seen reaching into the machine while the spool of thread was spinning at a high rate of speed. Because of the ever-present danger of entanglement when working near moving machinery parts, employers should continually strive to protect employees by providing machine guarding in the areas where work is actually performed upon the material being processed. Swivel double-bar gates would be one method of providing this protection. Employers should contact machine manufacturers and, if applicable, retrofit the machine with guards which will prevent any part of the body from contacting the machines moving parts. Electronic sensors can also be used to protect employees from moving parts and pinch points, as they shut down the machine whenever the sensor beam is broken.

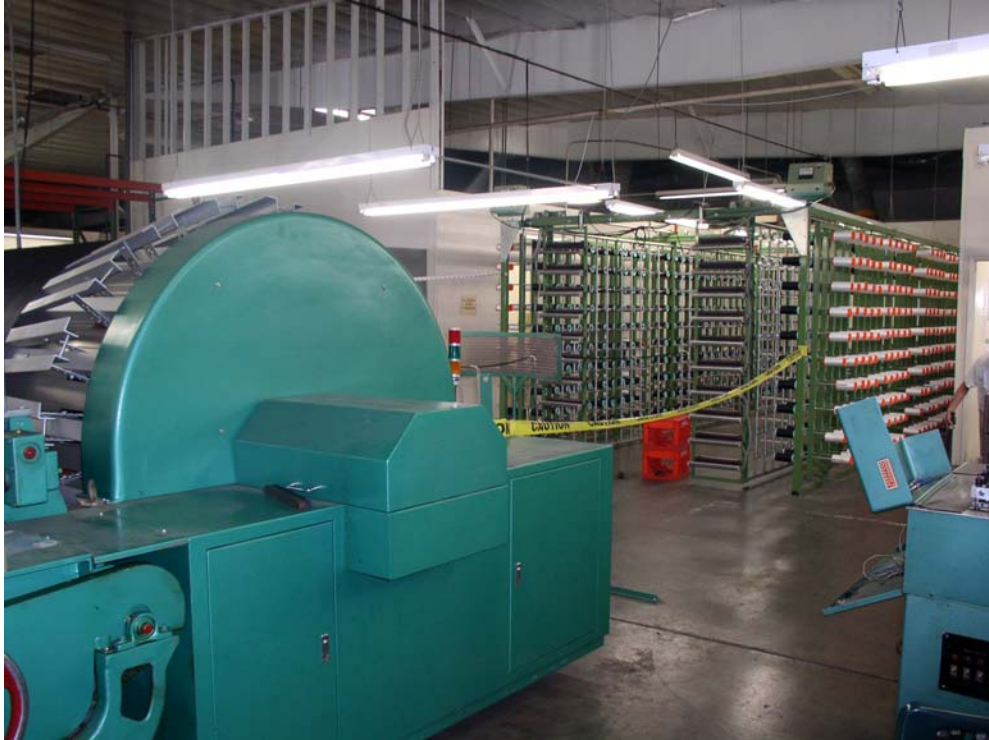
**Exhibit 2. A picture of the left side of the machine showing individual spools of thread on racks being fed into it.**

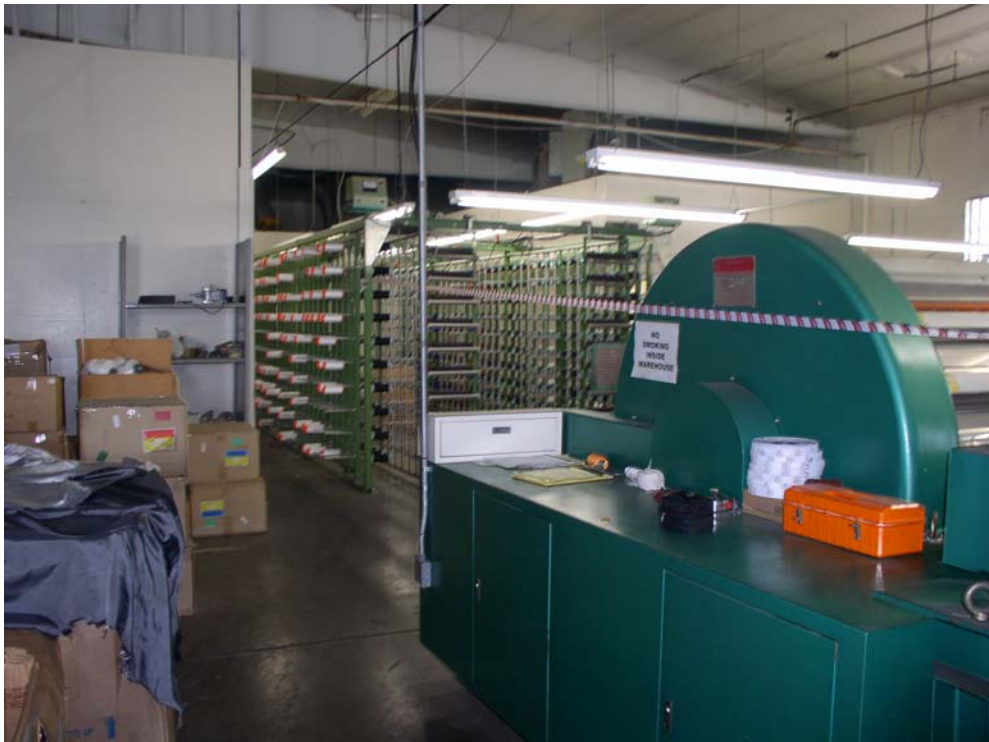
**Exhibit 3. A picture of the right side of the machine showing the individual spools of thread on racks that are being fed into it.**

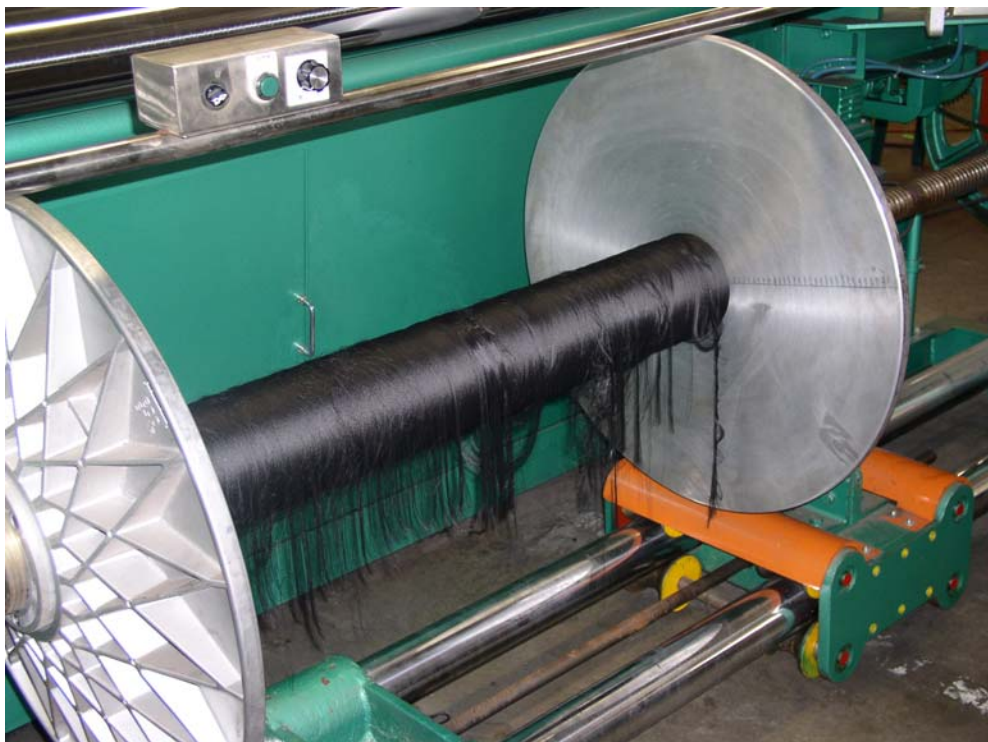
On the day of the incident, the victim was operating the warper machine, and a video surveillance camera in the shop showed that the victim placed his hands in the proximity of the spool while it was spinning. The victim hit the safety bar in front of the machine as he was being pulled into the spool. That action shut the machine down but not before the victim was wound tightly around the spool by the threads. The incident was not witnessed, and the time lapse before the victim was discovered was seven minutes. The company president discovered the victim and tried to rescue him by cutting the threads. The paramedics subsequently arrived and checked the victim for vital signs. They found no pulse or respiration and pronounced him dead.

**Exhibit 4. A picture of the spool of thread the victim was caught in.**

**Recommendation #5:** In addition, manufacturers should consider designing and installing an emergency brake system in conjunction with the emergency stop bar.

Discussion: In this particular case, when the victim was being pulled into the spool of thread, he hit the safety bar to shut the machine down. However, by the time the machine stopped rotating, the victim was wound tightly in the threads causing his death. A braking system activated by the use of the safety bar would have stopped all motion of the machine instantly, and might prevent future incidents such as this one from occurring.

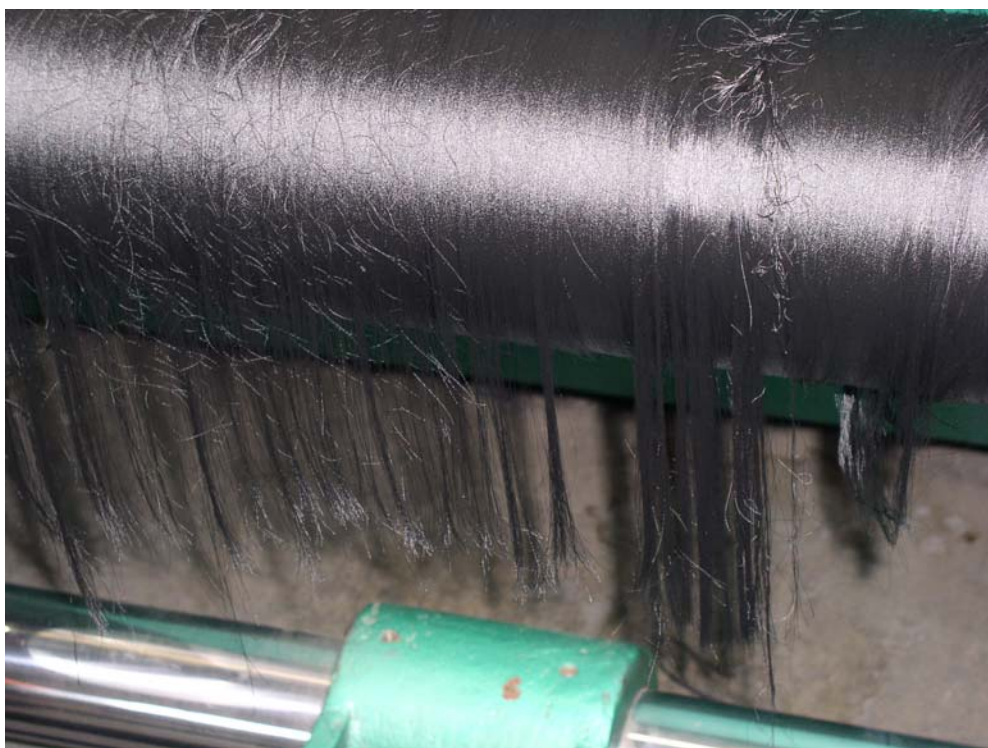
**Exhibit 5. A picture of the threads that were being wound on the spool the victim was caught in.**

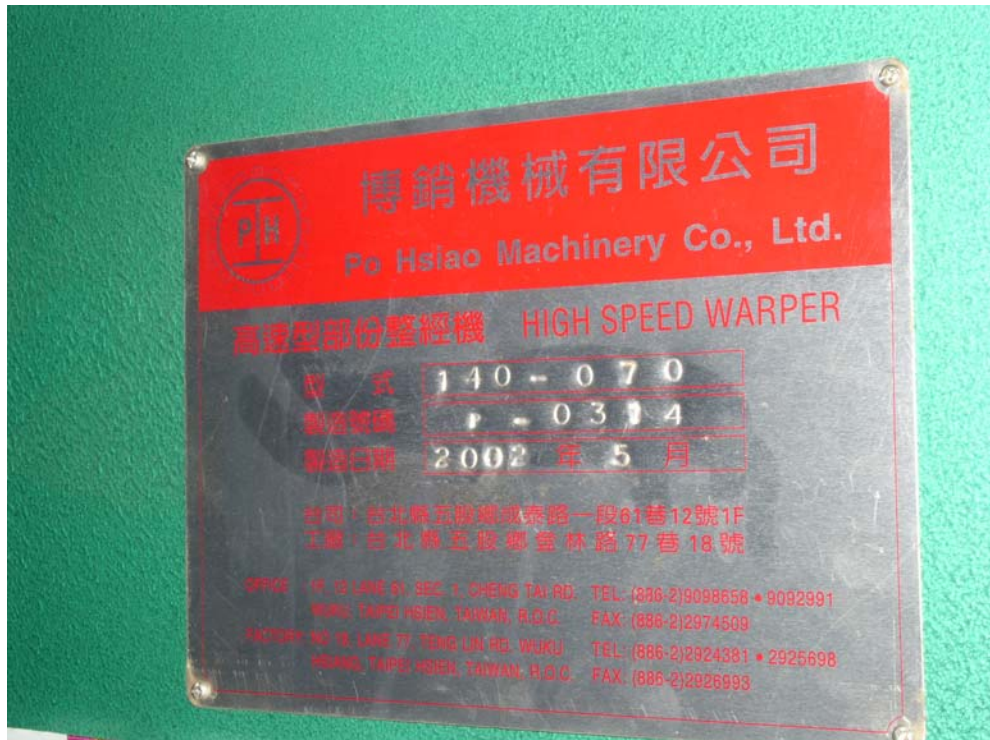
Exhibit 6. A picture of the name plate on the machine involved in the incident.
