MIFACE INVESTIGATION #06MI009

Subject: Machine Operator Dies After Being Struck by a Shredder Grate During Shredding Machine Maintenance

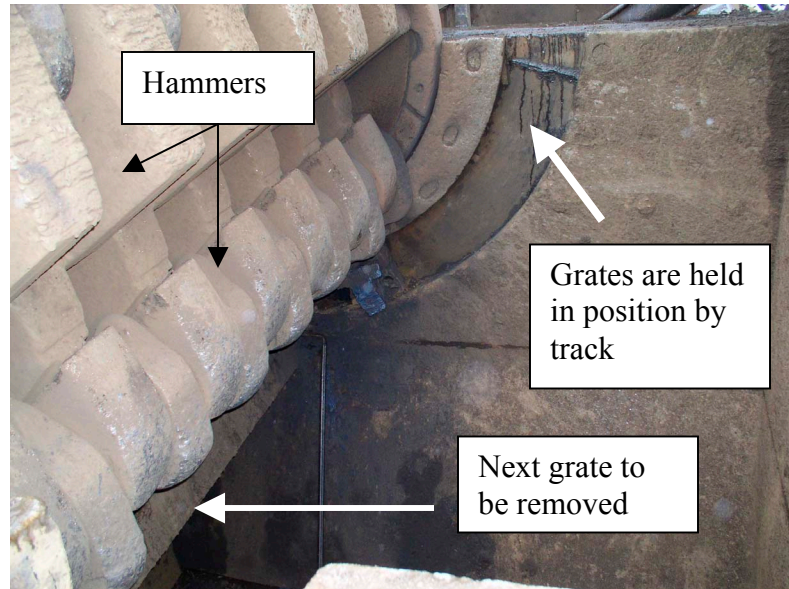
Figure 1. Grate and grate track in shredder box

and a mobile crane lifted the grate out of the machine via the grate track (Figure 1). The incident occurred during the removal of the sixth grate. The grate was located at a five o'clock position. The decedent had attached the chains to the grate and the hoisting process began. The grate became stuck in the grate track. To facilitate its removal, the decedent used a torch to partially cut through the grate while it was still under tension from the crane. The crane again attempted to lift the grate from the machine. Because the grate again did not move, the decedent cut through the grate end while the grate was still under tension. When the grate was cut through, the momentum of coming to center caused the grate to continue past center and strike the decedent in the side of his head. 911 was called and the decedent was transported to a local hospital where he died three days after the incident.

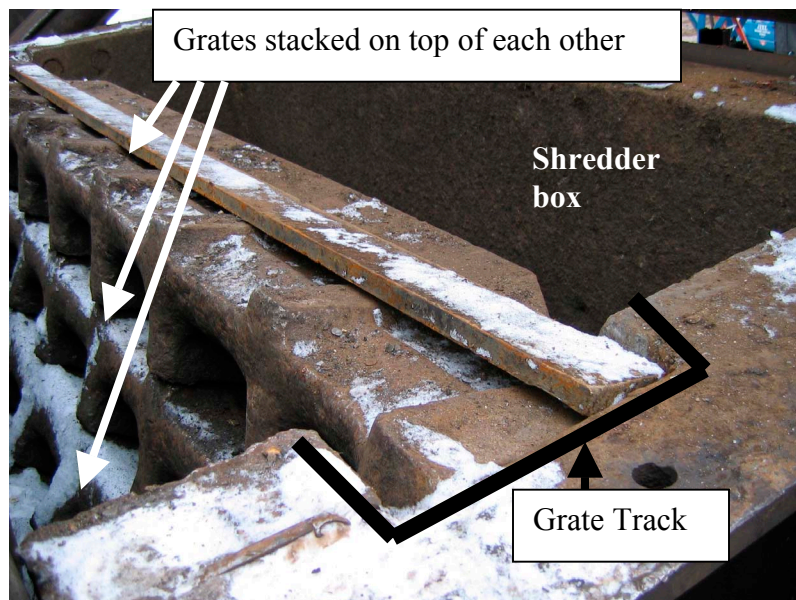
Figure 2. Grate position in track

shredder was loaded by a conveyor that dumped the metal into the hammering process in the shredder box where it was processed into pieces determined by the size of the grates. There were 13 grates in the shredder, each 112.5 inches long, 17.75 inches in height and 8.5 to 3.0 inches in width and weighing approximately 2,500 pounds. On each side of the shredder box was a track into which the grates were placed and stacked upon each other (Figures 1 and 2). The grates track down around the hammers from approximately a 3:00 position through a 9:00 position. There was a very small space between the edge of the grate and the wall of the track that holds the grates in position. This space was filled with

debris (dirt, metal shavings, etc) from the shredding operation. The debris in the track became compacted with time and the grates became “welded in” the track, which could make it difficult to remove them.

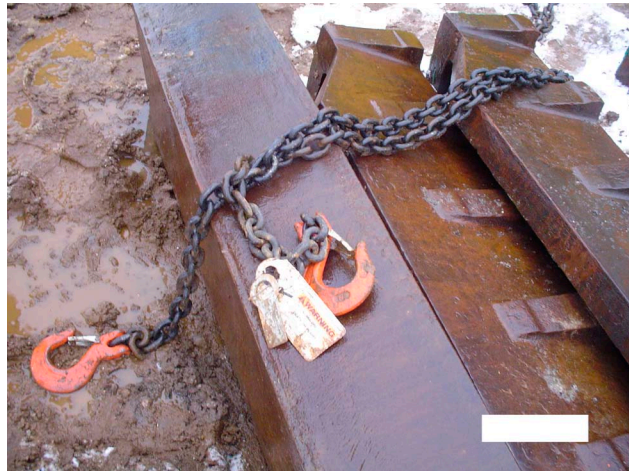
The chains and lifting configuration (D ring, steel alloy chains) are shown in Figures 3 and 4. The decedent was assigned to work in the shredder box. He accessed the shredder box via the box discharge conveyor. To remove a grate from the track, the decedent stood

Figure 3. Lifting chains

5. The chains must be 1/2", with all safety latches and hooks in good condition. Chains must be certified with serialized tag present.
6. When working above the mill deck and exposed to the open mill cavity, fall protection equipment must be used. This equipment will include a body harness, lanyard and anchor point.

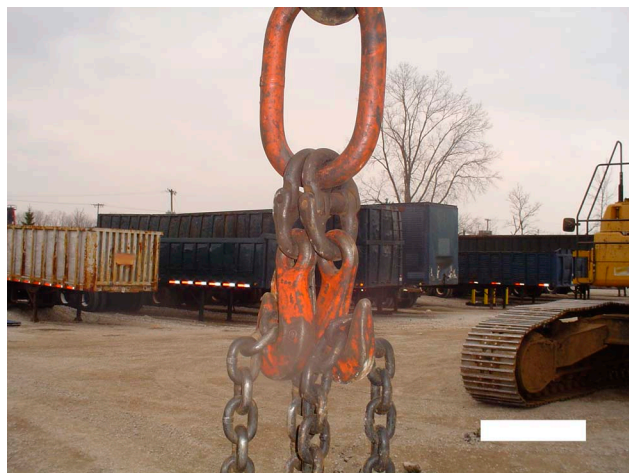
Figure 4. D Ring, chains, mobile crane

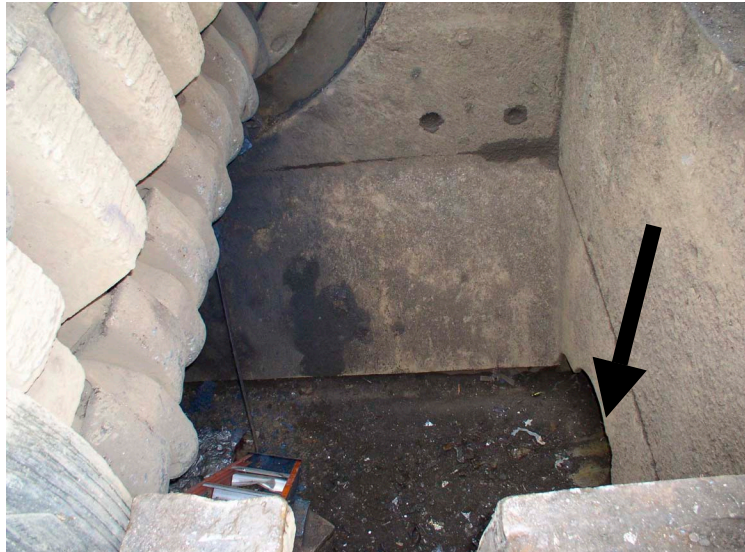
Figure 5. View into shredder box from platform outside of box showing access point from outside conveyor

To enter the shredder, the employee used a fixed ladder to access an outside platform and then climbed up the side of a belt conveyor that was approximately 41 inches tall from the platform. The employee then walked on the platform through rubber baffles that helped keep the debris from flying out of the shredder and then crawled on another conveyor (a shaker conveyor) to access the shredder box. According to the MIOSHA case file, at the time of the incident, the firm did not have this area identified as a confined space.
