## **Two 10<sup>th</sup> Grade Students Injured in Separate Incidents in the Same Mill/Carpentry Vocational School Shop - Massachusetts**

**Investigation: # 06-MA-1NF-01**

**Release Date: July 9, 2007**

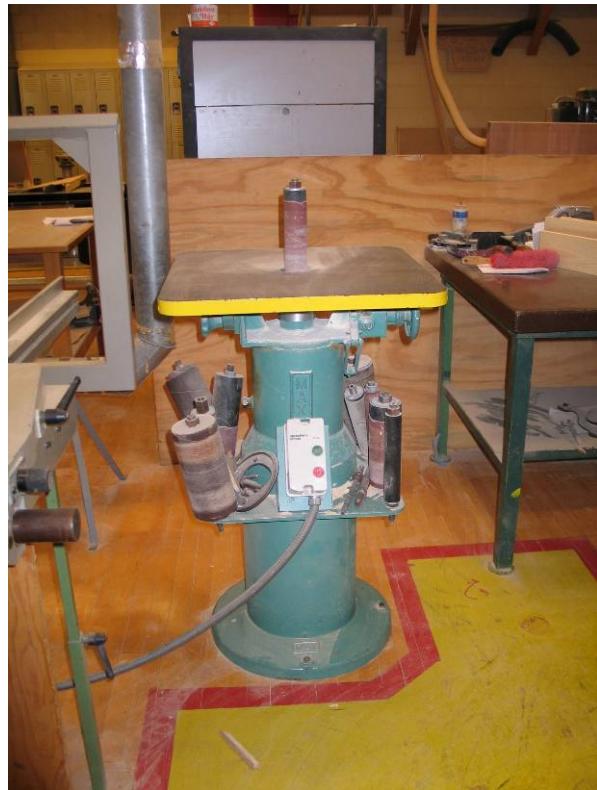
**Figure 1 – Spindle sander involved in the incident**

Incident #1 involved an oscillating vertical stationary spindle sander with a one horse power motor. The spindle sander was equipped with a 24 inch square horizontal table and a sanding spindle that protruded vertically through the table (Figure #1). Spindle sanders are designed to create clean, scratch free finishes to wood pieces. Spindle sanders are typically used to sand convex and concave surfaces, irregular curves and difficult to reach locations. Sanding with the spindle sander is typically performed by the operator using their hands to hold onto the wood piece during sanding, but a jig, a

device used to maintain the correct positional relationship between the wood piece and the spindle, can be used to increase sanding accuracy and stability. Multiple diameter spindles are available and the size of the spindle used depends on the task.

Although the spindle sander's unguarded spindle did not contribute to the injury the student sustained while operating the spindle sander (Incident #1), the unused top section of the rotating spindle sander should be guarded to prevent items such as the operator's hair and clothing from becoming entangled in the rotating spindle. Retrofitted guards for the spindle sander are also readily available.

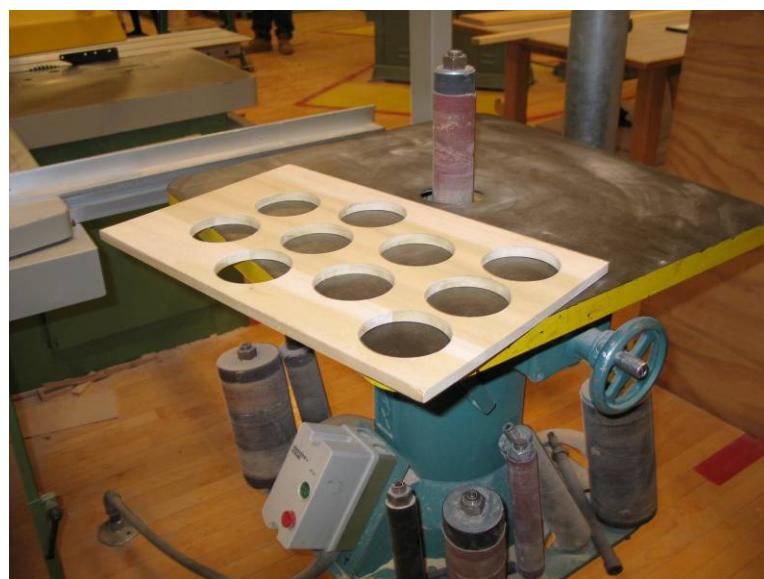
**Figure 2 – Wood piece being sanded**

On the day of incident #1, the student was working with a wood piece that contained multiple round holes (Figure #2). The wood piece was part of the student's project, which was to build a wine rack. At the time of the incident, the student was operating the spindle sander with a two inch diameter spindle to sand the interior edges of the round holes in the wood piece. During the sanding task, when the spindle was inside one of the holes and rotating, the student lost control of the wood piece when it started to rotate with the spindle. The rotating wood piece struck the student's hands. The student went to the school nurse's office, and a call was placed to the student's mother. The student was picked up at school by the mother and transported to a local hospital. The student had two fractured fingers on the left hand and cuts on the right wrist and thumb from the incident. The student missed two weeks of school after the incident.

In the incident involving the spindle sander, the injured student was sanding the interior edges of the round holes in the wood piece with a two inch spindle (Figure #2). If the student had been using a smaller diameter spindle, the area between the wood piece and the spindle would have been increased and would have reduced the continuous contact between the wood piece and spindle that most likely contributed to the student losing control of the wood piece.

**Discussion:** The size of the spindle to be used for a task should be based on the wood piece to be sanded. Larger spindles should be used only when sanding straight or gently curved surfaces. Smaller diameter spindles are best suited for wood pieces with tighter curves and/or more intricate details.

A hand held spindle sander might be a better piece of equipment to use when sanding the interior edges of holes in a wood piece. Use of a hand held sander would allow the wood piece to be clamped to a workbench during the sanding task, reducing the possibility of the wood piece rotating out of control.

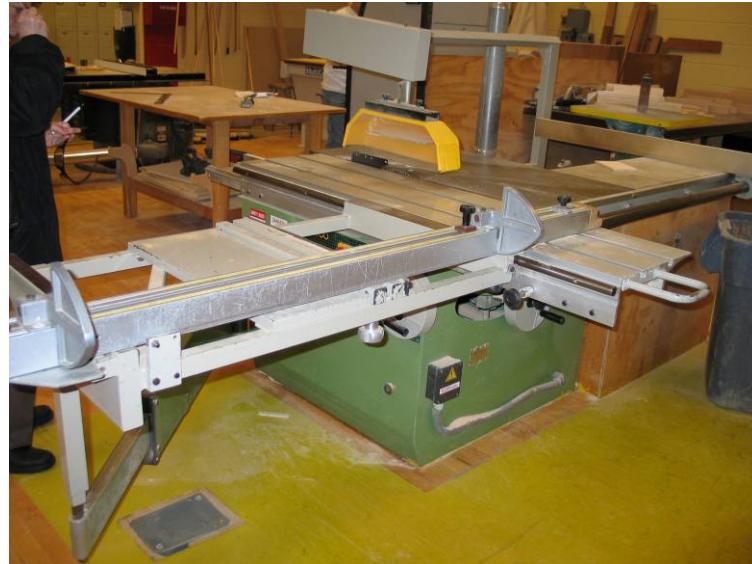
**Figure 3 – Table saw with sliding table involved in the incident**

Incident #2 involved a table saw with a nine horse power motor and a five foot sliding table (Figure #3). Table saws with sliding tables tend to be easier to handle and can provide a more accurate and precise cut than table saws without sliding tables. The sliding table is used to manually feed the wood into the rotating blade of the saw. Once the wood piece is positioned on the sliding table, the operator pushes/walks with the sliding table until the cut is completed.

The OSHA standard for woodworking machinery (29 CFR 1910.213) states that when using a circular hand-fed table saw to make a crosscut, the saw shall be guarded by a hood which shall completely enclose that portion of the saw above the table and that portion of the saw above the wood piece being cut. The hood and mounting shall be arranged so that the hood will automatically adjust itself to the thickness of and remain in contact with the wood piece being cut. The guard that was being used on the table saw at the time of incident #2 did not completely enclose the portion of the blade that was above the saw's table and was not an automatically adjusting guard.

In addition to the hood guard when crosscutting, the OSHA standard for woodworking machinery (29 CFR 1910.213) states that when using a circular hand-fed table saw to make a rip cut, the saw shall be furnished with a spreader to prevent material from squeezing the saw or being thrown back on the operator and anti-kickback fingers (or dogs) to prevent the wood piece being cut from being thrown back toward the operator. Although at the time of the incident involving the table saw the student was not ripping a wood piece, the saw was equipped with a spreader but was not equipped with anti-kickback fingers.

**Discussion:** As discussed, in the incident involving the table saw (incident #2), the saw was equipped with a manually controlled blade guard/dust hood that did not meet the requirements of the current OSHA standard 29 CFR 1910.213. The blade guard/dust hood was bulky and made of plastic; only one side was a clear plastic, the other sides of the guard were an opaque yellow plastic (Figure #3).

The blade guard/dust hood required the saw operator to manually adjust the guard for each cut. Although the saw was not being operated at the time of the site visit, the blade guard/dust hood was in the up position and was not covering the saw blade.

This blade guard/dust hood was designed to accomplish two functions: 1) to protect the saw operator and others from the rotating saw blade; and 2) to function as a hood to collect wood dust generated during the cutting process as part of the dust collection system. The dust collection function of the blade guard/dust hood was no longer in use at the time of the incident and during the site visit. The school had installed a down draft dust collection system on the table saw. Therefore, the equipment was being used for one of the two functions for which it was designed. Retrofitted guards for table saw blades that meet the requirements of the current OSHA standard are available.

Had the guard been designed for the sole purpose of reducing the chance that the saw operator would come in contact with the rotating saw blade, the guard's design might have offered a higher level of protection that would include features such as:

- automatically adjusting to the wood piece thickness, as required by OSHA, to keep the guard in constant contact with the wood piece being cut which would keep the blade covered at all times;
- smaller size to be less bulky;
- increased visibility of the point of operation by using clear plastic for the entire portion of the guard covering the blade.

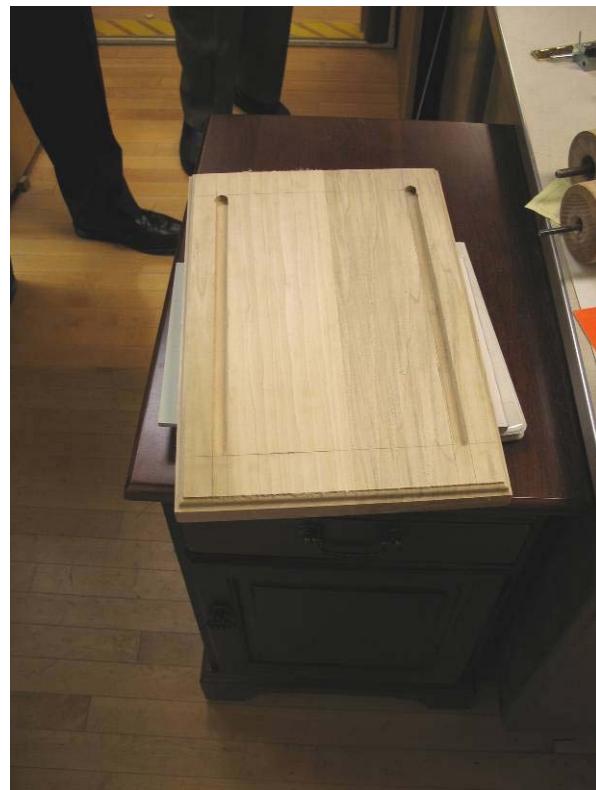
**Figure 4 – Wood piece being cut**

On the day of incident #2, the student was working with a wood piece that measured 11 inches wide x 16 inches long x 1 ½ inches thick (Figure #4). The wood piece was part of the student's project to build an occasional table. The student had made a cross cut to shorten the wood piece to the required length for the project. After the student finished the cross cut, the student reached either to remove the piece of wood that was cut off, or to grab the wood piece to rotate it and prepare for the next cut when the student's hand came in contact with the rotating saw blade. Immediately after the incident, the school nurse was called to the shop and then emergency medical services (EMS) were called. EMS arrived at the shop within minutes and transported the student to a local hospital. The student received 32 stitches in the right hand.

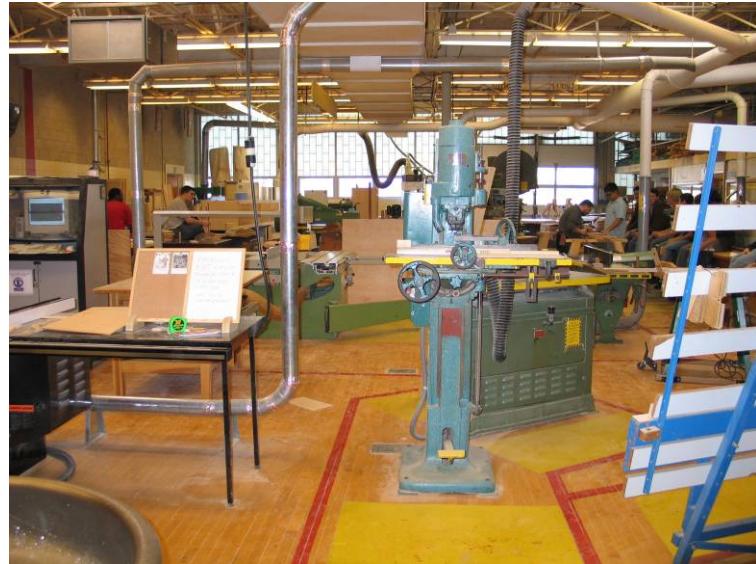
**Figure 5 – Mill/Carpentry shop**

**Discussion:** Both the spindle sander and the table saw involved in these incidents were located near the shop’s door that lead to a hallway. Relocating or reorienting the equipment could reduce the possibility of the operators being distracted by individuals entering, exiting or walking by the shop. Rotating the spindle sander clockwise, so the operator would be facing a wall when operating the sander, might reduce operator distractions. Relocating the table saw closer to a wall away from the doorway and positioning it so the operator has the least amount of contact with the other students in the class could also reduce the possibility of the operator being distracted operating the equipment.

It appeared that the overall layout of the shop could be improved (Figure #5). The shop was divided into two sections by an office for the teachers. The location of the office created a U-shaped shop area. One side of the shop was setup and used as a classroom, and the other side of the shop is where all of the machines were located, which seemed tight for space. The entire shop layout should be reevaluated, and the possibility of moving or changing the shape of the teachers’ office to allow for more space for the machines should be given some consideration. Any redesign should maintain ability of the teacher to have all students in view while using equipment.
