# STATE OF NEW YORK DEPARTMENT OF HEALTH

## FATALITY ASSESSMENT AND CONTROL EVALUATION

### Worker Crushed by a Crate of Glass at a Residential Construction Site

Case Report: 06NY001

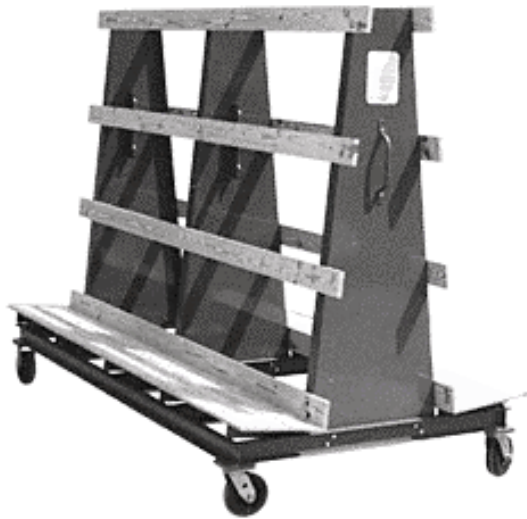
“A” frame carts (Photo 3) are available from material handling and fenestration equipment manufacturers. Currently these carts are mainly being used by the glass manufacturing industry. The “A” frame carts have angled supports and mechanisms to prevent loads from sliding and kicking back. With modification, it may be possible for the “A” frame carts to be used in construction sites and construction workers or glaziers could avoid manually tilting the crates. However, there are no standards or guidelines developed by American National Standards Institute (ANSI) or other standard setting bodies on designing, testing and using “A” frame carts. Manufacturers of the products should research and explore the possibility of safely adapting these devices for use at construction sites.

Photo 3. An example of “A” frame cart. \*
