SUBJECT: A forklift operator died when he was crushed in the mast of a forklift.

California FACE Report #04CA012

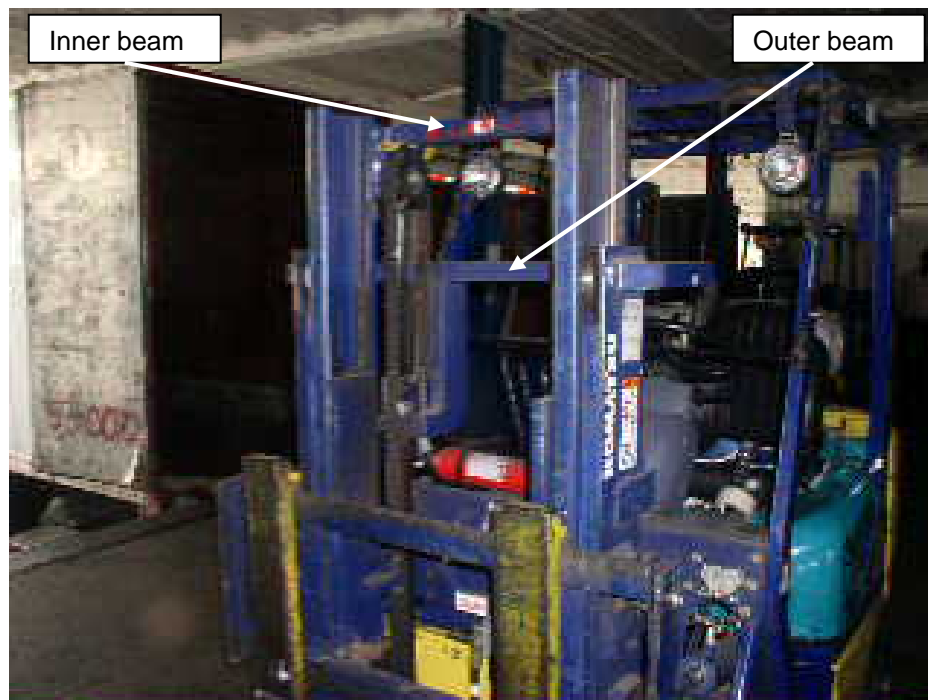
The site of the incident was a truck depot for the company where trucks exchange cargo for shipping. The machine involved in the incident was a forklift designed to enter the enclosed beds of trailers. The forklift was equipped with a seat belt. The forklift mast consisted of an outer mast which was stationary and an inner mast which was telescopic.

Exhibit #1: A picture of a forklift similar to the one involved in the incident.

Discussion: There are several devices which may have prevented this incident if they had been installed on the forklift. A screen (clear plastic or metal grate) in front of the forklift operator cabin would have prevented the operator from reaching forward between the masts. A safety interlock that requires the operator to engage two controls before moving the forks would have kept the mast from descending on the victim. A pressure interlock under the operator seat would have locked the controls in place when the pressure on the seat was released, or a sensor device could be attached to the seat belt of the forklift that when disconnected would shut off the power to the forklift. These are just some devices that, if installed on the forklift, might have prevented this incident from occurring.

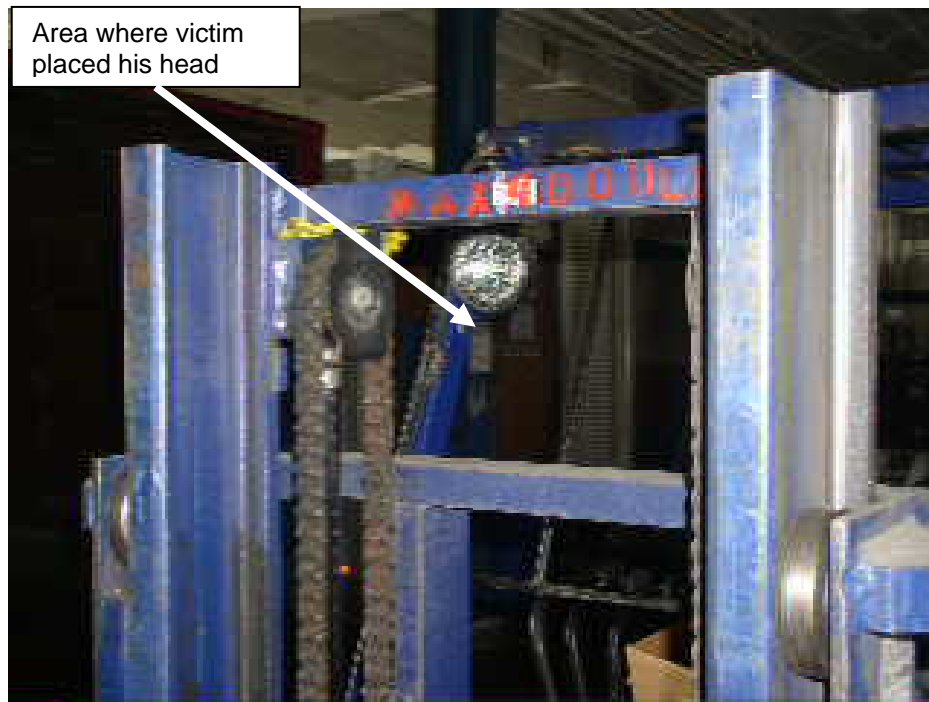
Although the incident was not witnessed, the position of the victim's body suggests that as he leaned forward and stuck his head between the beams of the outer and inner forklift mast, his right leg pushed the control lever forward. This caused the inner mast to come down on the victim's head before he could move out of the way.

Exhibit #2: A picture of the forklift mast showing where the victim placed his head.

Discussion: In this incident the victim was not wearing a seat belt while the forklift was running. This allowed him to lean forward into the mast structure. The operator of a forklift should always keep his/her seat belt fastened until the forklift is shut down. In this incident, if the

forklift operator had kept his seat belt fastened, he would have been unable to lean into the mast structure.
