SUBJECT: A 17-year-old Hispanic laborer died when crushed by concrete and stone castings.

SUMMARY
California FACE Report #05CA005

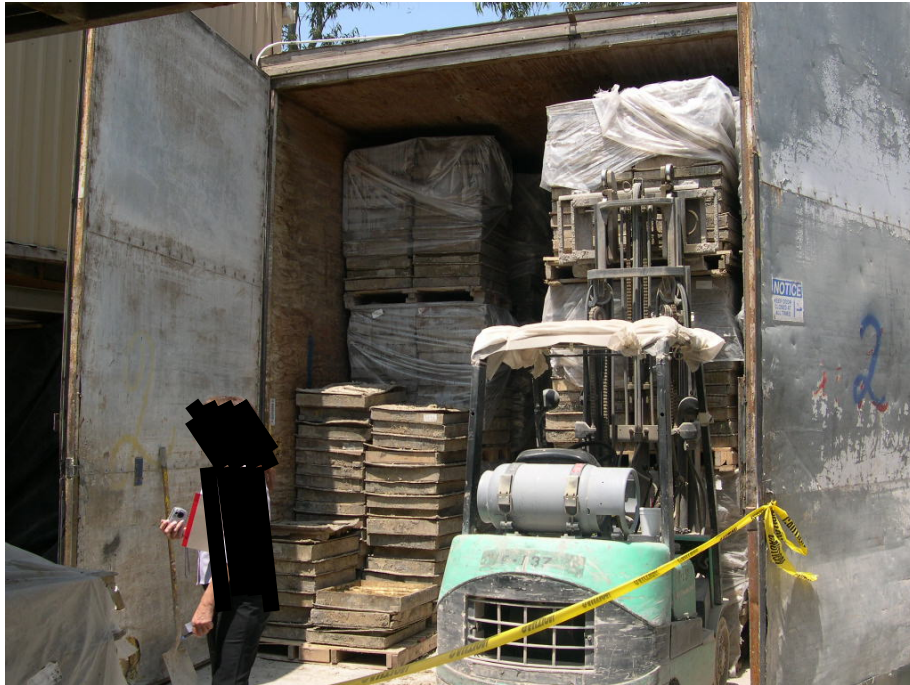
Exhibit 1. The incident scene showing the curing oven and the position of the forklift when the incident occurred.

The site of the incident was a curing oven located at a manufacturing plant that made concrete and stone products. On the day of the incident, the victim was helping forklift operator place a pallet of newly formed concrete and stone castings into a curing oven (Exhibit 1). The victim was acting as the eyes for the forklift operator because the load was obstructing the forklift operator’s view. The victim was standing in front of the forklift and near stacked pallets in the curing oven as he guided the forklift operator with a load of palletized concrete and stone castings into place. Without warning, the stacked pallets within the curing oven collapsed. The victim was unable to get out of the way and was crushed by the falling material. Several employees responded to help rescue the victim. The paramedics were called, and they treated the victim then transported him to a local hospital where he died from his injuries. The pallets that were used in the curing oven were of construction and design that were not compatible with the weight of the material being stored on it.

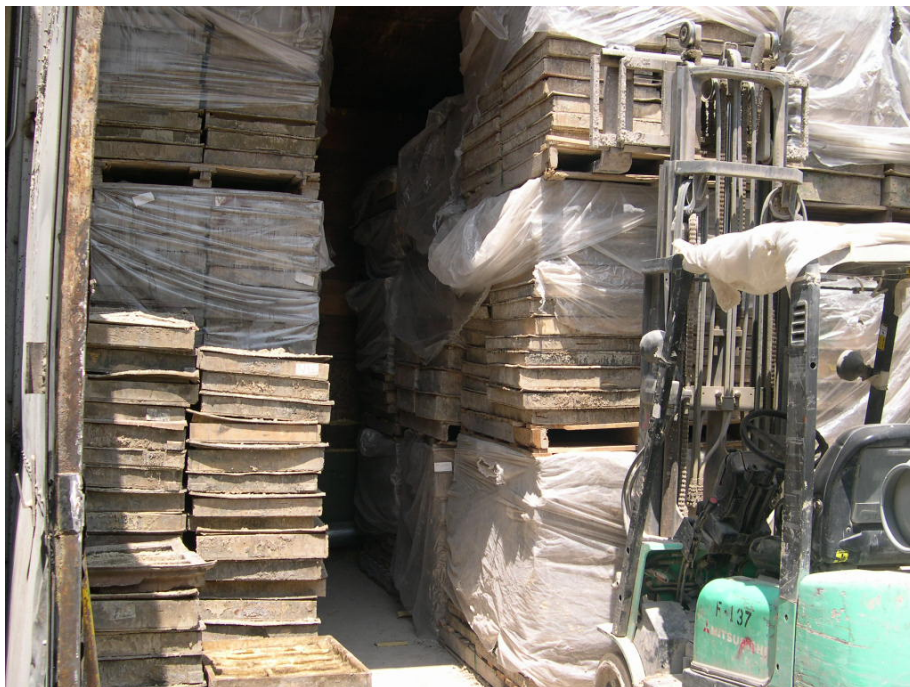
Exhibit 2. The incident scene showing the concrete and stone castings stacked on pallets in the curing oven. The pallets on the left collapsed onto the victim.

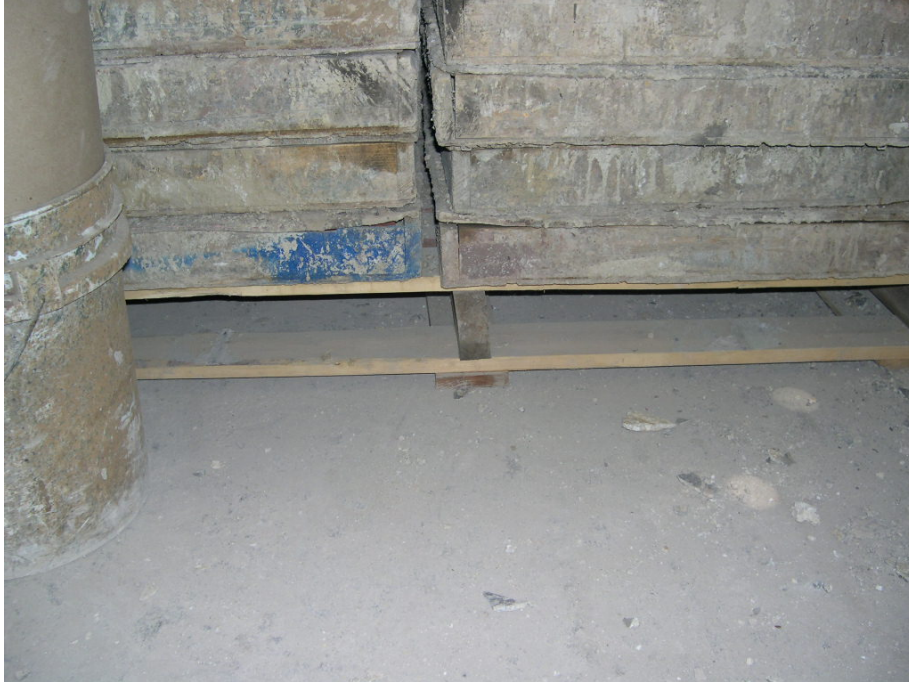
Exhibit 3. A picture of pallets used to stack concrete and stone castings.

Discussion: The material being stored in this case was heavy. When materials are stored on pallets, and then stacked on top of one another, the pallet must be designed to hold the weight of the material. In this case, some of the pallets being used were not of the proper design and construction to support all the weight of the concrete and stone

castings. Had heavier constructed pallets been used to stack and store the concrete and stone castings, this incident might have been prevented.

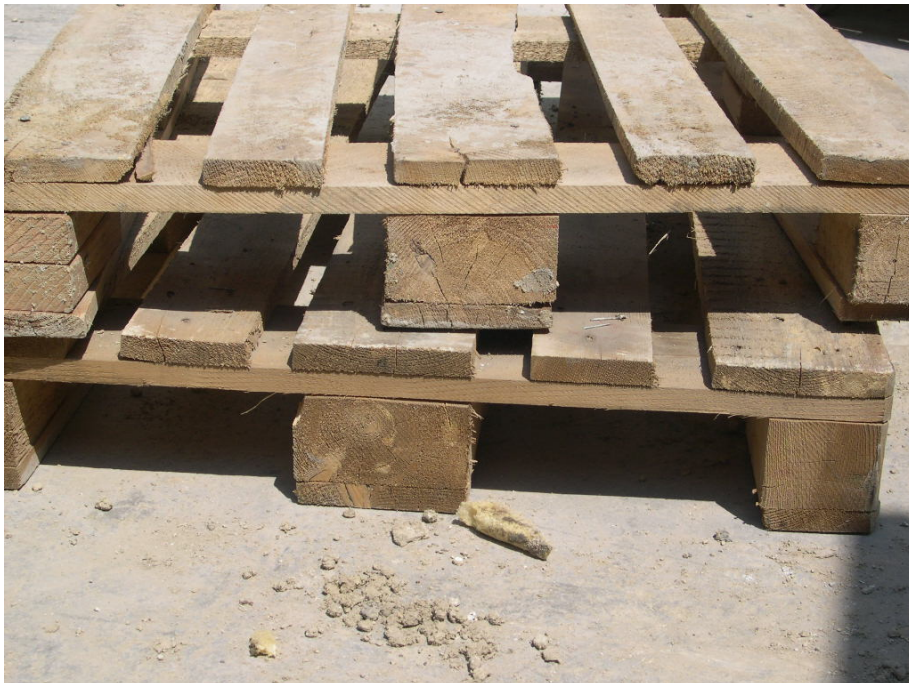
Exhibit 4. This type of pallet is strong enough to support stacked concrete and stone castings.

Recommendation #1: Ensure employees use the proper pallets to support the weight of the material being stored.
