**SUBJECT:** A utility cleanup worker for a brick manufacturer suffocated in a storage silo.

## SUMMARY

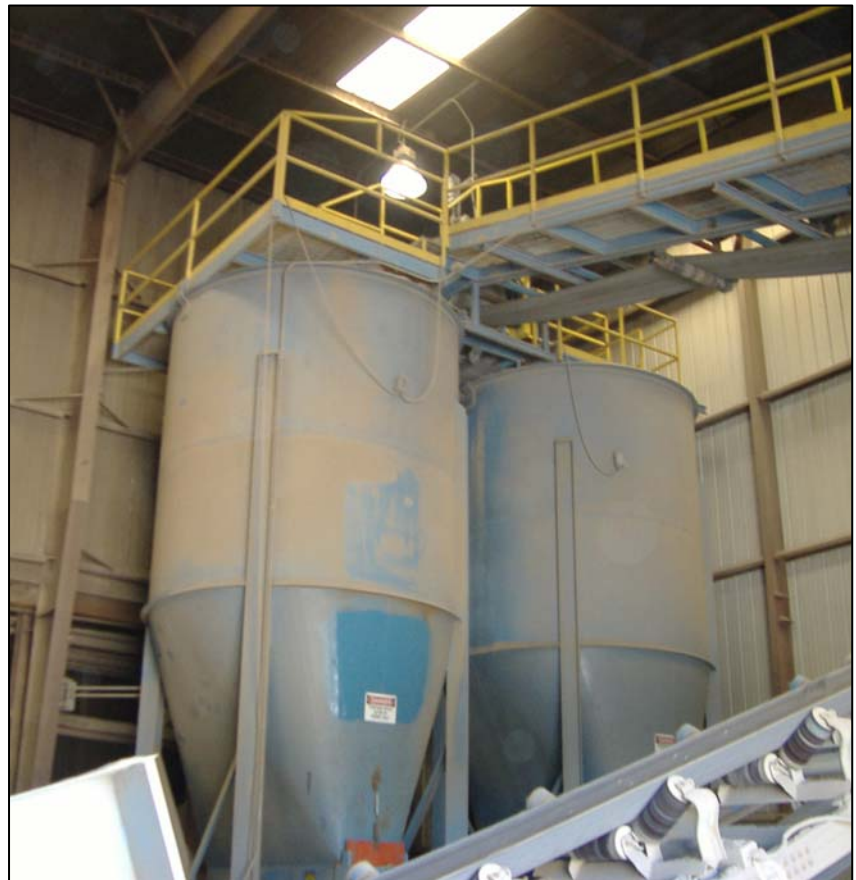
Figure 1. Silo involved in the incident

The incident involved one of two storage silos used to hold a final mix of ground shale (Figure 1). The silos were built in 1998 and maintained in good condition, but manufacturer instructions and warning devices were not present. An in-feed conveyor was used to fill the silos and an out-feed conveyor operated below the silos to carry ground shale to the next step in the manufacturing process (Figure 2). A utility crew was present on each of three shifts as the manufacturing facility operated 24 hours a day. The victim was a member of the crew whose shift was scheduled to end at 9:00 p.m. At the end of each shift, a cleanup crewmember was required to check a full silo indicator light and also ascend a stair and catwalk system (Figure 3) to the top of the silos to verify visually that the silos were full. It was standard practice to verify the contents of the silo by the use of the indicator light and a visual inspection. The safety policy prohibited employees from entering a restricted area while

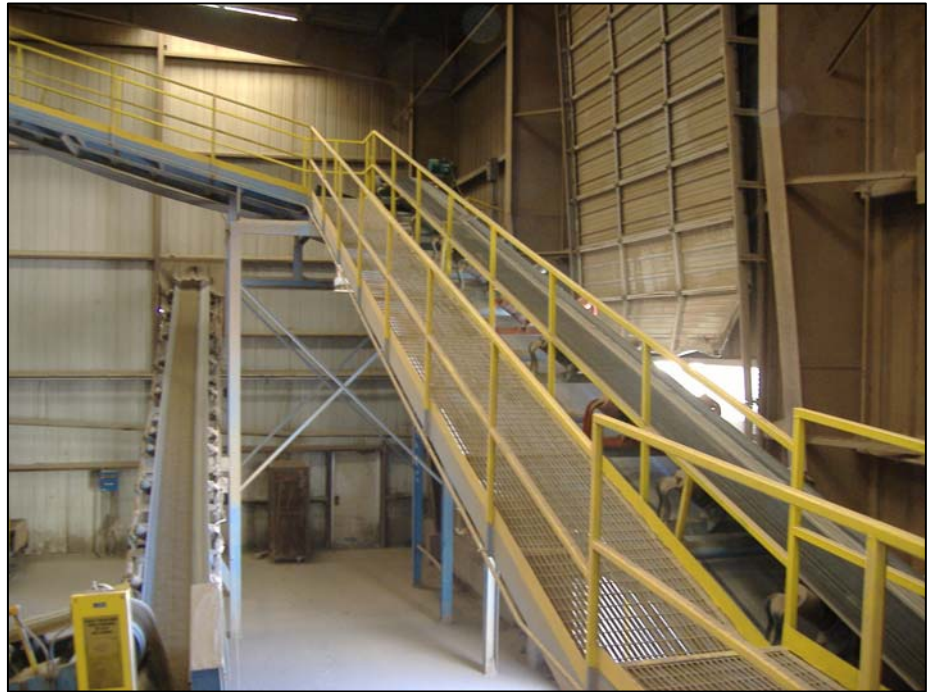
machines were in operation; however, the top of the silo area was not marked as restricted. The opening from the observation and work platform leading into the top of the storage silo was unguarded and signs were not posted to restrict access. If the silos were not full, employees would have to continue to work beyond the end of their shift to fill the silo and cover a sensor that was located inside the top edge of the silo. Each shift was supposed to leave full silos for the incoming shift of workers.

Figure 3. Catwalk system used to access the top of storage silos

**Recommendation #1:**  
Employers should install danger signs and guards to restrict employee access to confined spaces.

Discussion: According to OSHA regulations, danger signs reading "DANGER – PERMIT-REQUIRED CONFINED SPACE, DO NOT ENTER" or signs using similar language should be posted at the entrance of confined spaces. All posted signs should be appropriate for the language and literacy level of all employees in the area. In addition to signs, guards in the form of railing, doors, chains, or other physical barriers should be installed to restrict voluntary or involuntary (i.e., falling) employee access to confined spaces. Danger signs and physical barriers can be useful in reinforcing written procedures and safety training to restrict unauthorized employee entrance of confined spaces. Posting signs, however, does not negate the need for a comprehensive confined space entry program and effective training.

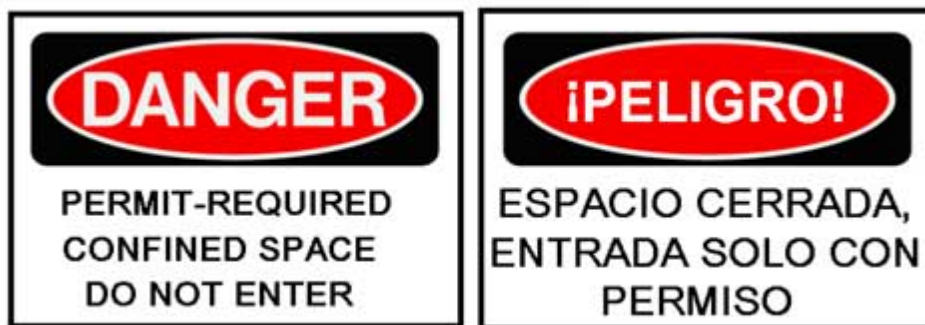
Figure 5. Example of a warning sign in English and Spanish
